MISUSE OF THREE-POINT OCCUPANT RESTRAINTS
IN REAL-WORLD COLLISIONS

Robert N. Green
Alan German
Zygmunt M. Gorski
Edwin S. Nowak
University of Western Ontario

D. Murray Dance
Transport Canada

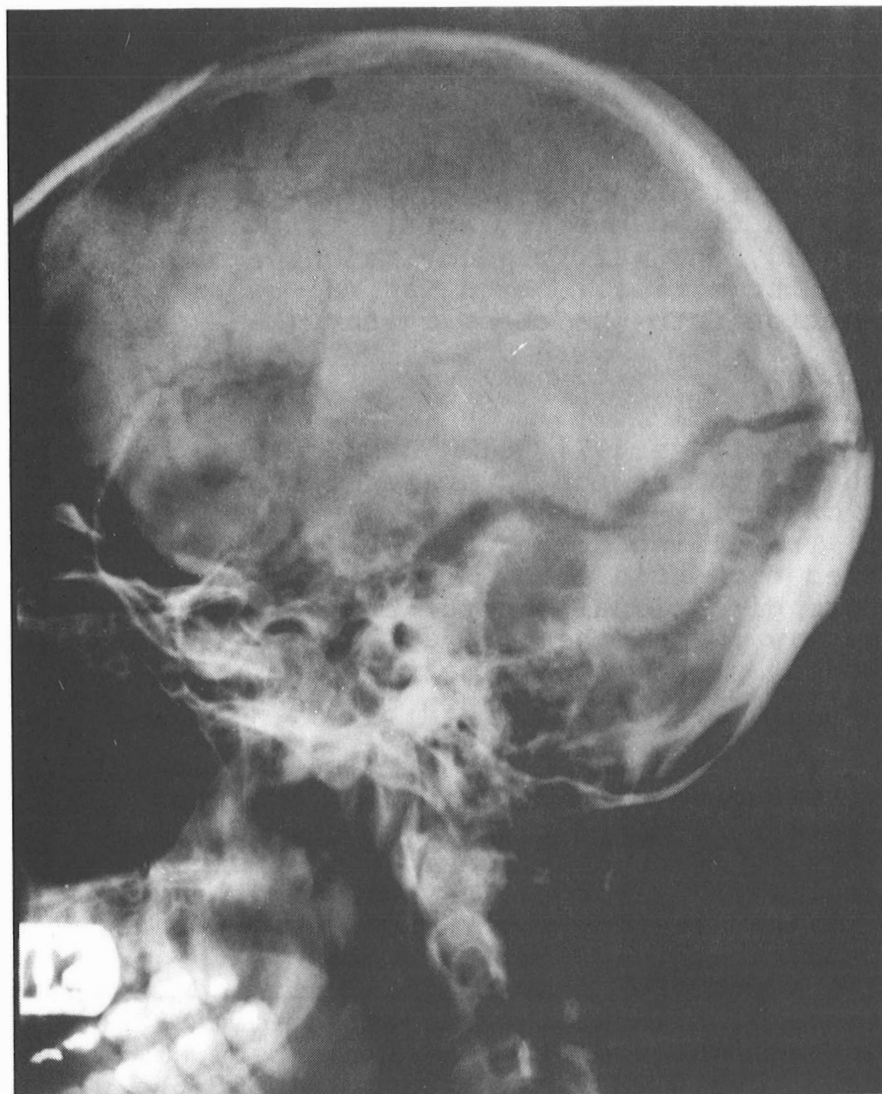
Despite the degree of side intrusion into his occupant space, the lap-belt restrained truck driver survived the impact with multiple major fractures and serious internal injuries. The fully-restrained driver of the case vehicle loaded the upper portion of the steering wheel rim with her head, bending the rim forward and causing a 3 cm impression in the upper instrument panel. This forceful head contact resulted in a spectacular skull fracture, bilateral basal and bi-occipital (Figures 1 and 2), with transection of the basilar artery and avulsion of the brain stem. Death was instantaneous (MAIS 6).

Figure 1 Radiograph showing lateral view of the bilateral basal and bi-occipital skull fracture to the driver in Case Study No. 2

Case Study No. 2 represents an inadvertent panic ducking manoeuvre that places the head forward and downward prior to any sudden vehicle motion such as braking which would have engaged the restraint system's emergency locking retractor. Pelvic contusions in the region of the anterior, superior iliac spines were evidence of the proper positioning of the lap belt prior to collision. If the driver had maintained an upright posture prior to collision she would have experienced enough forward excursion to make head contact with the steering wheel. From our reconstruction, and the known performance of this restraint system in crashes of this severity, the head injuries would have been much less severe than actually occurred. Driver education is necessary to avoid such panic manoeuvres as head ducking.

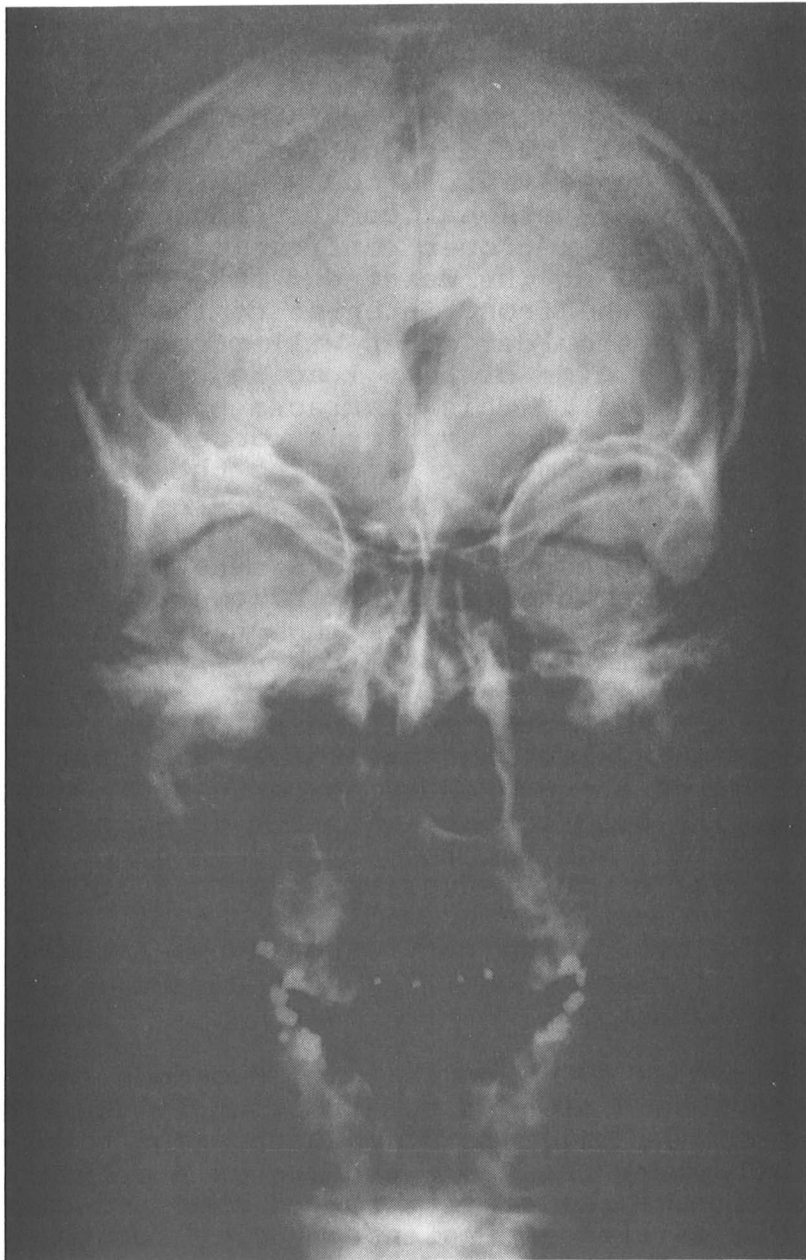
Figure 2 Radiograph showing frontal view of the bilateral basal and bi-occipital skull fracture to the driver in Case Study No. 2

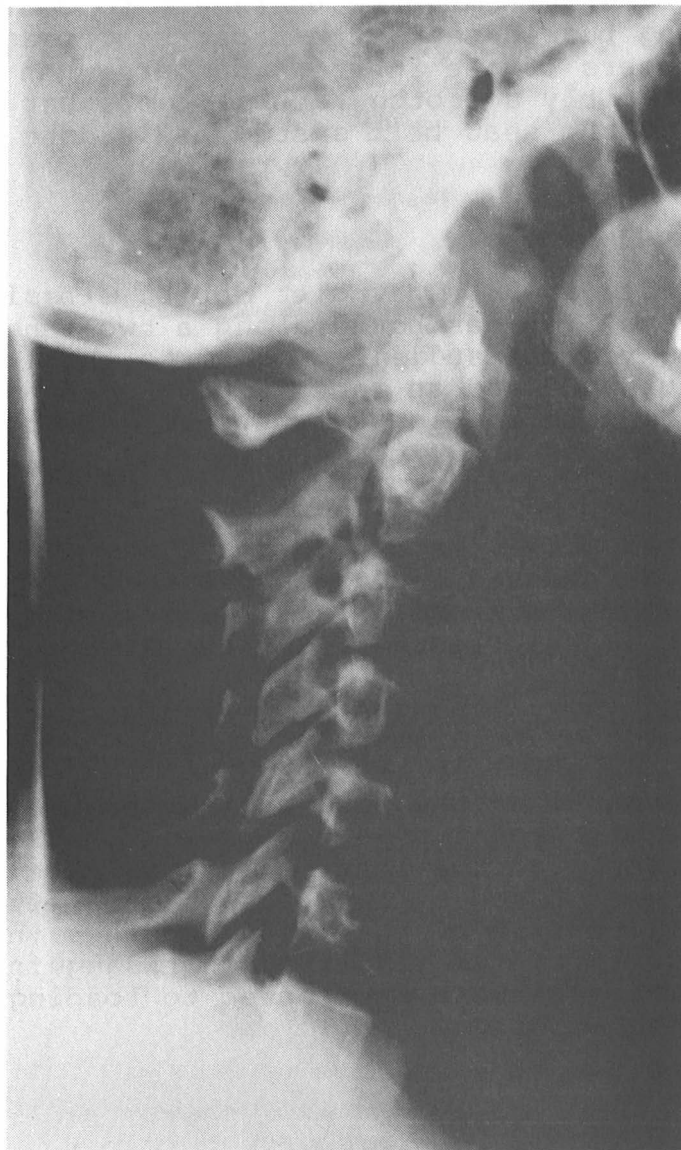
The right-front passenger in the case vehicle was fully restrained and had the back rest of her bucket seat in the fully-reclined position. As a result of the frontal impact the occupant slid forward and the torso portion of the restraint system caught her under the chin. She sustained a fracture of the lateral pedicles of C2 and fracture of the superior and inferior articular facets of C2-C3 on the right side (Figure 3). There was a minor sprain to the right ankle. She was unconscious briefly and subsequently complained of pain to the neck and shoulders. She lost function in both legs (MAIS 3).

Figure 3 Radiograph of the cervical spine of the front passenger from Case Study No. 3 showing the hangman's fracture

This female passenger, belted in the supine position, slid under her restraint system at the time of frontal collision. The shoulder harness engaged her upper neck and chin resulting in a hangman's fracture with moderate spinal cord damage at level C2. Distraction of the upper cervical spine with the head in extension is the mechanism employed in judicial hanging,

calculated to traumatize or sever the cord and cause instant death. The mechanisms of such injuries resulting from automobile collisions are discussed in detail in a companion paper (2). If vehicle manufacturers are to continue to provide fully reclining bucket seats for front seat passengers, they must caution users of the inherent dangers when the vehicle is in motion. Possibly a crotch harness component could be introduced into the seat belt system as is done in Formula 1 racing cars.
