Pedestrian Injury Patterns in the United States and Relevance to GTR

Becky C. Mueller, Joseph M. Nolan, David S. Zuby, Anne G. Rizzo

Keywords GTR 9, injury patterns, pedestrian crashes, United States

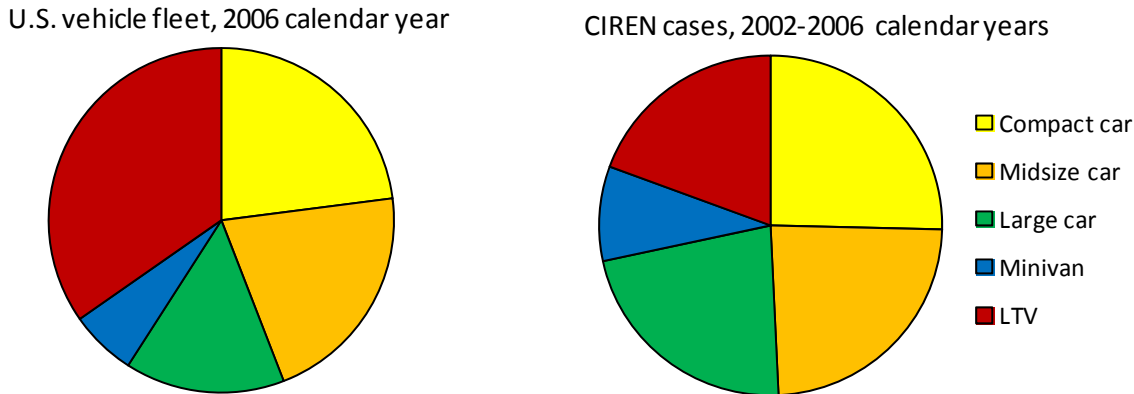
Fig. 1. Distribution of vehicles by class for U.S. vehicle fleet and CIREN pedestrian-striking vehicles

Striking vehicles were manufactured during 1986-2006. Figure 1 compares the distribution of study vehicles by class with the composition of the U.S. vehicle fleet in 2006. There were more large cars and minivans and fewer light trucks and vans (LTVs, i.e., pickups and SUVs) in the sample than would be expected from the fleet composition in 2006.

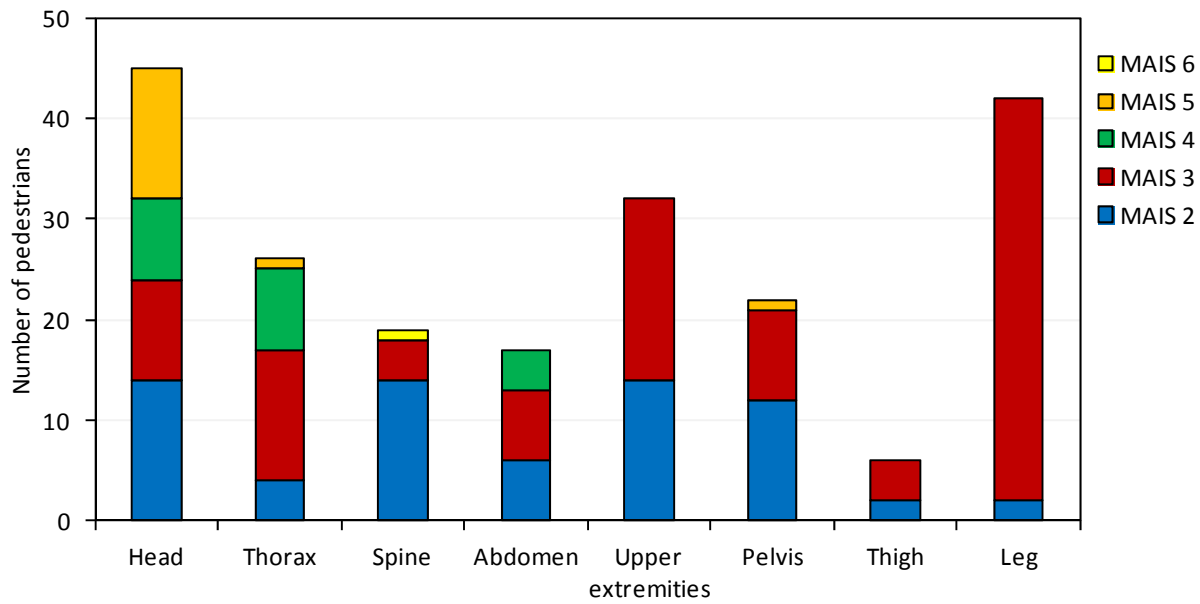
Fig. 2. Distribution of MAIS scores by pedestrian body region

Figure 2 shows the distribution of maximum AIS (MAIS) scores by body region for injuries of AIS 2 and greater. Injuries with severities greater than MAIS 3 most commonly involved the head, thorax or abdomen. The majority of AIS 4+ head injuries involved brain injuries, the majority of AIS 4+ thorax injuries involved rib fractures or lung contusions and the majority of AIS 4+ abdominal injuries involved spleen or liver lacerations. The MAIS 6 spinal injury was a complete cord syndrome, and the MAIS 5 pelvis injury was an open book pelvis fracture with greater than 20 percent blood loss. Seventy percent of all cases had MAIS 3 or greater injuries to the torso, spine, abdomen or pelvis.

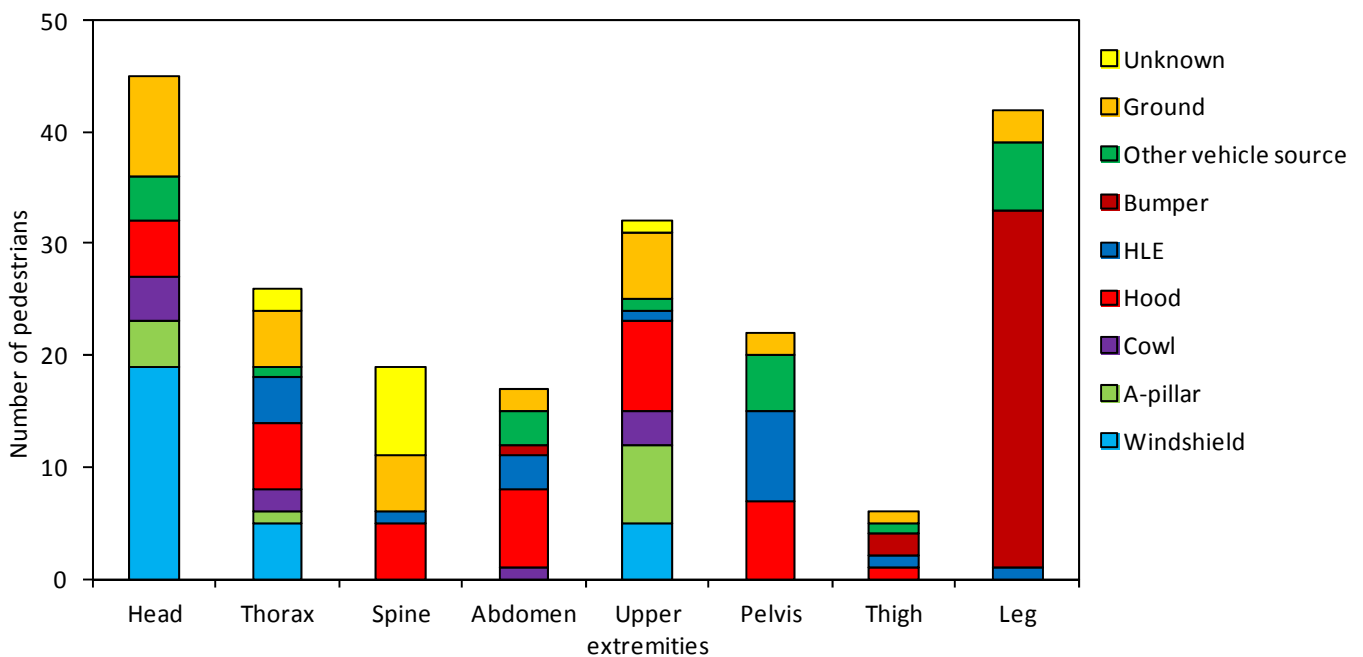
Fig. 3. Injury source associated with the most severe injury by body region

Figure 3 shows the injury sources associated with the most severe injury for each body region for all pedestrians in the sample. With the exception of spinal injuries, impacts with vehicle components accounted for the majority of injuries in each body region.

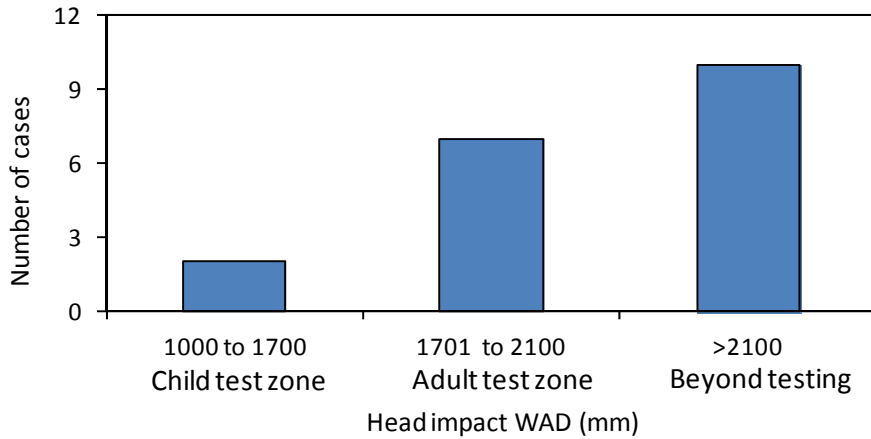
Fig. 4. Measured head impact location WAD for head-injured pedestrians

The WAD of the head impact location was available for 19 of the 40 pedestrians with head injuries. Figure 4 shows the distribution of head impact WADs relative to the GTR 9 test zone definitions. Although nearly half of the impacts were within one of the test zones as defined by the WAD boundaries, only two were on the hood. Figure 5, which shows the distribution of WADs for the rear of the hood, indicates that only one of the 19 vehicles had a hood with a rear edge behind the rearward extent of the adult test zone WAD. The locations of the 19 impacts are shown in Figure 6. In this figure, the locations of head impacts were scaled relative to the

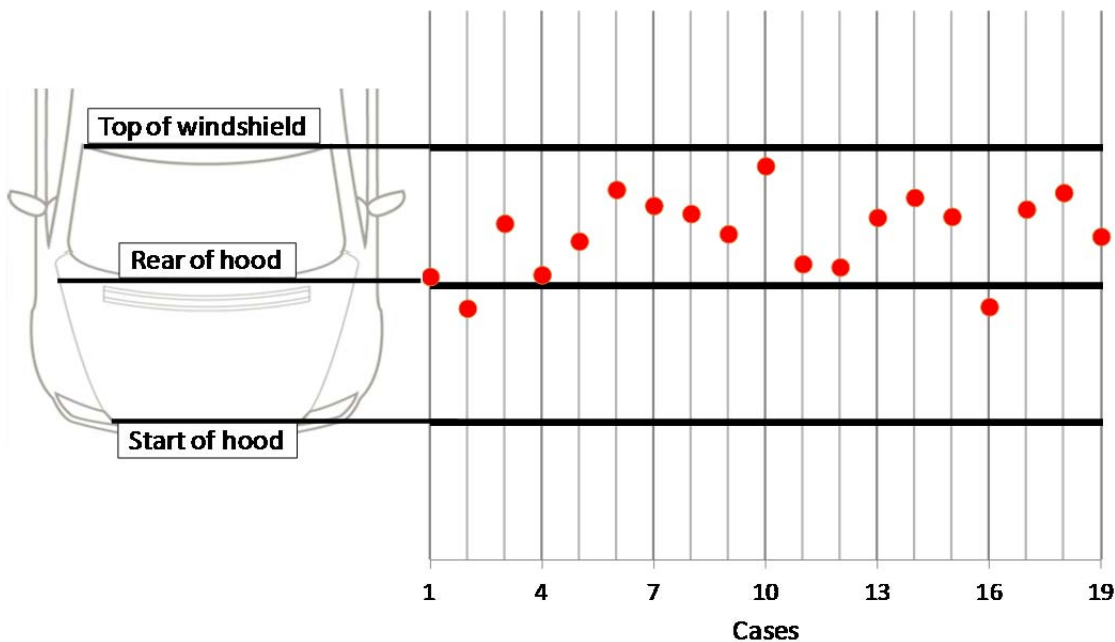
Fig. 6. Normalized head impact locations relative to vehicle landmarks for pedestrians with AIS 2+ head injuries

difference between WADs for the HLE and hood trailing edge of the actual striking vehicle, and windshield/A-pillar impacts were scaled relative to the difference between WADs for the leading and trailing edges of the windshield. Only 2 of the 19 impacts resulted in contact with the hood, while the remaining was beyond the hood in the range of the windshield and A-pillar.

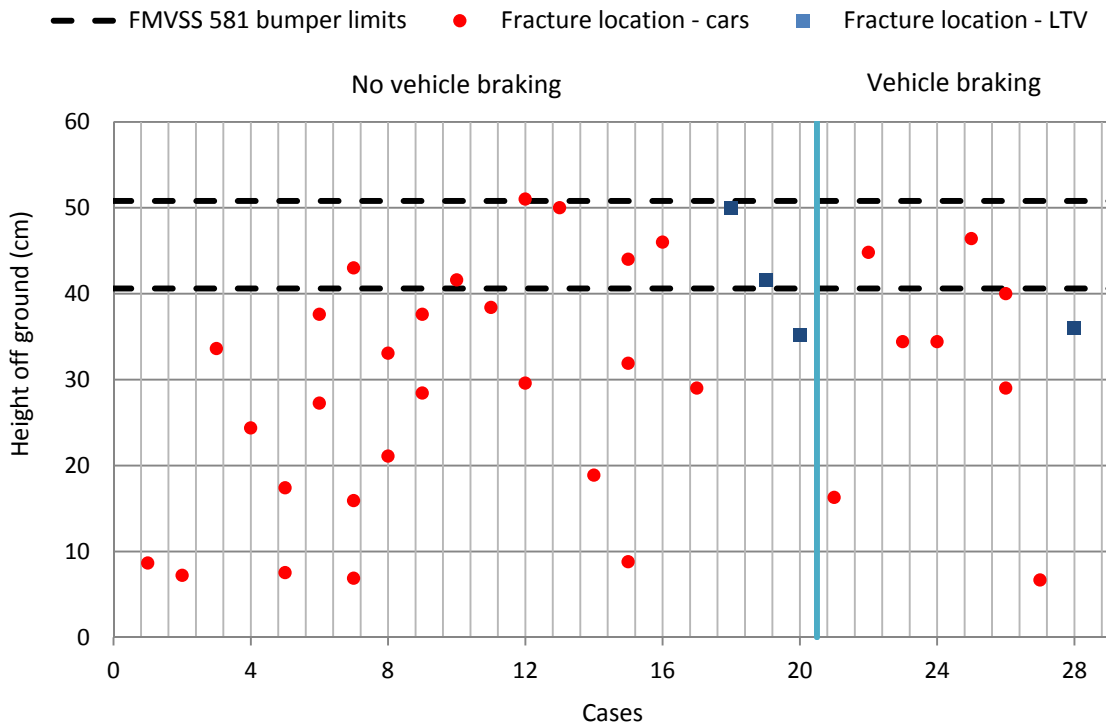
Fig. 9. Leg fracture locations relative to average bumper bar height

The recorded tibia and fibula fracture locations from X-rays for each of the 28 pedestrians were compared with the height off the ground relative to the bumper zone specified in Federal Motor Vehicle Safety Standard 581, as shown in Figure 9. The 28 cases are grouped according to whether or not the report indicated vehicle braking. Braking affects vehicle pitch and the actual height of the bumper bar in these cases may be below the bumper zone limits illustrated in the figure.

Ten of the 28 pedestrians had leg fractures that aligned with the approximate height of the striking vehicle bumper. The other 18 had fractures below the height of typical bumpers. Four pedestrians were struck by a pickup or SUV (LTV), for which bumper heights may be greater than those mandated by FMVSS 581 for cars.

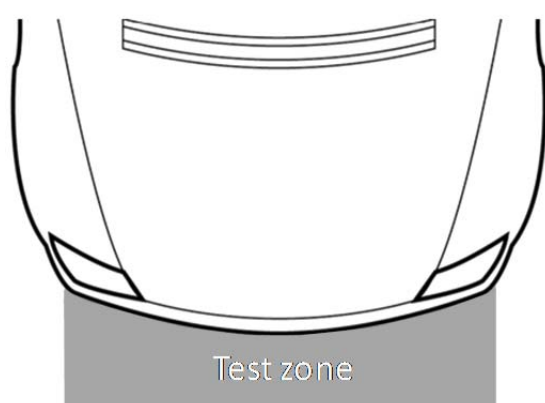
Fig. 10. Representative GTR 9 bumper test zone for case vehicle designs

Although the large majority of leg injuries in the study sample were associated with impacts in the GTR 9 test zone for the striking vehicle design, recent design trends may reduce the efficacy of the GTR 9 leg protection requirements. Figure 10 shows the plan view of typical bumpers for the study vehicles. The GTR 9 test zone covers 74 to 98 percent of the vehicle's overall width. In contrast, Figure 11 shows the same view of a bumper shape becoming more common among new vehicle designs. Due to the protrusions near the center of the bumper in these designs, the GTR 9 test zone is reduced to 39 to 60 percent of the vehicle overall width. Appendix B includes pictures and bumper zone measurements for specific examples of such designs. EuroNCAP recognizes that the test zone defined in GTR 9 may not always capture the bumper zone of modern vehicles due to bumper styling contours. Consequently, EuroNCAP [28], with test procedures similar to those of GTR 9, includes testing outside of the specified test zone if components in these areas appear injurious. A similar exception for GTR may increase relevance of bumper testing with modern vehicles.
