Errata in

Paas R, Davidsson J, Masson C, Sander U, Brodin K, Yang JK (2012), *Pedestrian Shoulder and Spine Kinematics in Full-Scale PMHS Tests for Human Body Model Evaluation*, International Research Council on the Biomechanics of Injury Conference (IRCOBI); Dublin, Ireland, p. 730-750.

## Pedestrian Shoulder and Spine Kinematics in Full-Scale PMHS Tests for Human Body Model Evaluation

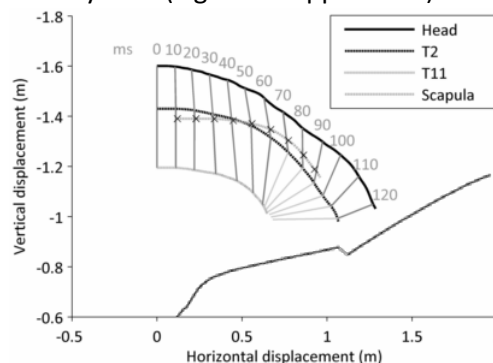
Fig. 3. Displacements of the head CG, T2 and T11 vertebral body centres and the scapulae in relation to the vehicle; test FSR02. Movement in y-direction was not considered. T11 displacement after 68 ms was estimated.

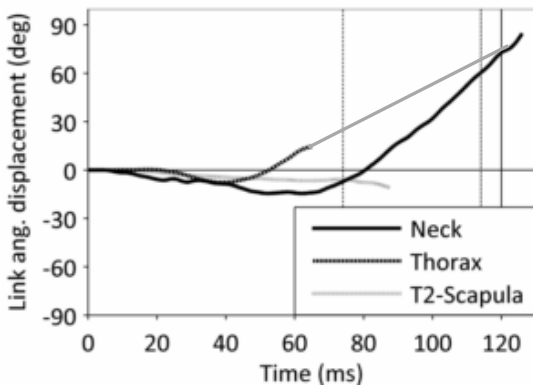
Fig. 4. Link angular displacements, test FSR02. Thorax angle was estimated from 65 ms to head impact.

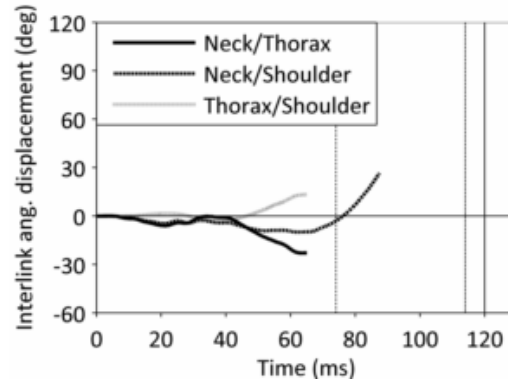
Fig. 5. Interlink angular displacements, test FSR02.

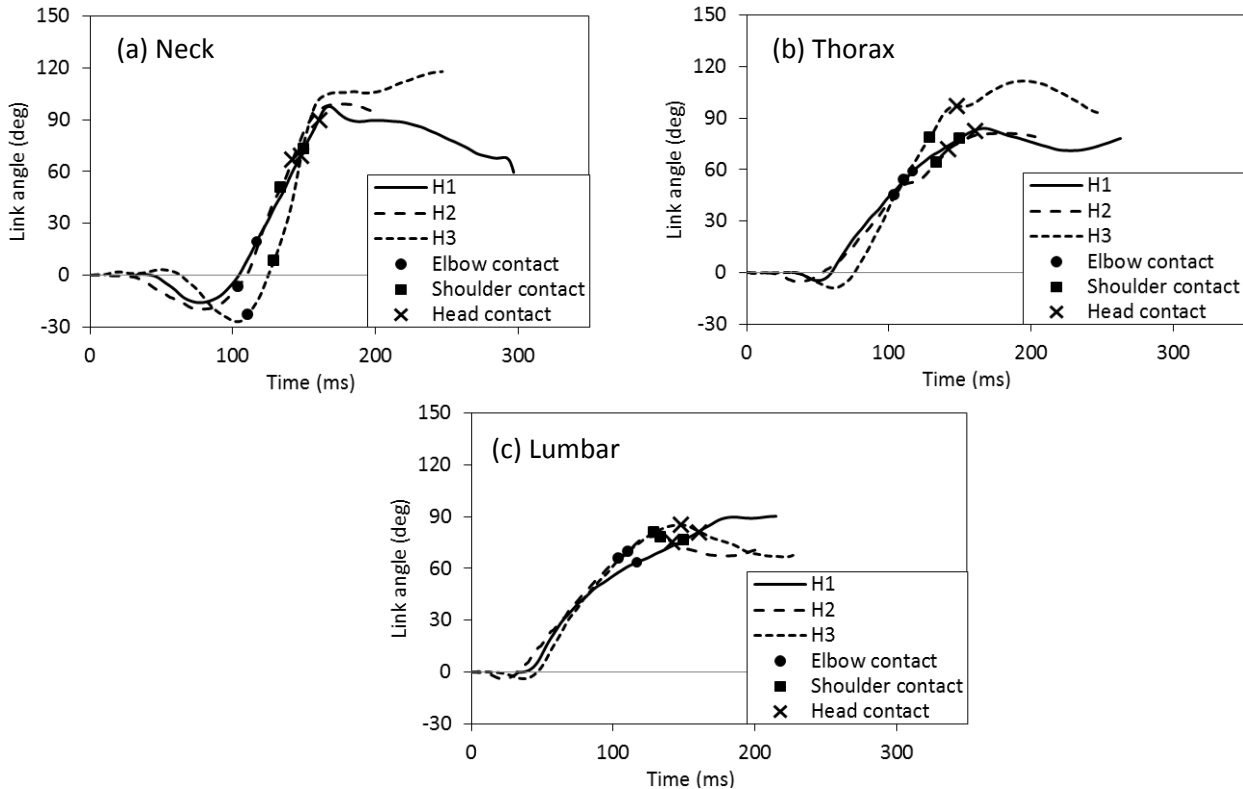
Fig. 6. Link angular displacements projected into the film plane; tests H1, H2 and H3.

The thorax of the subjects' continuously rotated towards the vehicle in the coronal plane until head contact (Fig. 6b). Thereafter, the angle increased only slightly. Thorax rotation in the subjects' sagittal plane was not visible in any of the tests. After head impact and in the transverse plane, the thorax showed a slight clockwise rotation towards the vehicle in H1 and H3, whilst the contrary showed in the H2 test. The latter appeared to be the consequence of early leg and pelvis anticlockwise rotation.

Thorax motion highly influenced neck and head kinematics. Due to the flexibility of the neck, head rotation was different to thorax rotation (Fig. 6a). In the sagittal plane and around the time of pelvis impact, the head began a slight forward rotation in the H1 and H2 tests, but then rotated rearward again such that the neck was neutral in the sagittal plane at the time of head contact. In the transverse plane, all head rotations began around the time of pelvis impact, directing the face away from the vehicle, and continued until elbow impact. In the coronal plane, while the thorax rotated towards the vehicle, the head lagged behind resulting in a lateral neck flexion. Around the time of elbow contact, the head began to rotate in a transverse and coronal direction towards the vehicle. This may be a result of the support that the elbow-shoulder complex provided for the thorax. However, in the H1 test, the upper arms were tied to the thorax. Thus, the elbow did not move away from the body as much as in the H2 and H3 tests, and for this reason provided less support for the thorax.

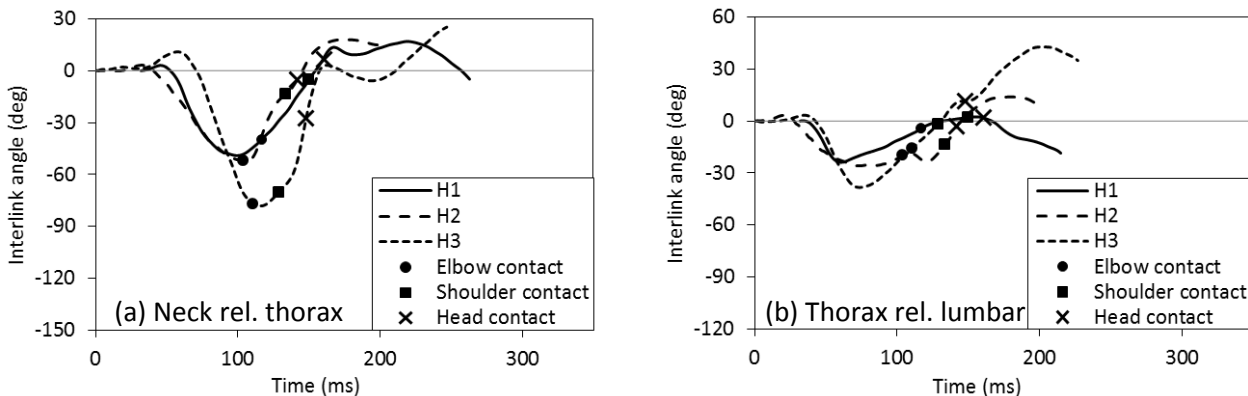
Fig. 7. Neck relative to thorax (a) and thorax relative to lumbar (b) angular displacements; tests H1, H2 and H3.

After pelvis contact, the spine curved towards the vehicle (Thorax-Lumbar interlink angle, Fig. 7b). In H1 and H3, the curvature gradually ceased and the spine was straight close to the time of elbow impact. After head impact, spine curvature varied from test to test.

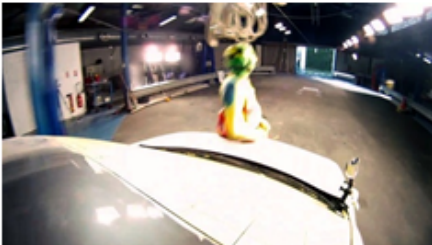
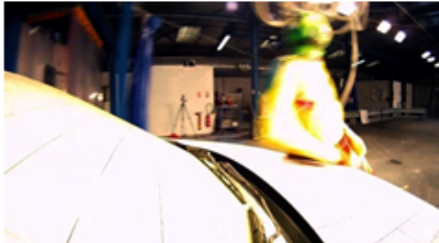
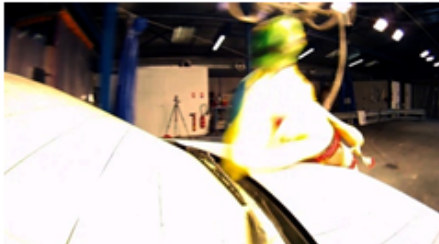
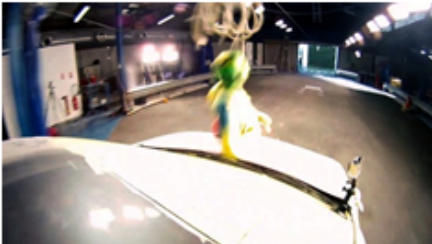
Fig. C1b: FSR02 in four camera views. From left to right: rear view, frontal view, on-board camera 1 and on-board camera 2.
