A VTR SYSTEM WHICH RECORDS ON-THE-SPOT ACCIDENT SCENES

By Osamu KANAYA, Hideo SAKAI,
and Nobuyuki INOKUCHI

Japan Automobile Research Institute, Inc.

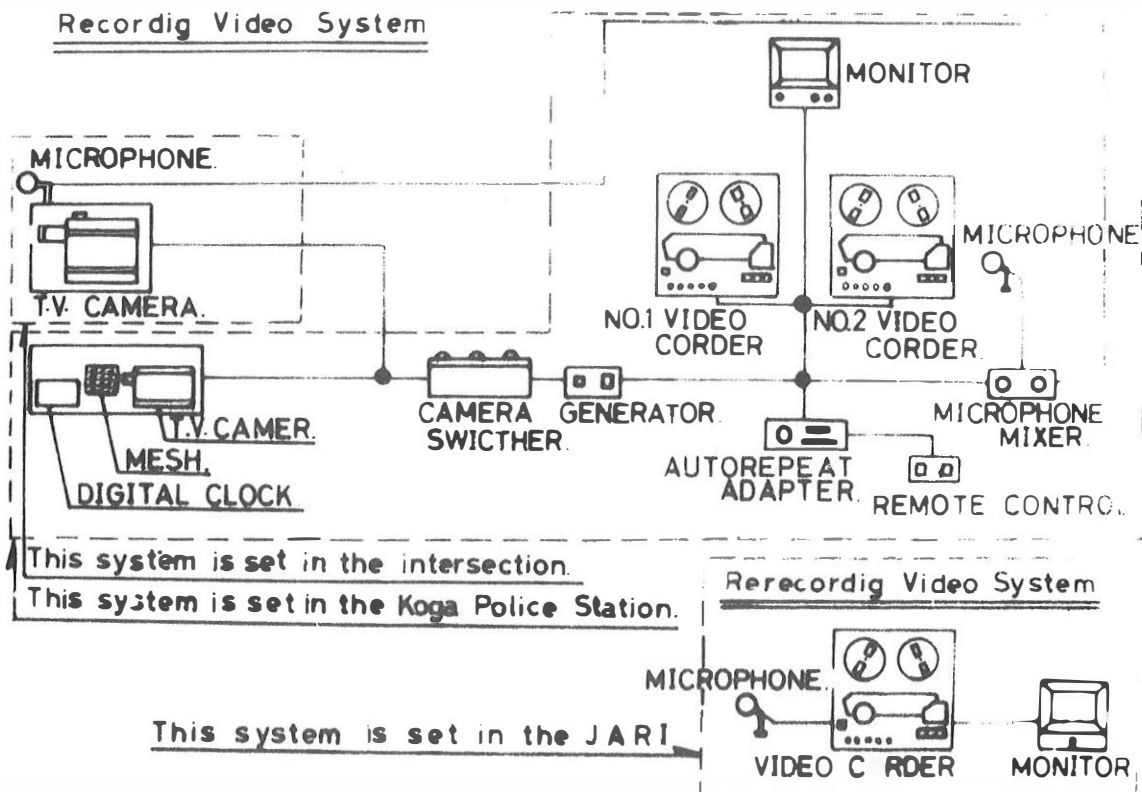
Fig.1- Construction of the VTR recordig system for traffic accidents on-the-spot.

This VTR system is operated continuously for 24 hours by an automatic device. The diagram of the system is shown in Fig. 1. This VTR system provide two cameras, one recording road conditions and another recording background meshes. The scenes recorded by the two cameras are composed into one and recorded on a video tape. Therefore, we can confirm the time of accident occurrence and the speed of collision as well as its derrection.

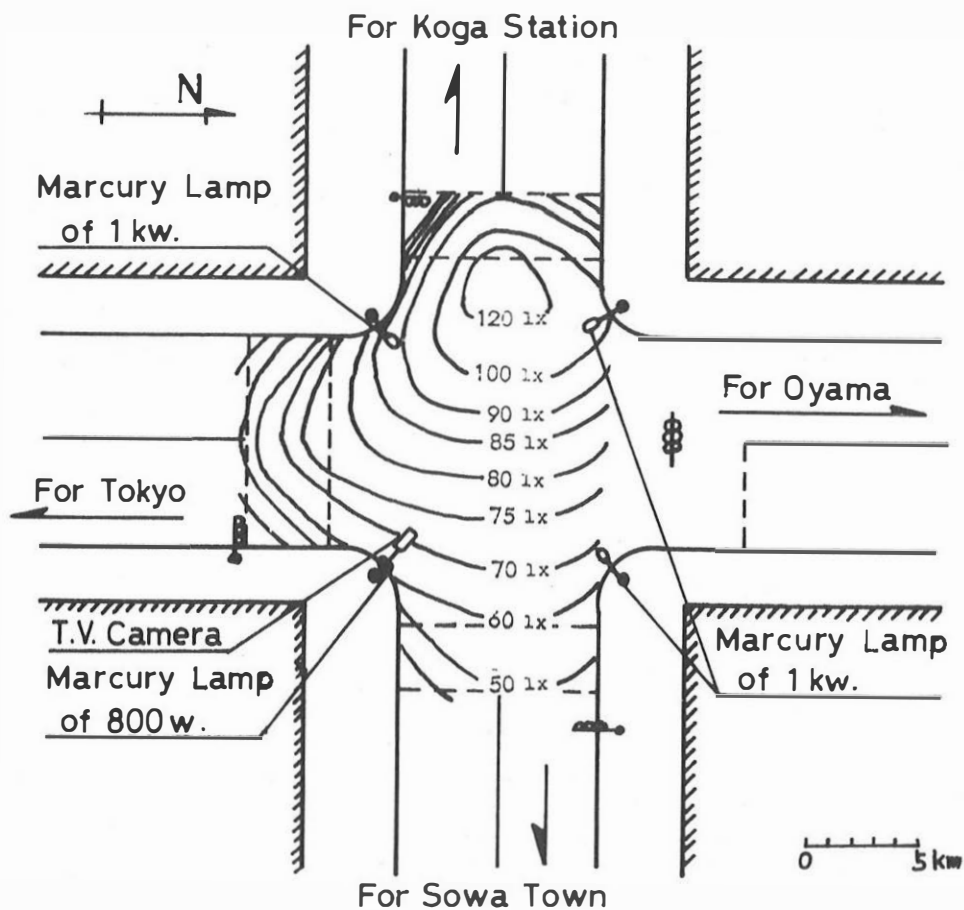
Fig.2- Distribution of illumination of lights at night in the intersection of road.

- The record tape is wiped out in every two hours unless any accident is recorded.
- It records 60 scenes every a second.
- The recorders use a tape of one inch wide making it possible to record clear pictures.
- The television camera is set stop an iron pole as high as 19 meters. It monitors the seems around the intersection of roads by wide-angle lens with a focal distance of 8.5 mm.
- Mercury lamps (about 1000 w) are installed on 4 poles of as high as 11 meters. (Fig. 2 shows distribution of illumination) in order to record during night hours.

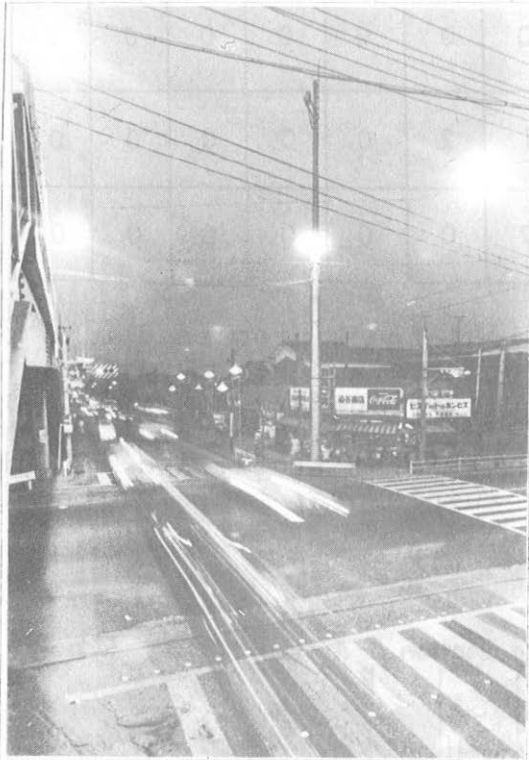
Fig. 6 - Night lights scene.

A wide-angle lens with a focal distance of 8.5 mm was used in the TV camera, in order to catch of scenes of as for wider as possible. In view of the fact that accidents happened frequently during night rather than day hours, three mercury lamps, each 1 km and two mercury lamps each 400 w were installed at four corners of the intersection. The strength of illumination was (50 - 120 Lx) on the surface of the intersection. (see Fig. 6)

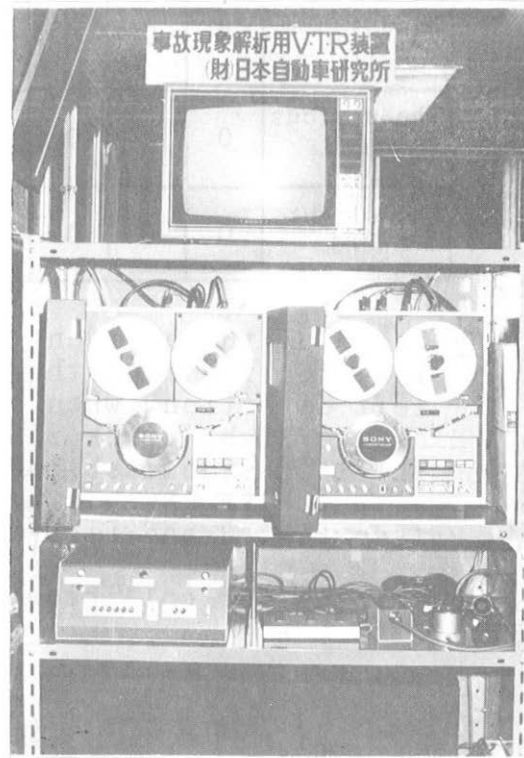
Fig. 7 - Set of VTR recorders.

As a result we could record accident scenes during night hours as well. The reflections were transmitted by wire to the Koga Police Station, which is located about 50 meters apart from the spot. The transmitted figures were recorded by the VTR system, which was installed in the building of the police station. (see Fig. 7)

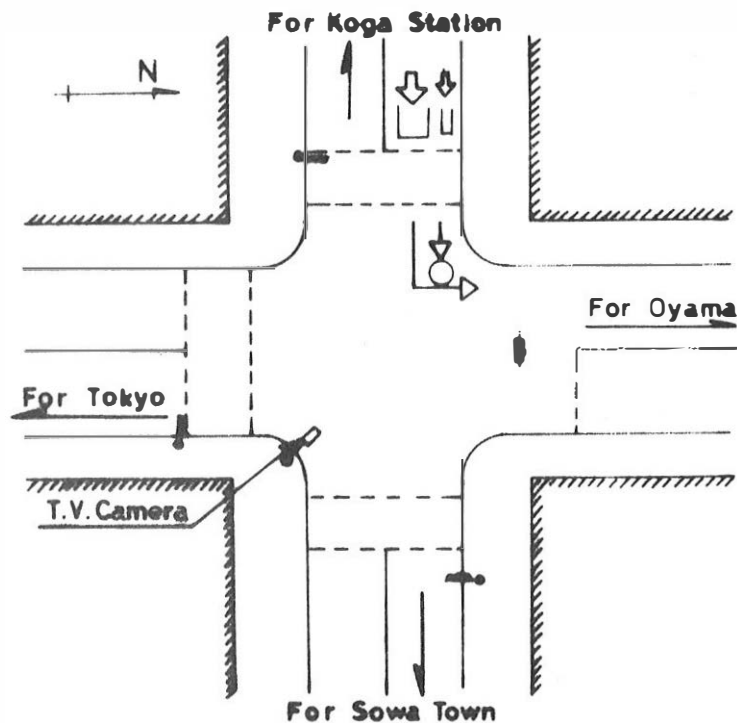
Fig. 8-A sketch of traffic accidents on-the-spot.

- State of the accident: A light truck proceeded into this intersection from the Koga Station and began to turn to the left direction, when a bicycle following on the left side of the light truck ran straight on without being aware of the left sideflash lamp of the light truck, and collided with the truck and then was turned over to the left side. (see Fig. 8 and Fig. 9)
- Velocity of collision: 12 km/h

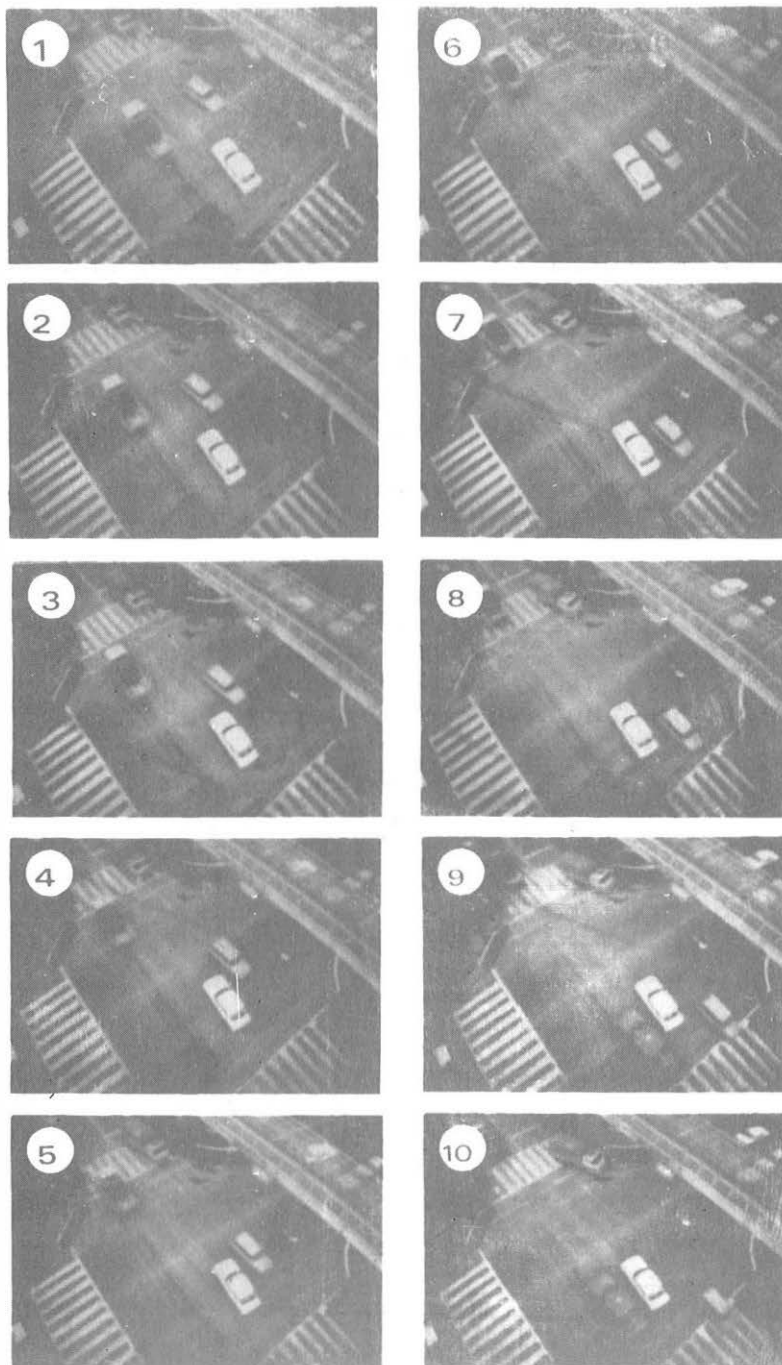
Fig. 9- Process of accident which was caught by video monitor (Interval 10/60 second).

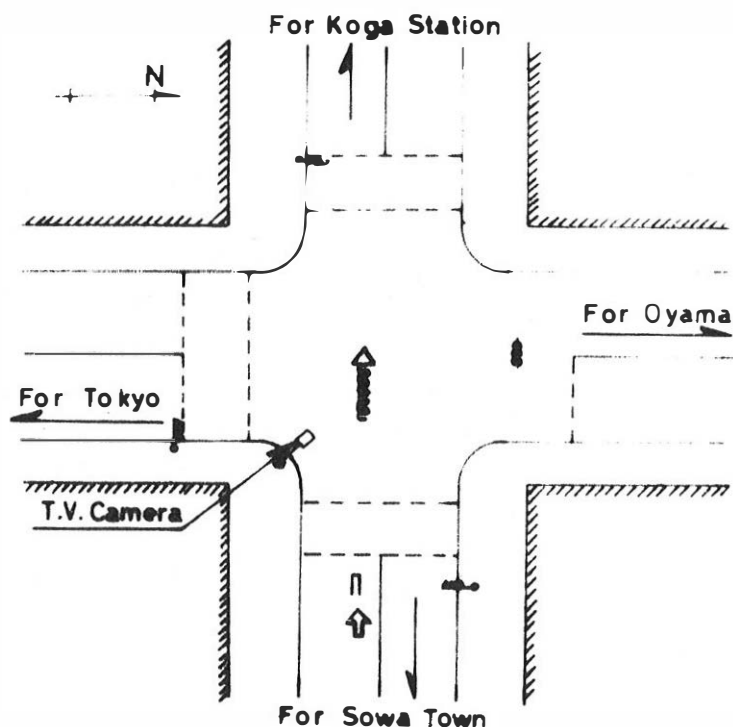
Fig.10- A sketch of traffic accidents on-the-spot.

- Date: Saturday, 23 September, 1971, p.m. 9:02 (JST)
- State of accident: An intoxicated man was moving from the Sowa Town to the Koga Station by bicycle. After proceeding into this intersection, (see Fig. 10 and Fig. 11) he was turned over as riding bicycle.
- Velocity of bicycle: 27.2 km/h
- Grade of injury: He had an abrasion on his head. (completely recovered after one week)
- Notes: The driver of a taxi passing the intersection spotted a man falling down, and judged that it was a hit-and-run accident. The driver informed the Koga Police Station of this accident. The Police issued an emergency search instruction. However, the police confirmed after observing

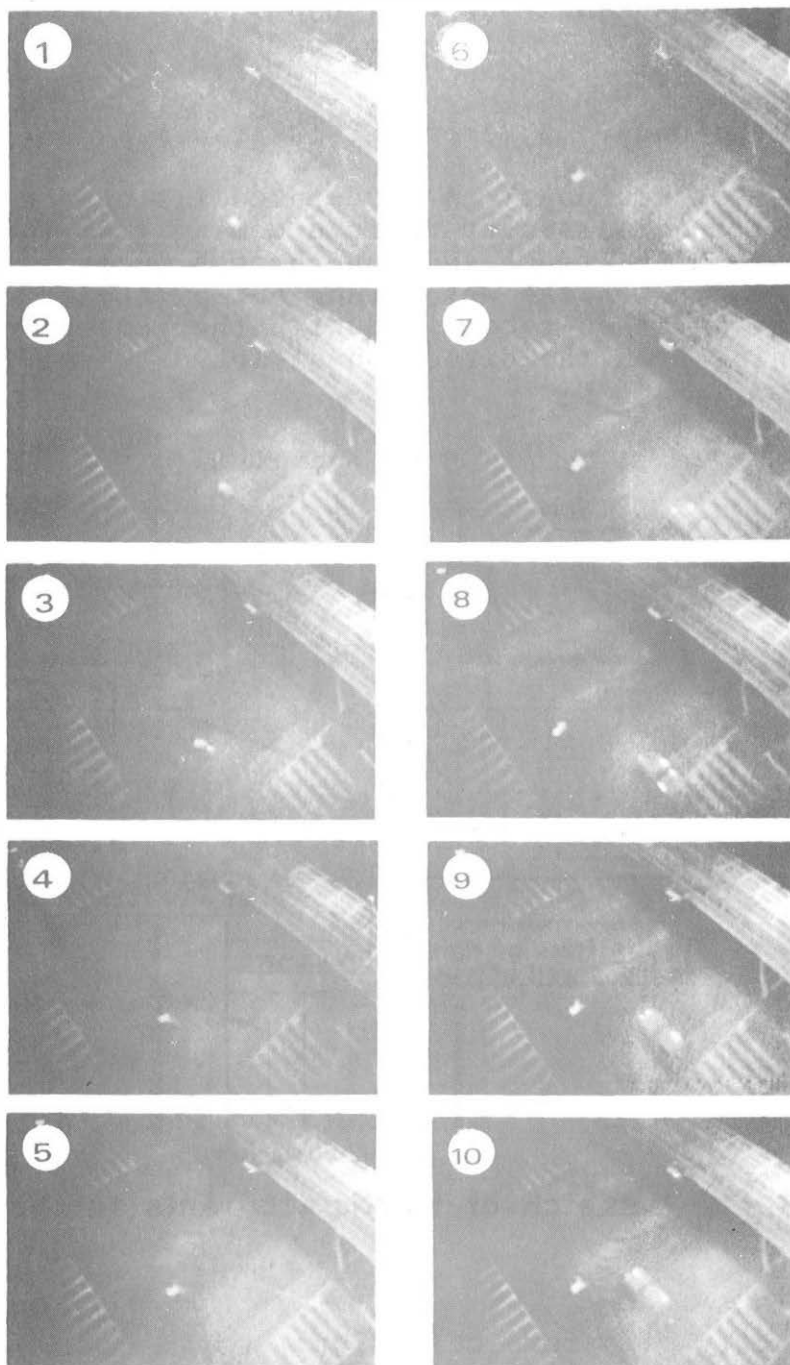
Fig.11- Process of accident which was caught by video monitor (Interval 10/60 second).

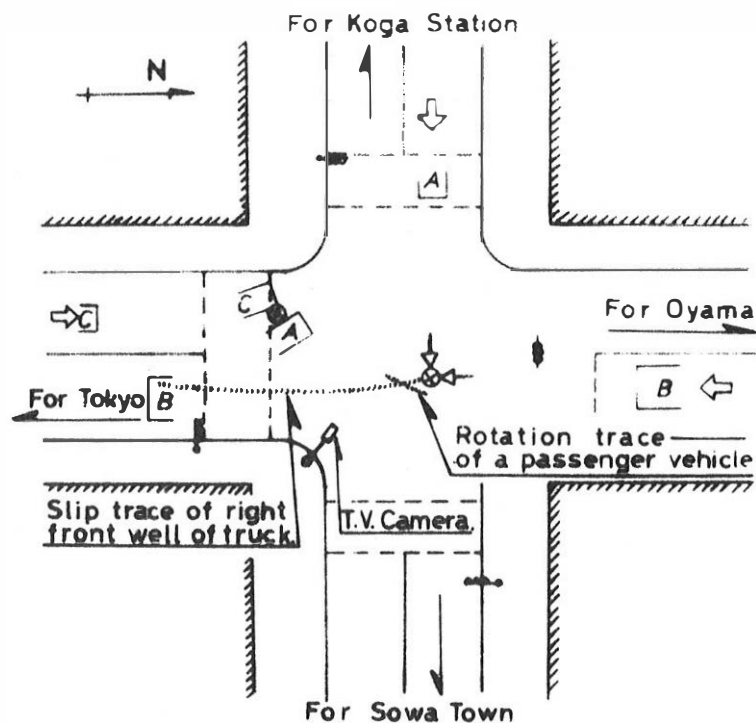
Fig.12-A sketch of traffic accidents on-the-spot.

- Date: Sunday, 5 December, 1971, a.m. 2:42(JST)
- State of accident: A head-on collision occurred between a small type passenger vehicle coming from the Koga Station and an 8-ton truck running through Oyama toward Tokyo. The passenger vehicle was sprang out by the truck after collision, and then recollided with the another passenger vehicle running from the direction of Tokyo. (see Fig. 12 and Fig. 13)

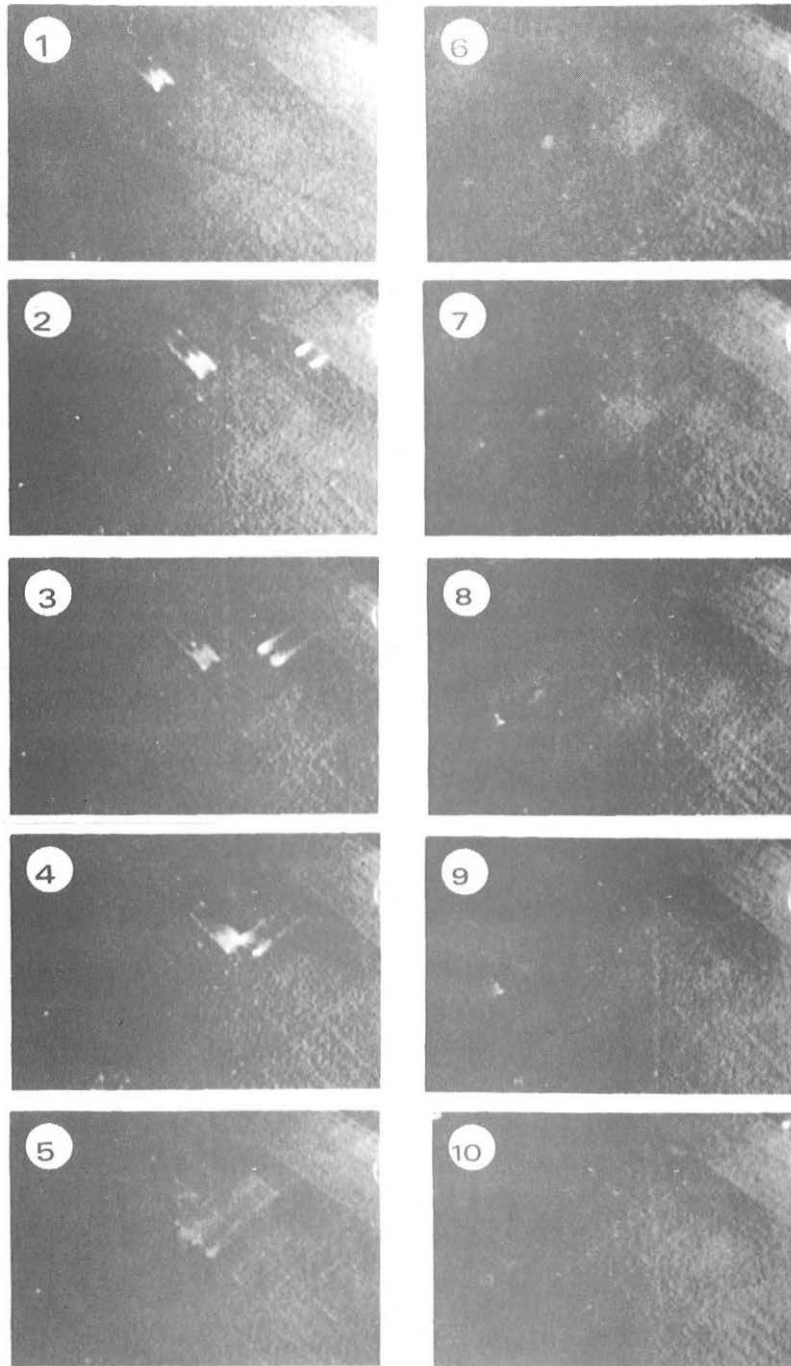
Fig.13- Process of accident which was caught by video monitor (Interval 10/60second).

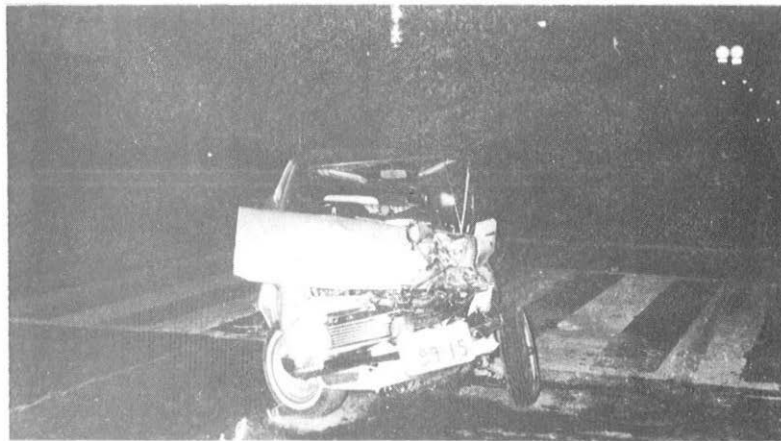
Fig. 14— Damaged appearance of a passenger vehicle

- Velocity of before collision:
 - Passenger vehicle (A): 30 km/h
 - 8-ton truck (B): 57.6 km/h
- Damage of vehicles:
 - Passenger vehicle (A): Left fender, left door and front wind-shield glass were broken out. (see Fig. 14)

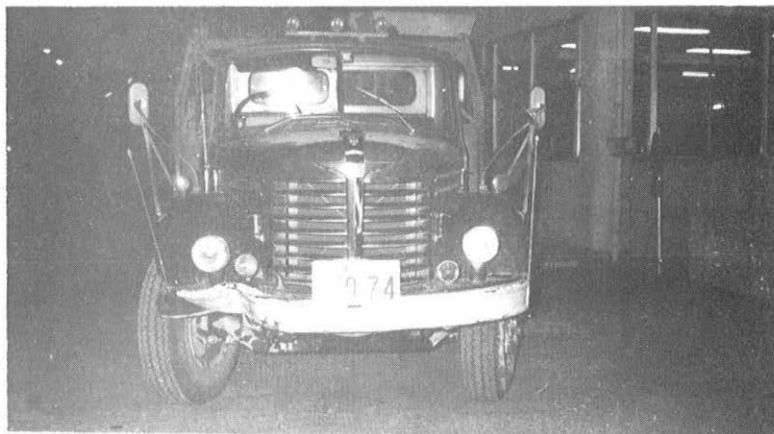
Fig. 15— Damaged appearance of 8-ton truck

8-ton truck (B): Half right of bumper was broken (see Fig. 15)

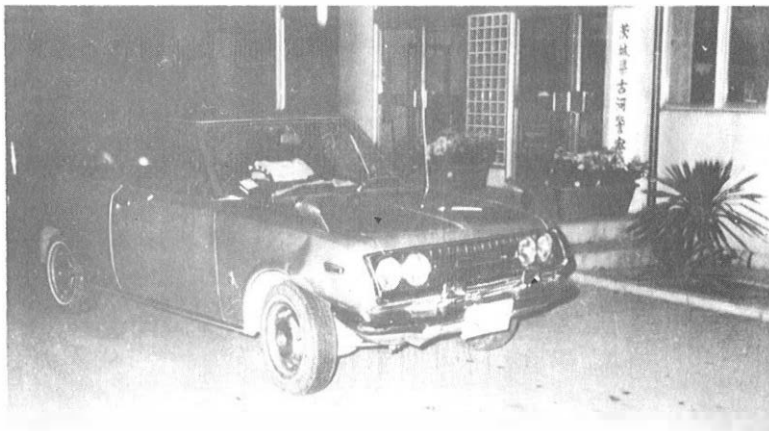
Fig. 16— Damaged appearance of another passenger vehicle

Another passenger vehicle (C): Right fender and right bumper were broken slightly. (see Fig. 16)
