FIELD ACCIDENT DAMAGE AS A BASIS FOR CRASH TESTS

J.L.G.Hardy, G.M.Mackay, S.J.Ashton and P.F.Gloyns
Department of Transportation and Environmental Planning,
University of Birmingham, U.K.

ABSTRACT

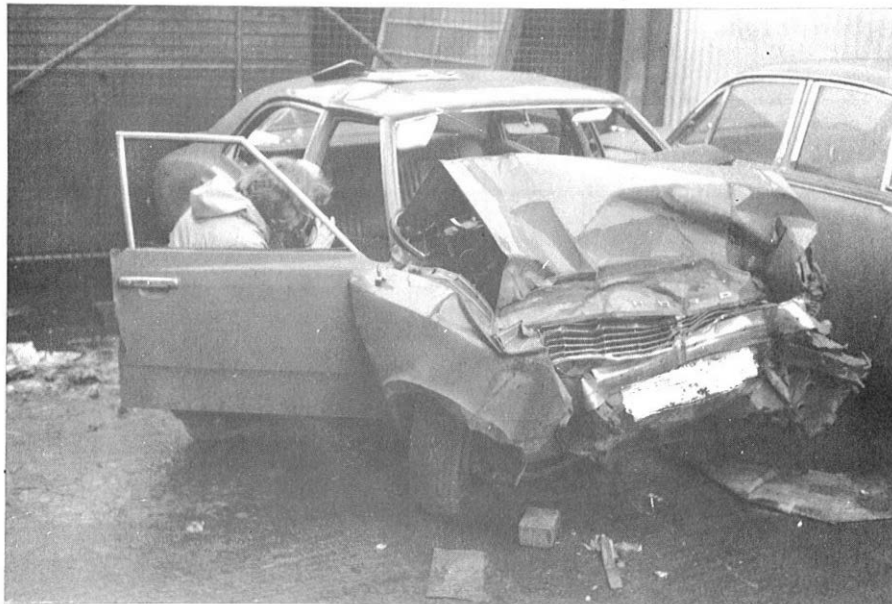
FIGURE 2

Note stiff members protruding beyond softer structure

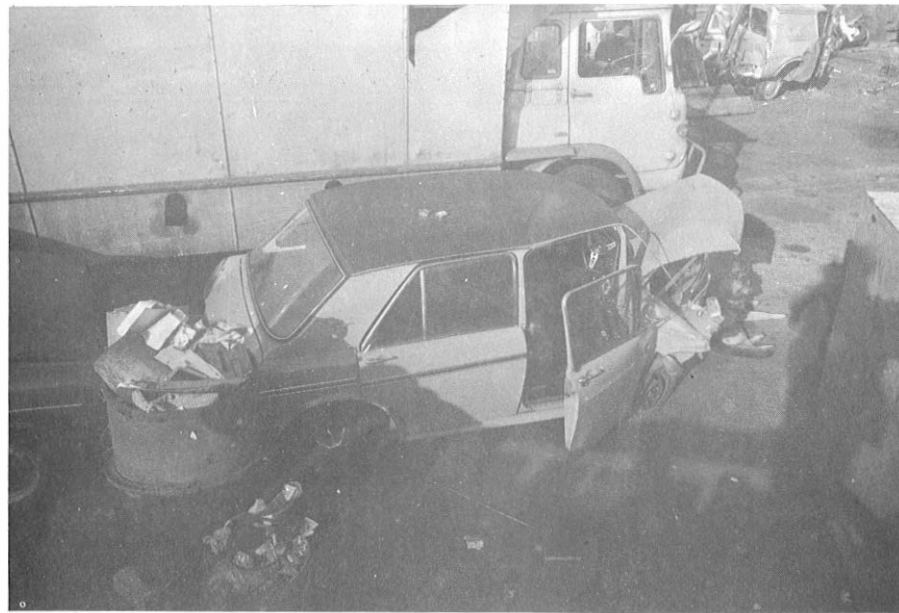
FIGURE 3

Rearward movement of fascia due to compression of front door in $\frac{1}{4}$ - $\frac{1}{2}$ overlap impact

Optimising crash-performance in both front distributed and $\frac{1}{4}$ overlap offset barrier collisions is likely to be difficult, but field experience indicates that many present designs could be improved considerably before the inherent design conflicts become apparent. In particular, some designs of 'A' pillar area and front suspension systems lead to large amounts of interior crush in the $\frac{1}{4}$ offset situation. Front doors which are weak in compression also contribute to the reduction of the passenger compartment volume in this type of impact. The cases shown in Figure 3, 4 and 5 illustrate these points.

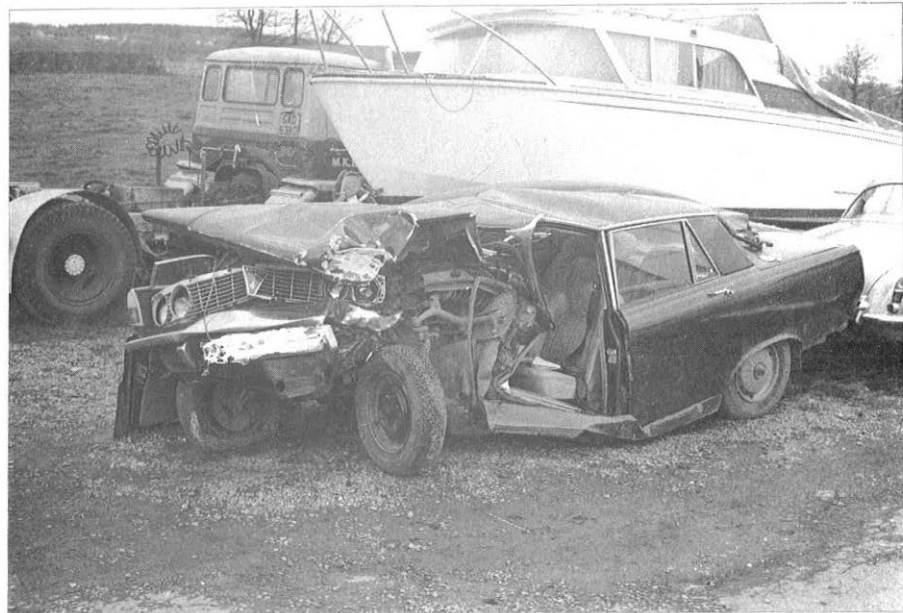
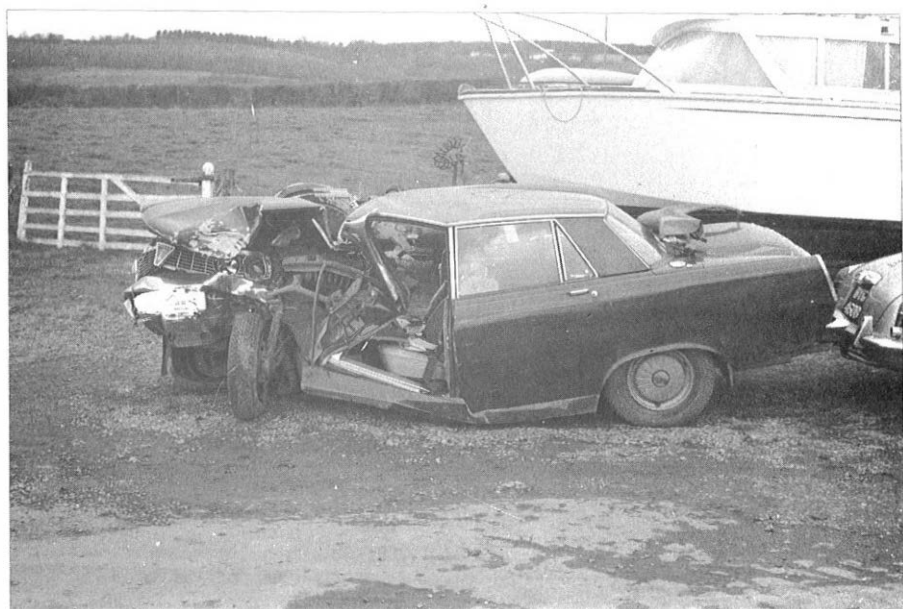
FIGURE 4

Gross reduction of left front passenger's seating area through rearward movement of 'A' pillar in a $\frac{1}{4}$ overlap situation.

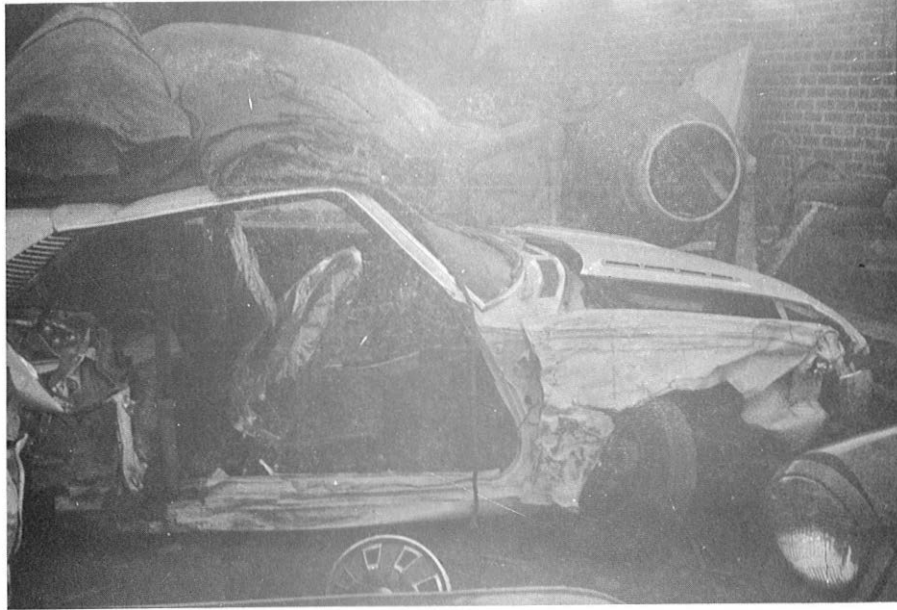
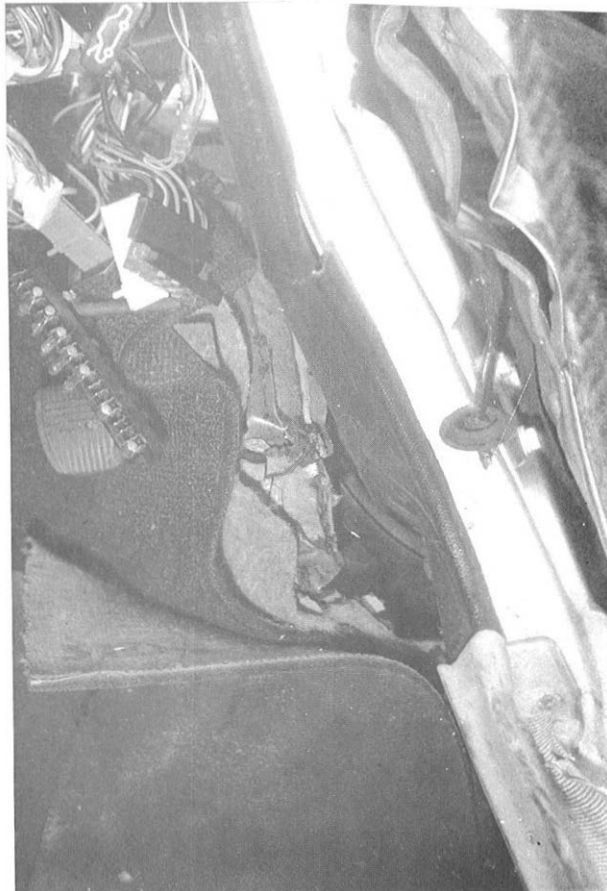
FIGURE 5

A sideswipe accident. The right front road wheel moved back through the floor, (b) leading to a compound comminuted fracture of the driver's right ankle.
