SIDE COLLISION TESTING WITH SMALL CARS

Wolfgang Sievert, Ernst Pullwitt
Federal Highways Research Institute (BAST)
Bergisch Gladbach

Passenger protection in a side collision was investigated in four tests with small cars, two Ford Fiesta and two VW Polo. The aim of this project is to investigate the resistance of small cars in side impact tests.

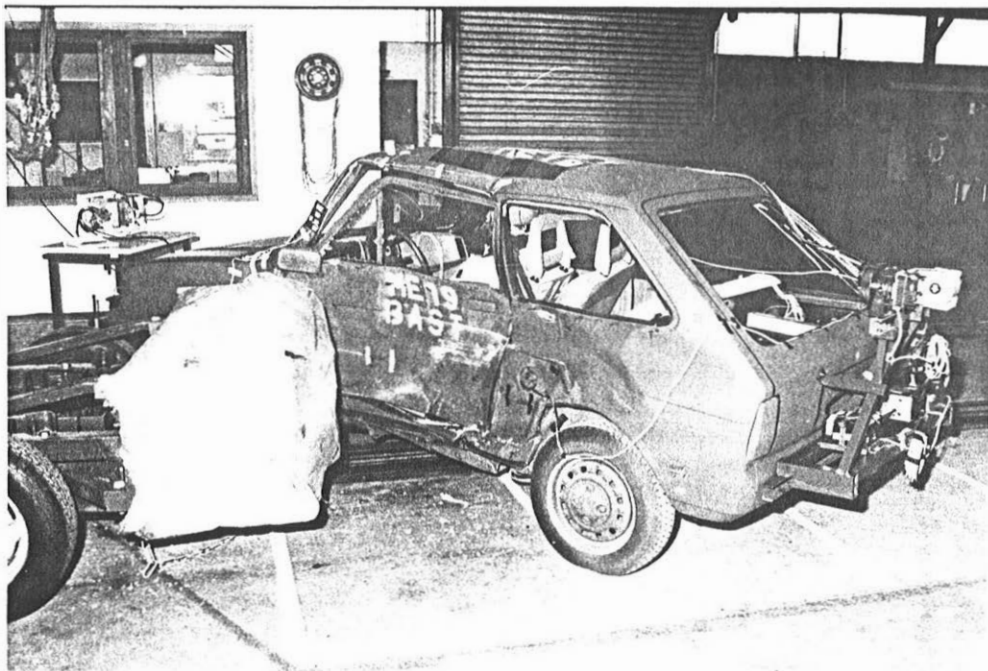
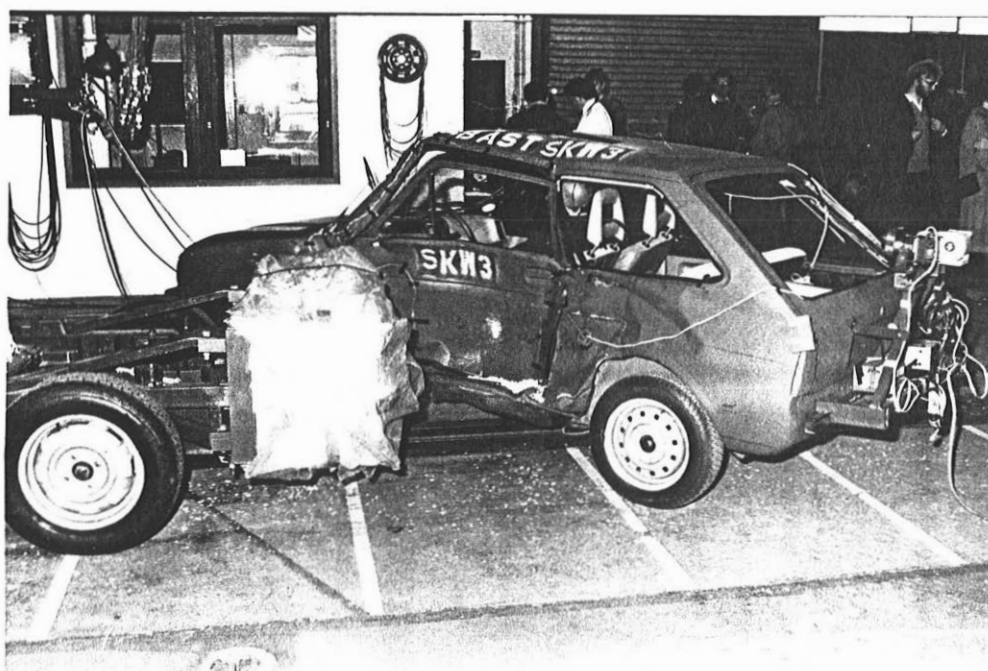
ME 19 is equal SKW 01

Fig A.1 : Final Position and Deformation Picture in the Tests
with a Ford Fiesta

The impact accuracy of the movable deformable barrier in tests with small cars lay within the range of 1 cm. The front structure of the barrier demonstrated good deformation behaviour, with no large undeformed pieces detaching themselves. The deformation pictures of both the vehicles and the barrier front face were very similar in all tests (c.f. Fig. A.1 and A.2 in the Appendix).

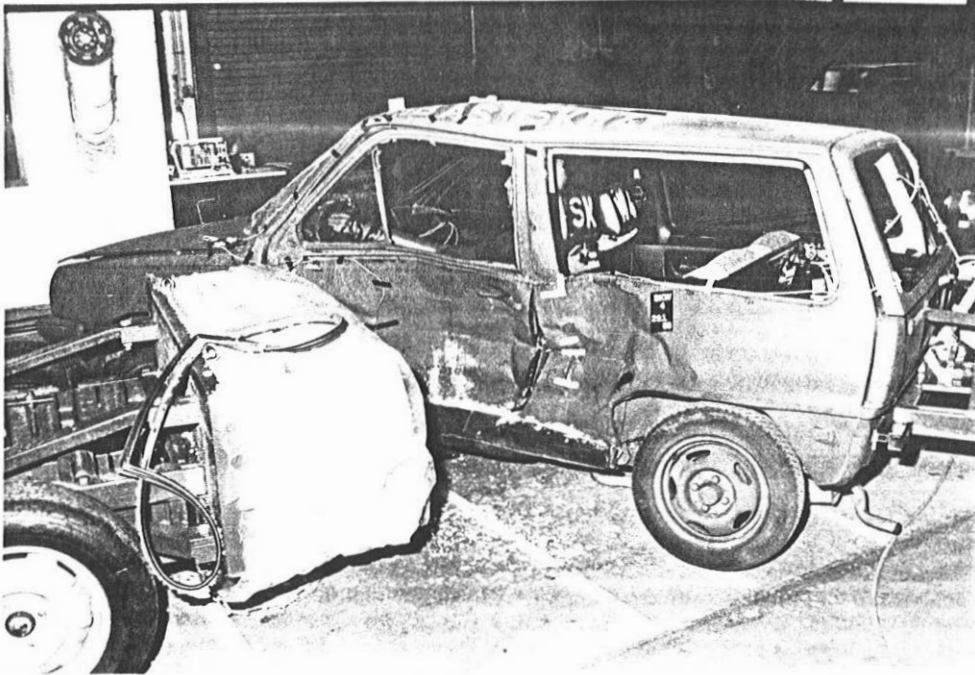
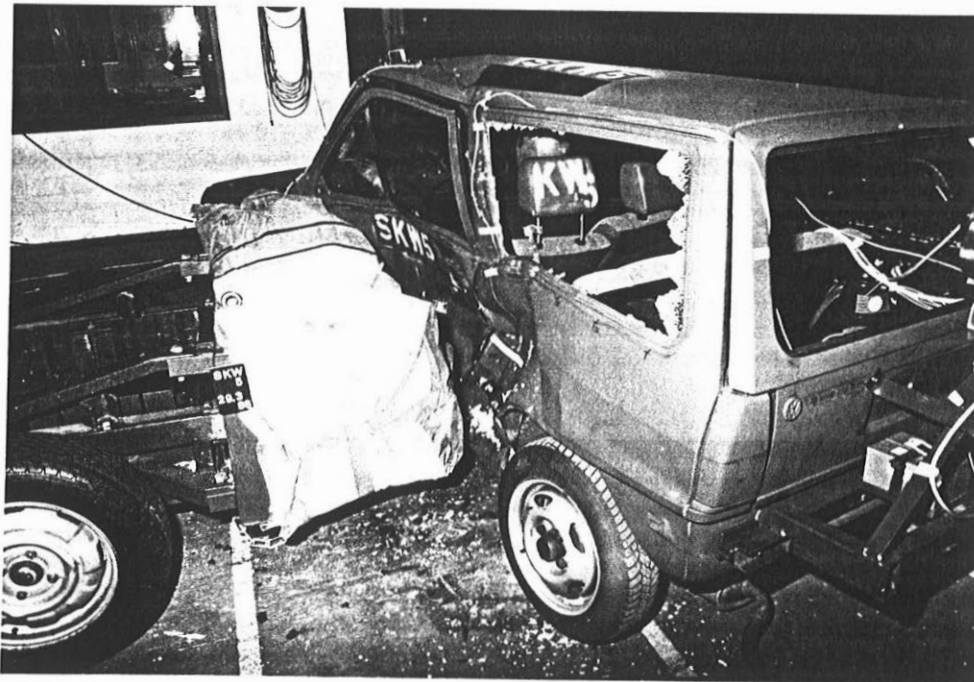
Fig. A.2 : Final Positions and Deformation Picture in the Tests with the VW Polo.

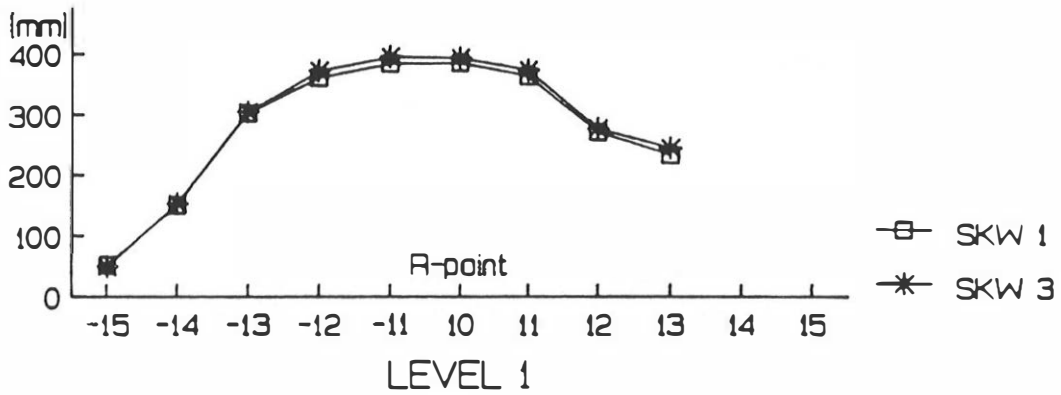
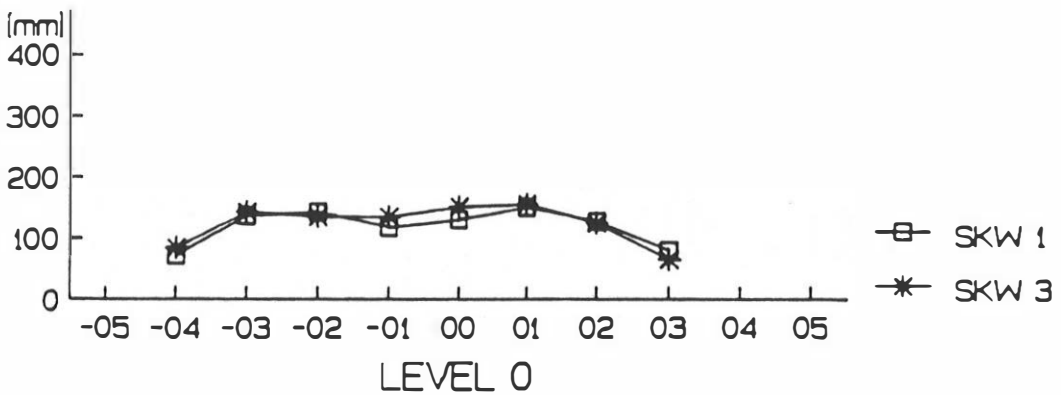
Fig. A.3 : Representation of the Residual Vehicle Deformation in the Three Measuring Planes in the Tests with the Ford Fiesta. Position of the Measuring Points. See Fig. A.4

Both vehicles suffered severe deformation on the left side, which consisted of a deep intrusion into the A-pillar and wind-screen frame, side door and B-pillar and into the rear third of the wheel house. The deformation at the three measurement planes, seen in Fig. A.3 make this clear. The position of the deformation measurement points given in Fig. A.4, was similar in all tests.

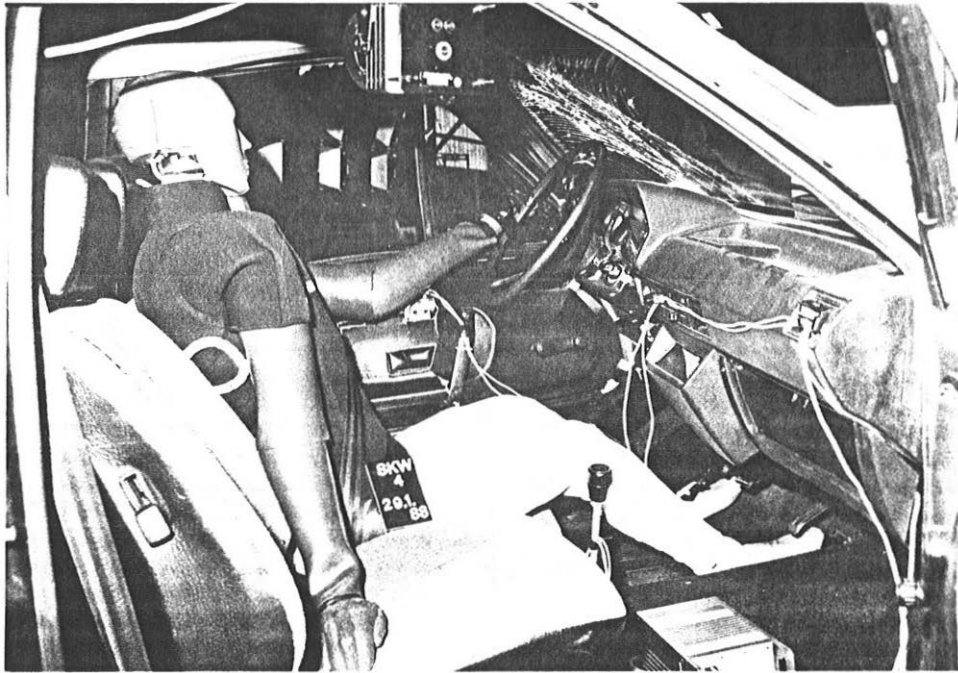
Fig. A.7 : Interior of the VW Polo after Impact.

The damage in the interior (see Fig. A.7) was also the same as in the Ford Fiesta tests. Details, such as a broken door panel (hard cardboard) or a shelf protruding from the dashboard, were different.

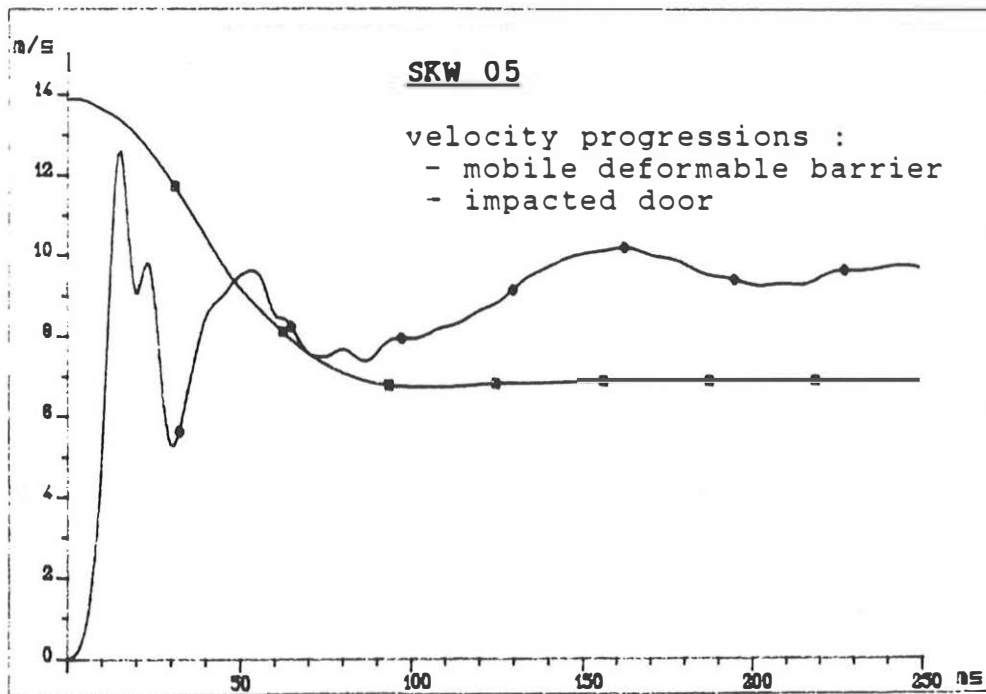
Fig. A.10 : Behaviour of the Vehicles (VW Polo/ m.d.b.) during Impact, Represented by the Velocity Progressions.

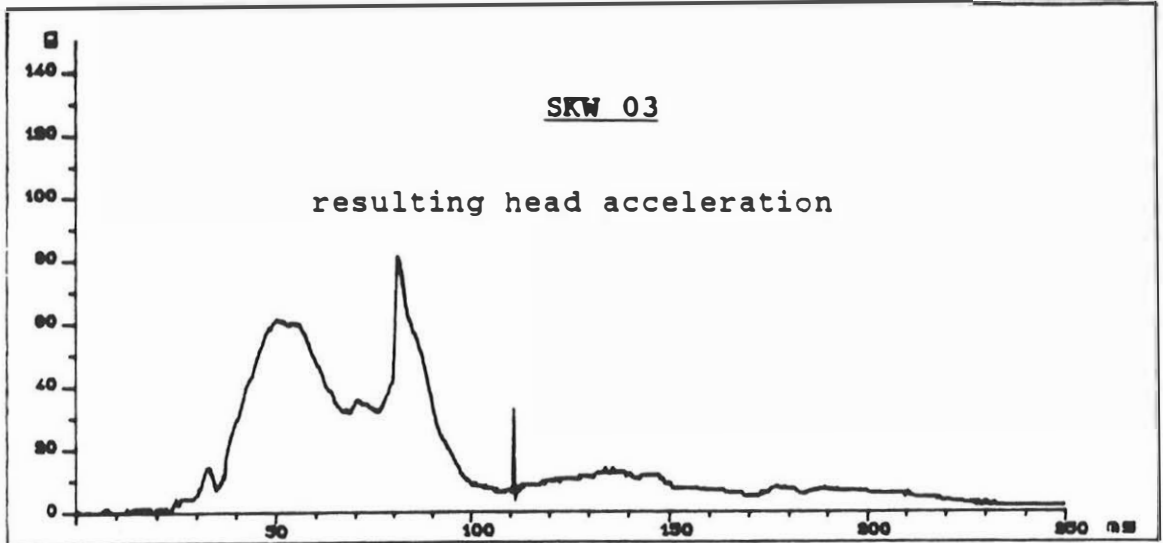
Fig. A.13 : Loads Measured on EUROSID during the Side Collision of a Fiesta with an EEVC Barrier

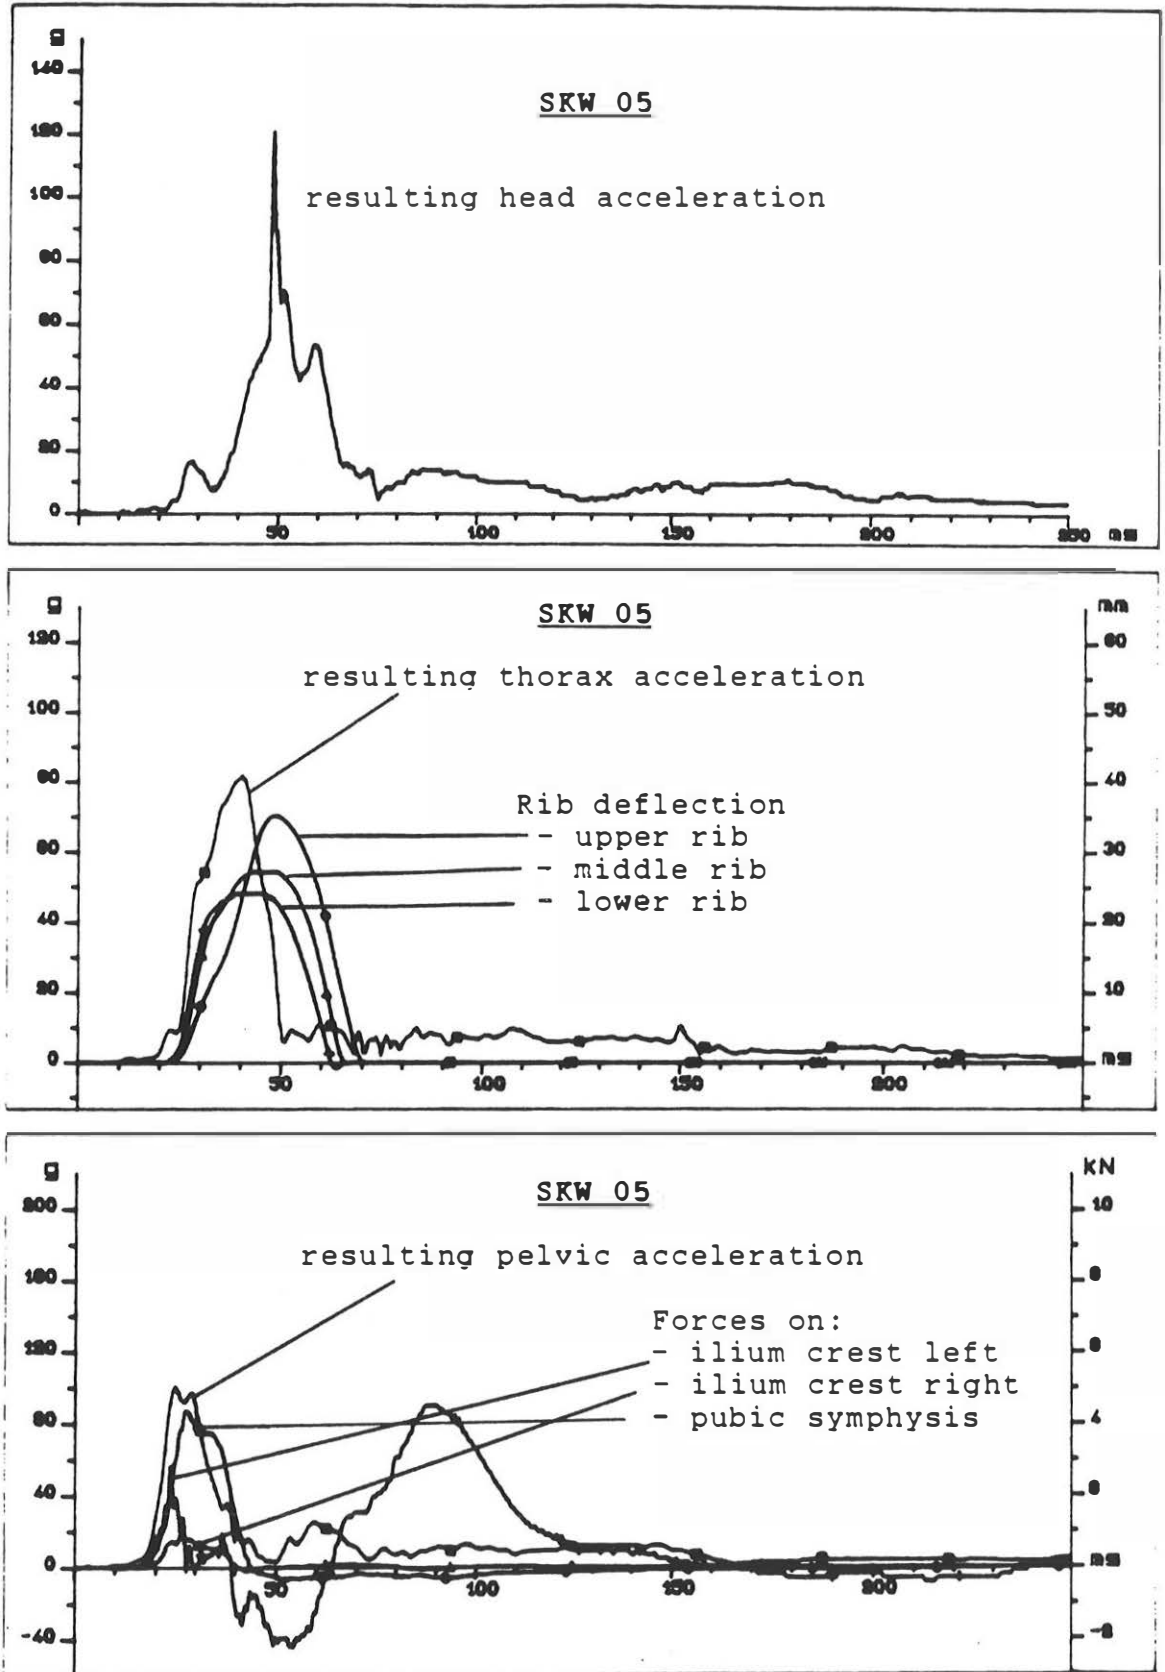
Fig. A.15: Loads Measured on EUROSID during the Side Collision of a VW Polo with an EEVC Barrier
