Occupant Protection in Transit Buses: Do We Have the Correct Tools?

Suzanne Tylko, Kathy Tang, François Giguère, Alain Bussières

Keywords ATD, frontal, offset, structural reinforcement, transit bus.

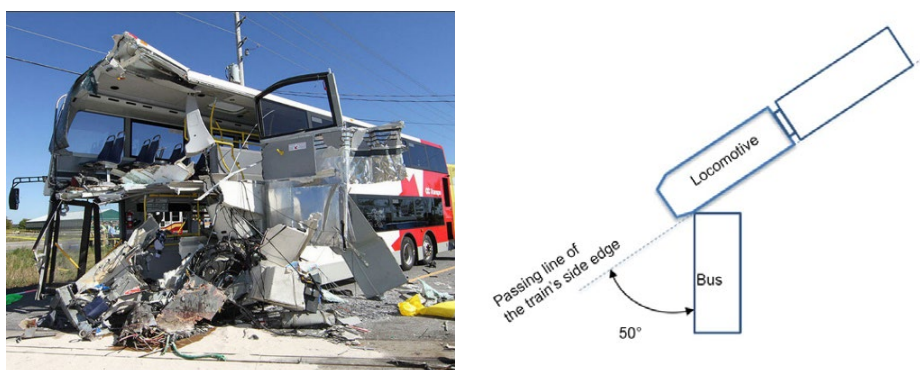
In 2013, a double-decker bus collided with a passenger train in Ottawa, Canada. The collision was investigated by the Transportation Safety Board (TSB) [5]. The photo in Fig. 1 shows the extensive destruction to the front of the bus. According to the TSB analysis, the left front corner of the transit bus, travelling at 8 km/h collided with the front, left side of the locomotive as shown in the schematic. The train had reduced its speed to 69.2 km/h.

Fig. 1. (Left) Photo of damage to the bus and (right) schematic of the 2013 collision between a bus and a passenger train.

The collision resulted in five occupant ejections, six fatalities, and 34 injuries. As part of the report, the TSB suggested that “a more robust front structure and crash energy management design might have reduced the damage to the bus and prevented the loss of a protective shell for the occupants”. In 2015, the TSB issued the

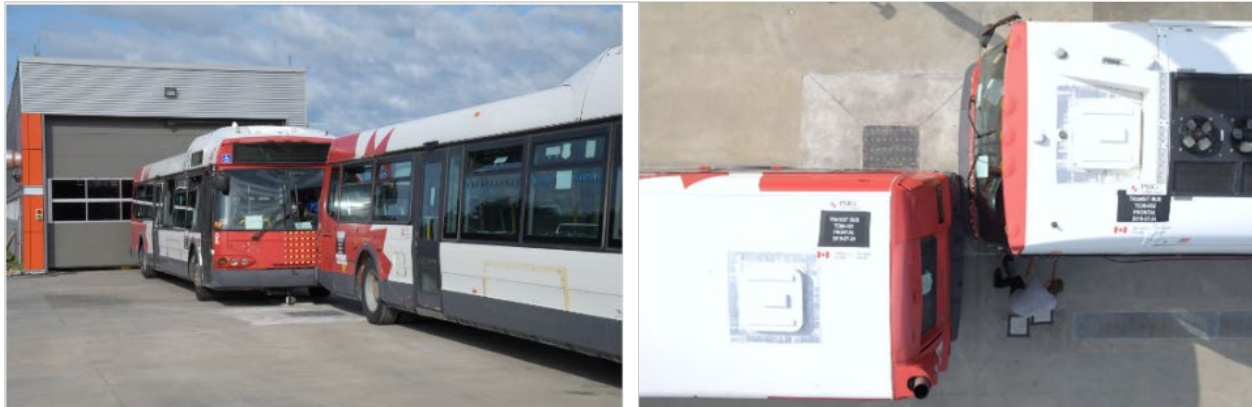
A total of five transit bus crash tests were conducted. Test weights for all bullet and target buses are presented in TABLE A I. In each crash test, the driver side of a moving bus (Striking Vehicle) impacted the right rear corner of a stationary bus (Target Vehicle). The impact speed of the Striking Vehicle was 40 km/h and the overlap at impact was 40 %, as shown in Fig. 2.

Fig. 2. Front and top view of vehicle alignment for Test 1 and Test 2

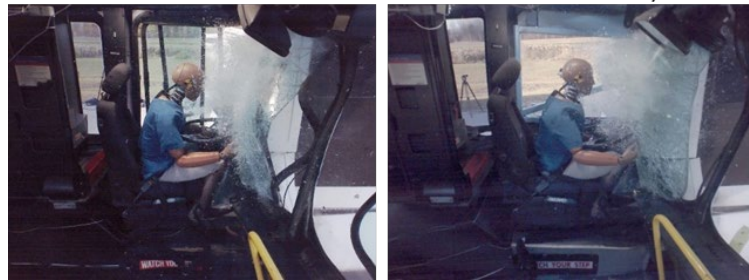
Fig. 7. Freeze frames of the driver ATD at peak head excursion in Test 3 and Test 4 (pair of New Flyer B40 LF buses with and without reinforcement).

166 g but in Test 2, the head contacted the shattering glass and recorded a head acceleration of 54 g (Fig. 6). No head strikes were observed in either Test 3 or Test 4 (Fig. 7).

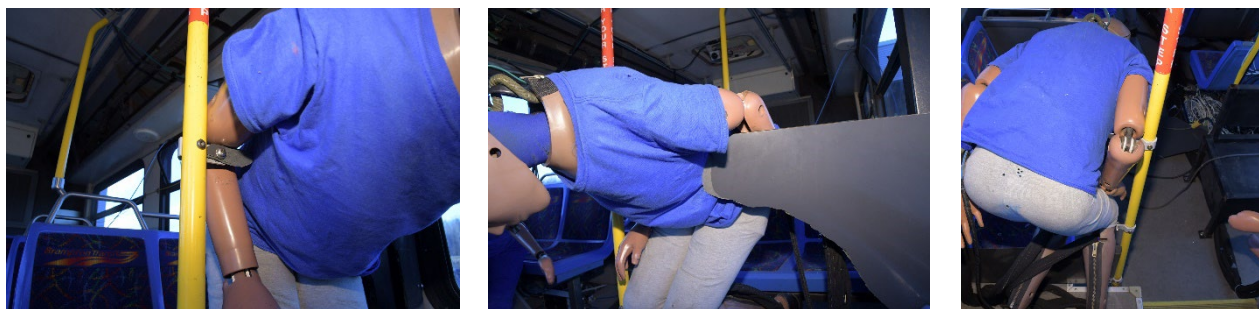
Fig. 12. Post-test photos of final positions of the Hybrid III 5th percentile interaction with barrier hardware.

ATDs that were ejected, either completely or partially from the seat, were found suspended from adjacent structures, seated upright or lying on their sides. Examples of the less than humanlike final resting positions are shown in Fig. 11 and Fig. 12.

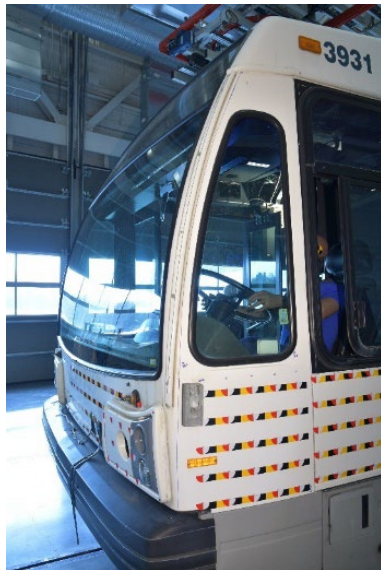
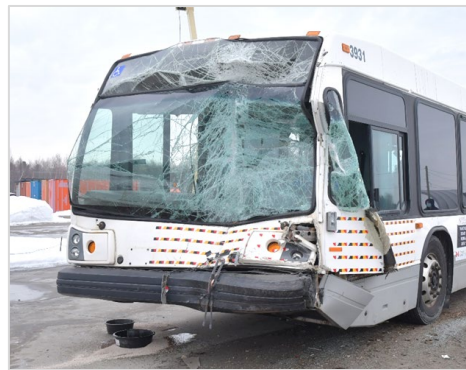
A post-test photo of the bus in Test 5 is shown in Fig. A3. The A-pillar/windshield frame of the striking bus was displaced rearward into the occupant compartment. The front body panel of the bus was also displaced rearward, along with the bumper. The bumper was deformed primarily where it met with the right edge of the target bus. No major rearward displacement was visually observed along the side of the bus or front undercarriage. The frame surrounding the driver's sliding window does not appear to be displaced.

Fig. A3. Pre- and post test photos of Striking Vehicle in Test 5.

In Test 5, the longitudinal displacements at the A-pillar near the window frame measured 290 mm and 226 mm at the base of the A-Pillar. The greatest longitudinal displacement along the front of the bus was 313 mm, located 400 mm to the left of centre and just below the windshield. Displacement of the underbody of the bus in Test 5 appeared to be negligible. On the struck side, deformation of the lateral beam supporting the bumper and the longitudinal beam measured 65 mm vertically and 50 mm longitudinally.
