## Analysis of Nearside Narrow Object Impacts with and without Shoulder Injuries in Real-World Crashes

Greg W. Stadter, Narayan Yoganandan, Dale E. Halloway, Frank A. Pintar

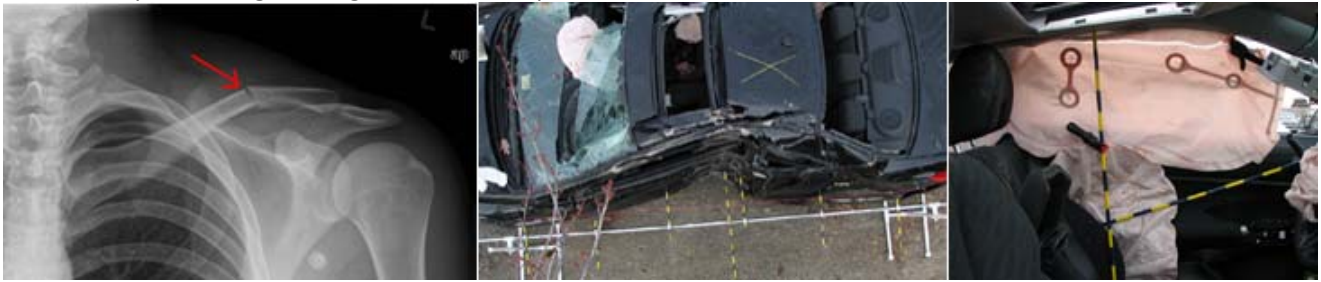
**Case 160157102:** This case involved an 18-year-old belted male driver who lost control, departed a roadway and struck two trees. The first impact was to the right side with a small tree, causing the vehicle to rotate clockwise before it struck a larger tree with its left side. This second impact to the left side with the larger tree was coded in the CIREN as the most severe event. The left-side impact had a primary direction of force of 290 degrees, and caused 29 cm of maximum crush to the vehicle exterior and 18 cm of intrusion to the left front door. The center of the vehicle damage for the left-side impact was 20 cm behind the center of the vehicle's undamaged wheelbase. Additionally, the near-side impact had a non-horizontal element, as there was more crush to the vehicle's rocker panel (floor sill) than to its door sill or roof rail. The driver's frontal, left seat-mounted thorax and left curtain airbags all deployed during the second event. The driver sustained a small left

apical pneumothorax, a clinically diagnosed mild concussion without loss of consciousness and a left mid to distal clavicle fracture with minimal inferior angulation of the distal fracture fragment. In this case, the CIREN sourced the clavicle fracture and the pneumothorax to the occupant's shoulder loading the left door through the side impact airbags during the second impact.

Fig. 3. CIREN Case 160167102 Radiology and Vehicle Exterior and Interior

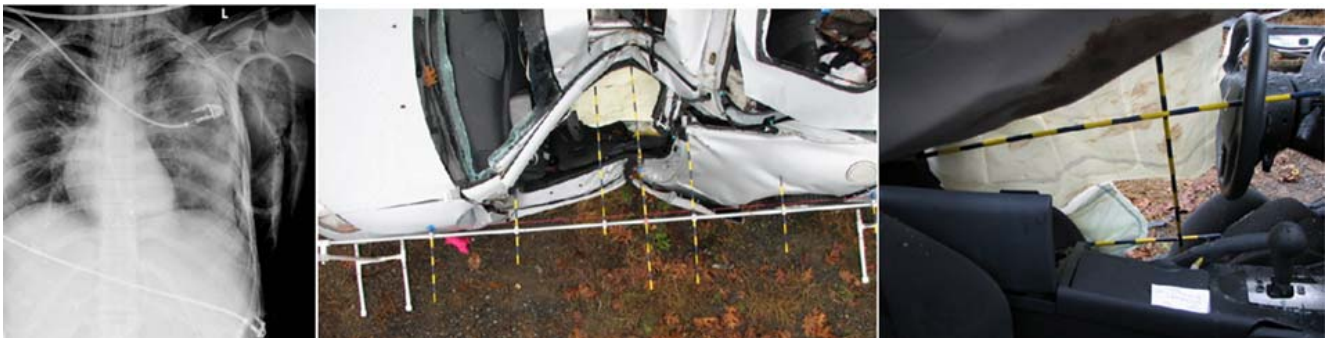
**Case 160158143:** This case involved a 22-year-old belted female driver who departed a roadway, began to yaw clockwise, and struck a large tree on the left side plane. The primary direction of force was 290 degrees, and the impact caused 71 cm of maximum crush to the vehicle exterior as well as 51 cm of intrusion to the left door. The center of the vehicle damage was 19 cm behind the center of the vehicle's undamaged wheelbase. Additionally, the near-side impact had a non-horizontal element, as there was more crush to the vehicle's roof side rail and there was direct damage to the outboard edge of the vehicle's sunroof. The left sided seat-mounted thorax and left curtain airbags both deployed during impact. The driver sustained a basilar skull fracture, grade III spleen laceration, a left T1 transverse process fracture, right 1<sup>st</sup> rib and left 1-4 and 6-11 rib fractures, as well as a left lung laceration and bilateral pneumothoraxes. Additionally, she sustained a left midshaft clavicle fracture. Each of the occupant's thoracic and shoulder injuries were sourced by the CIREN to the left door, through the side impact airbags.

Fig. 4. CIREN Case 160158143 Radiology and Vehicle Exterior and Interior

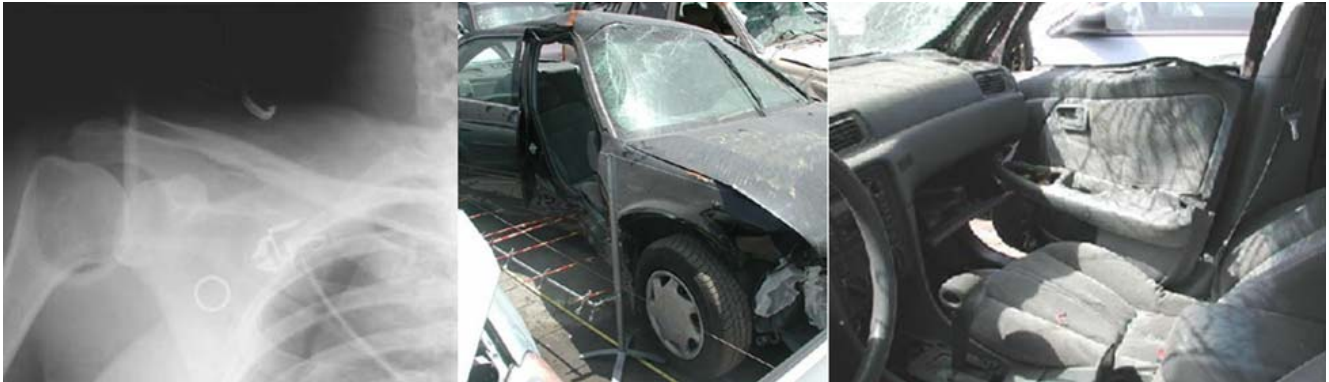
**Case 407068584:** This case involved a 27-year-old belted female in the right front passenger seat of a vehicle that departed a roadway, entered a counterclockwise yaw, and struck a utility pole with its right side. The primary direction of force was 80 degrees, and the impact caused 36 cm of maximum crush to the vehicle's exterior as well as 22 cm of intrusion to the right front door. The center of the vehicle damage was 13 cm in front of the center of the vehicle's undamaged wheelbase. Additionally, the near-side impact had a non-horizontal element, as there was more crush to the vehicle's rocker panel (floor sill) than to its door sill or roof rail. No airbags deployed in the occupant's seating position. This passenger sustained a clinically diagnosed concussion with a loss of consciousness under one hour, a liver contusion, bilateral inferior/superior pubic rami fractures, and a right sacral fracture. In addition, she sustained a right 5<sup>th</sup> rib fracture, a right pneumothorax, a right pulmonary contusion and a right comminuted, displaced distal clavicle fracture. The CIREN sourced all of this occupant's thoracic and shoulder injuries to the right front door.

Fig. 5. CIREN Case 407068584 Radiology and Vehicle Exterior and Interior

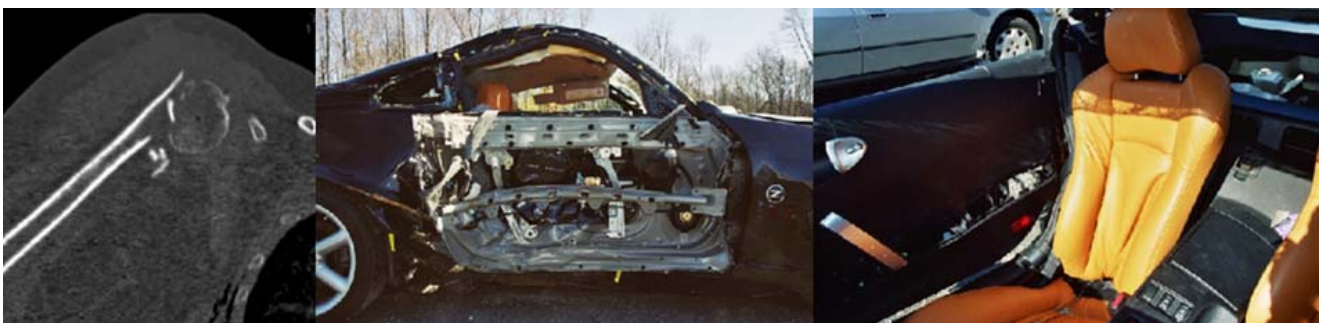
**Case 857088552:** This CIREN case involved a 46-year-old belted female in the right front passenger seat of a vehicle that departed a roadway, began to yaw counterclockwise and then struck a utility pole on its right door. The primary direction of force was 70 degrees, and the impact caused 33 cm of maximum crush to the vehicle's exterior as well as 26 cm of intrusion to the right front door. The center of the vehicle damage was 41 cm behind the center of the vehicle's undamaged wheelbase. This impact with a pole was completely planar based on vehicle damage. No airbags deployed in the occupant's seating position. This passenger sustained a right kidney contusion, a left (inboard) clavicle fracture, a grade III liver laceration, transverse process fractures from L3-L5, bilateral pubic rami, and right sacrum and acetabulum fractures. Additionally, the occupant sustained left rib fractures from 4-6, right rib fractures of the 6<sup>th</sup> and 8-11 ribs, a right-sided pneumothorax and a comminuted and open fracture of the anterolateral right humeral head and neck. The rib fractures, pneumothorax and humerus fractures were all sourced by the CIREN to the right front door. This occupant's left-sided clavicle fracture (far-sided relative to the impact) was postulated by the CIREN to be caused by contact with the vehicle's driver.

Fig. 6. CIREN Case 857088552 Radiology and Vehicle Exterior and Interior

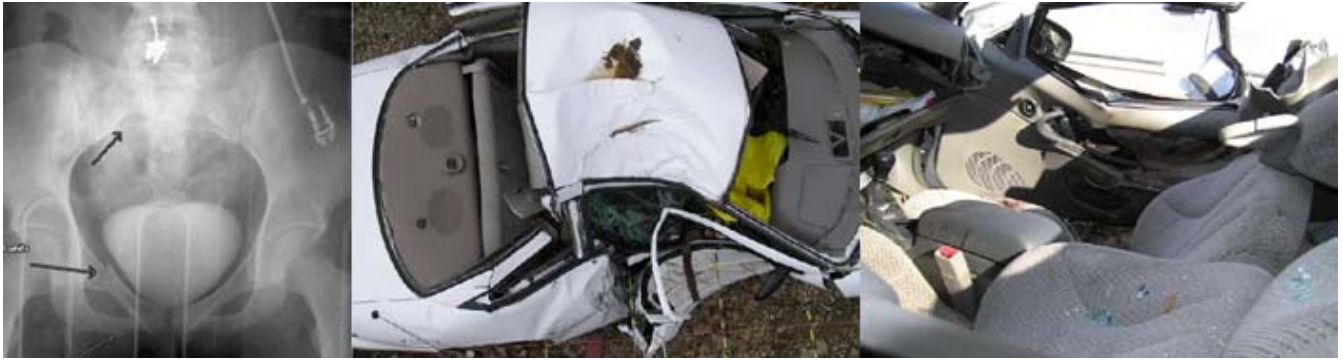
**Case 117404:** This CIREN case involved a 16-year-old belted female in the right front passenger seat of a vehicle that departed the roadway, began to yaw counterclockwise and struck a large tree on its right door. The primary direction of force was 80 degrees, and the impact caused 43 cm of maximum crush to the vehicle's exterior as well as 40 cm of intrusion to the right front door. The center of the vehicle damage was 15 cm behind the center of the vehicle's undamaged wheelbase. The near-side impact had a non-horizontal element, as the vehicle was on a down slope and probably struck the tree at an angle. No airbags deployed in the occupant's seating position. This occupant died from her injuries 22 days post-crash. This passenger sustained head injuries, including diffuse axonal injury (DAI), cerebrum contusions, epidural and subarachnoid hemorrhages, pneumocephalus, and basilar, vault, orbital and mandible fractures. In addition, she sustained bilateral lung contusions, a right pneumothorax and right rib fractures 1-4 and a left 1<sup>st</sup> rib fracture. She also sustained an L5 spinous process fracture and right pubic rami, sacral and pubic symphysis fractures. Her head injuries were sourced by the CIREN to the struck tree, while her thoracic and pelvis injuries were sourced to the right front door.

Fig. 7. CIREN Case 117404 Radiology and Vehicle Exterior and Interior

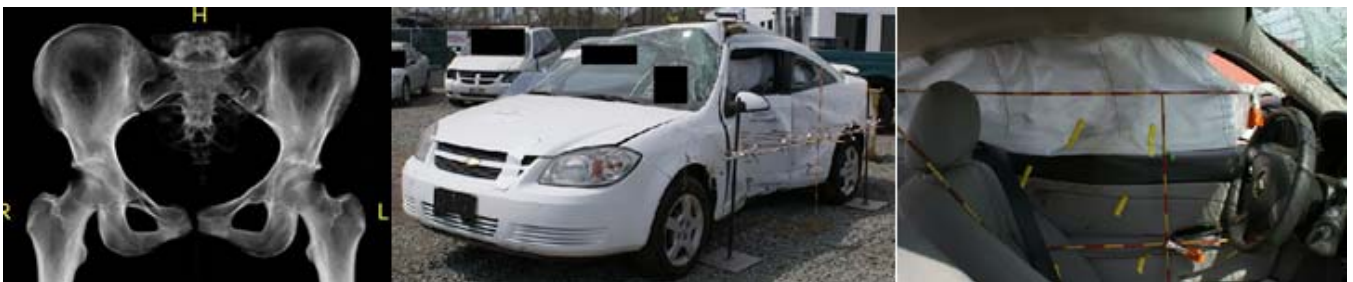
**Case 286038494:** This case involved a 17-year-old belted female driver who departed a roadway, entered a clockwise yaw, and struck a utility pole on its left door. The primary direction of force was 280 degrees, and the impact caused 44 cm of maximum crush to the vehicle's exterior as well as 30 cm of intrusion to the driver's door. This vehicle was equipped with an Event Data Recorder (EDR), which recorded a longitudinal delta-V of 4 kmph and a lateral delta-V of 39 kmph. The center of the vehicle damage was 5 cm behind the center of the vehicle's undamaged wheelbase. This impact with a pole was completely planar based on vehicle damage. The curtain airbag deployed in the driver's position, but no other airbags deployed. The driver sustained a basilar skull fracture and a brief loss of consciousness, as well as left sacrum, iliac and bilateral superior pubic rami fractures. The CIREN sourced the pelvic fractures to contact with the driver door and the head injuries to contact with the right front passenger in the vehicle.

Fig. 8. CIREN Case 286038494 Radiology and Vehicle Exterior and Interior

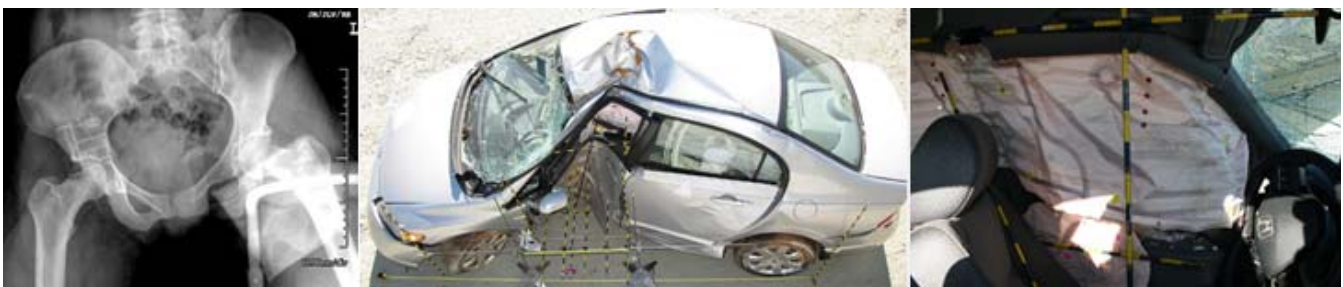
**Case 338055651:** This case involved a 26-year-old belted female driver who departed a roadway in a clockwise yaw and struck a tree with the vehicle's left door. The primary direction of force was 270 degrees, and the impact caused 46 cm of maximum crush to the vehicle's exterior as well as 40 cm of intrusion to the driver's door. The center of the vehicle damage was 13 cm in front of the center of the vehicle's undamaged wheelbase. Additionally, the near-side impact had a non-horizontal element, as there was more crush to the vehicle's rocker panel (floor sill) than to its door sill or roof rail. The curtain airbag and the seat-mounted thorax airbag both deployed during the impact. The driver sustained a midshaft displaced left femur fracture, a left radial head fracture, a left L5 transverse process fracture and fractures to the left sacral ala and superior pubic rami. All of the occupant's injuries were sourced by the CIREN to the left door except the pelvic injuries, which were postulated to be caused by the pelvis contacting the left door while the vehicle's center console acted as a boundary condition on the occupant's pelvis.

Fig. 9. CIREN Case 338055651 Radiology and Vehicle Exterior and Interior

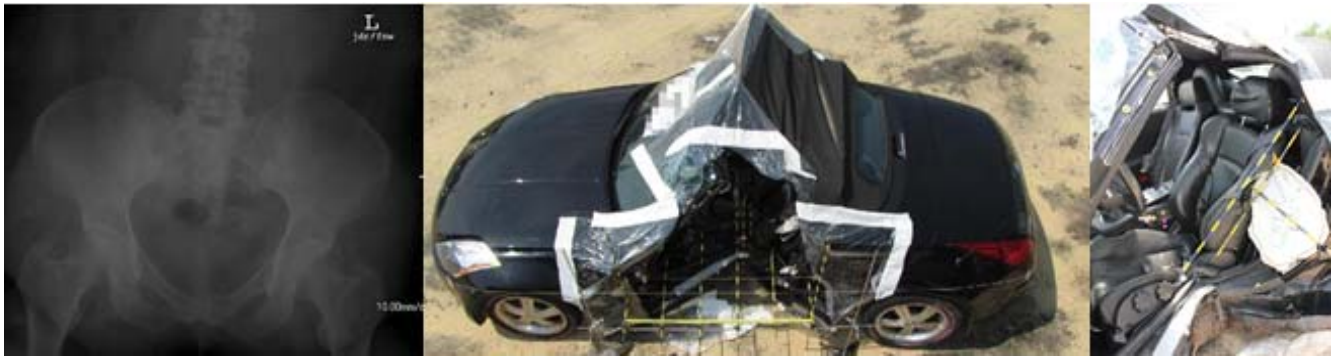
**CIREN Case 338090847:** This case involved a 44-year-old female driver who entered a clockwise rotation, departed a roadway and struck a large utility pole with the vehicle's left side. The primary direction of force was 260 degrees, and the impact caused 44 cm of maximum crush to the vehicle's exterior as well as 21 cm of intrusion to the driver's door. The center of the vehicle damage was 38 cm behind the center of the vehicle's undamaged wheelbase. This impact with a tree was completely planar based on vehicle damage. The seat-mounted head and thorax airbag deployed during this impact. The driver sustained rib fractures 2-4 and the 6<sup>th</sup> on the left and a left lung contusion. In addition, she sustained a right sacrum, left pubic rami, left radial shaft and right transverse processes L2, L4 and L5 fractures. The CIREN sourced all of these injuries to the left door except for the pelvic injuries, which were postulated to be caused by the pelvis contacting the left door while the vehicle's center console acted as a boundary condition on the occupant's pelvis.

Fig. 10. CIREN Case 338090847 Radiology and Vehicle Exterior and Interior

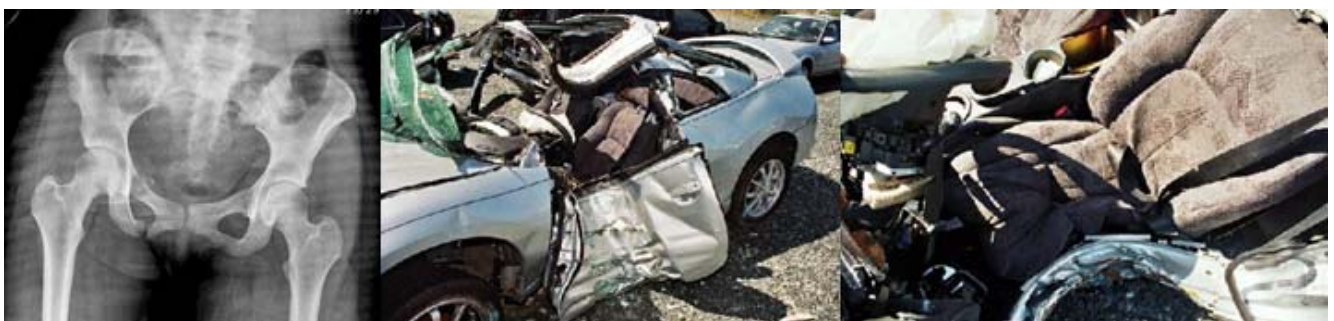
**CIREN Case 857076265:** This case involved a 16-year-old female driver who entered a clockwise yaw, departed a roadway and struck a non-breakaway traffic signal pole with its left door. The primary direction of force was 310 degrees, and the impact caused 52 cm of maximum crush to the vehicle's exterior as well as 23 cm of intrusion to the driver's door. The center of the vehicle damage was 31 cm in front of the center of the vehicle's undamaged wheelbase. This impact with a pole was planar based on vehicle damage, but there were two impacts with a barrier curb prior to the pole impact that could have induced a non-horizontal element to the crash. Both of the vehicle's frontal airbags deployed during this impact. The driver sustained bilateral superior pubic rami and right inferior pubic rami fractures in this impact. In addition, she also sustained a diffuse axonal injury and concussion, along with a left femoral shaft fracture. The CIREN sourced all of this occupant's injuries to the left door, although it was noted that the head could have also contacted the pole or the vehicle's left A-pillar.

Fig. 11. CIREN Case 857076265 Radiology and Vehicle Exterior and Interior
