## Assessing the Effects of Load Limiting Retractors on Occupant Motion

Steven E. Meyer, Arin Oliver Nelson, Davis A. Hock, Jeremy T. McMillin, Brian R. Herbst

**Keywords** Torsion Bar, Load Limiting, Belt Spoolout, Belt Payout, Offset Frontal Impact

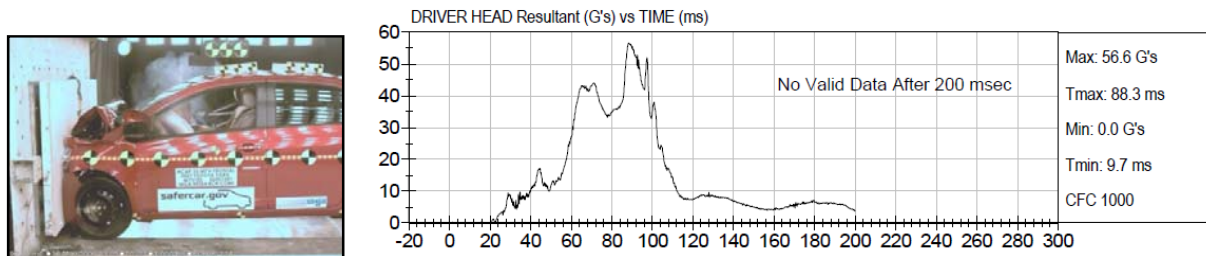
Fig. 1. NHTSA #5677 2007 Toyota Yaris NCAP, Head Peak G's Correspond to Noted Maximum Forward Excursion

airbag and strike the hub and/or instrument panel. Consistent with that reported by Brumbelow, the head acceleration data shows a spike in the head acceleration when such contact occurs. Also consistent with Brumbelow's findings, the complete system in this test circumstance does prevent such contact from reaching injurious levels. Fig. 1 depicts this circumstance in the 2007 Toyota Yaris NHTSA NCAP Test #5677 wherein the recorded ATD Driver's Head Peak G's corresponds to video analysis of the driver's forward most movement and airbag penetration.

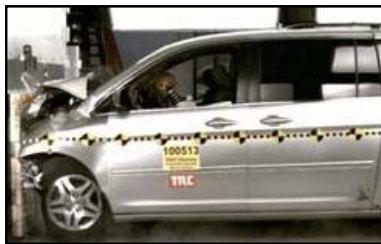
Fig. 2. 50<sup>th</sup> Percentile Male ATD Contacting Steering Wheel

Additionally, a review of NHTSA NCAP Test #6946 [7] wherein "the vehicle's supplemental restraint system was disabled", demonstrates the effective occupant excursion allowed by the load limiter without the benefit of the airbag. This tests shows that, despite being belted, the 50<sup>th</sup> percentile male driver ATD continues to move forward as the vehicle decelerates until the ATD's face impacts the vehicle's steering wheel hub approximately 75 milliseconds into the collision (See Fig. 2). A video analysis indicates the head is still moving forward at a speed of approximately 43 kph (27 mph) while the vehicle has decelerated to approximately 9 kph (5.5 mph), indicating the dummy's head impacted the steering wheel hub with a relative speed of approximately 34.5 kph (21.5 mph). Similarly, the belted 5<sup>th</sup> percentile female passenger ATD was also noted to impact the dash (See Fig. 3). With the load limiting seatbelt systems and without the benefit of frontal airbags, there was little limit to the forward movement of the ATDs (Note: neither ATDs were instrumented in this test).

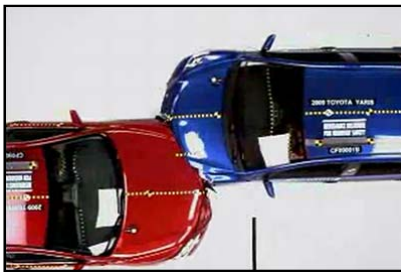
Fig. 7. IIHS 50% Offset 65 kph (40 mph) Frontal

Similar occupant kinematics were observed in an IIHS car-to-car crash test. The car-to-car test was a 50% offset frontal test of a 2009 Toyota Camry into a 2009 Toyota Yaris (equivalent platform to the 2007 model year) at approximately 65 kph (40 mph) (See Fig. 7) [12]. The driver's door in the Yaris was again seen to open (See Fig. 8 & Fig. 10), similar intrusion was observed, the PDOF was again forward and to the left, and the driver ATD was seen to move forward and glance off the left side of the frontal airbag and impact the vehicle structure to his left (See Fig. 9). Both the test and the field study demonstrate that in such a car-to-car offset circumstance the occupant did not receive the full benefit of the frontal airbag while also experienced a load limiter allowed forward excursion.

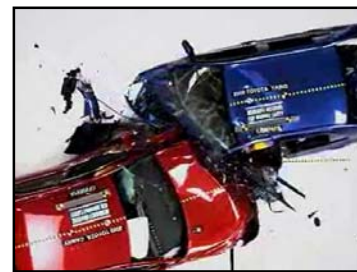
Fig. 8. Blue Yaris Driver's Door Opens during Impact

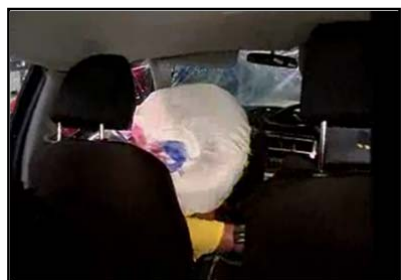
Fig. 9. Driver Does Not Fully Engage Airbag

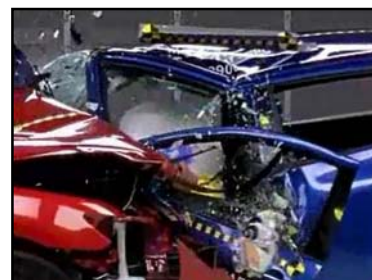
Fig. 10. Blue Yaris's Door Opens during Impact

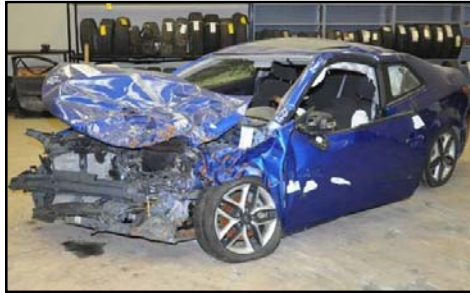
Fig. 11. Offset Frontal Impact

Field Case 2 experienced an offset frontal collision when opposing traffic crossed into its lane of travel (See Fig. 11). The police report narrative describes that post-accident the fatally injured right front passenger's head was very firmly lodged between the steering wheel of the vehicle and the driver's right leg. The right front occupant was a female, approximately 150-152 cm (59-60") tall and approximately 114 kg (251#). NCAP barrier tests demonstrating frontal airbag deployment reveals a gap between the driver's and passenger's airbags such that in the angled frontal with the PDOF and vehicle rotation taking the right front occupant forward and to the left, she moved between the two frontal airbags making fatal head contact with the front vehicle structure (See Fig. 12 & Fig. 13).

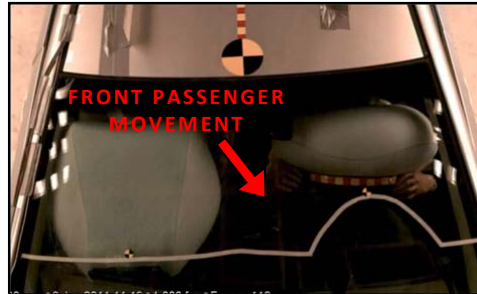
Fig. 12. Airbag Deployment in NCAP  
(Depicting Gap Between Deployed Frontal Airbags)

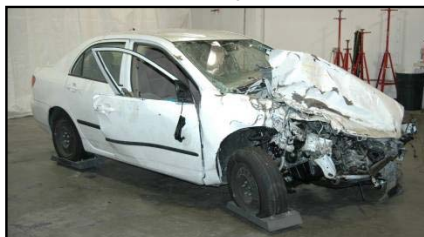
Fig. 16. Offset Frontal Impact

Field Case 3 involves a 2005 Toyota Corolla which lost control in a dangerous section of curved roadway, ultimately traveling into on-coming traffic and experiencing an offset frontal collision (See Fig. 16). The deltaV was approximately 35 mph with a PDOF forward and significantly to the right. The driver's seatbelt demonstrated evidence of approximately 300 mm (~12") of webbing spoolout before the belt became bound up and cut by the latch plate (See Fig. 17 & 18). The tearing the belt was determined to be associated with belt geometry changes associated with the PDOF and the significant belt spoolout.

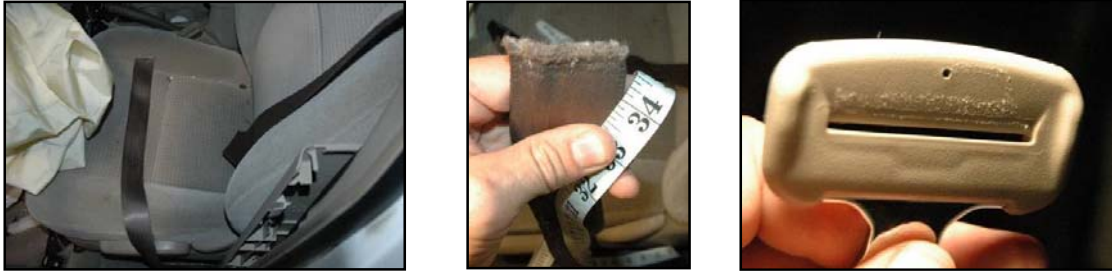
Fig. 18. Driver's Belt Cut via Roping in the Latch Plate

Once the belt had been cut, the driver was then free to travel across the occupant compartment interacting with the center console, dash and right front door before ultimately being ejected out the right front window sustaining traumatic and permanent brain injuries (See Fig. 19). The driver was 175-178 cm (69-70 in) tall and approximately 75-82 kg (165-180 lbs).

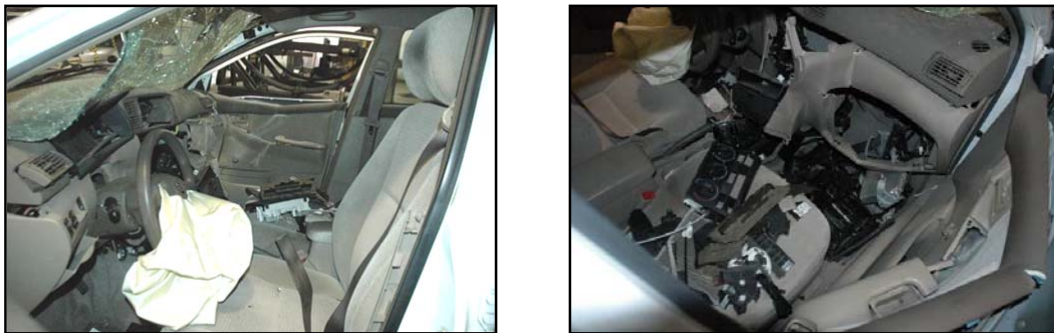
Fig. 19. Deformed Interior and Right Front Door Structure

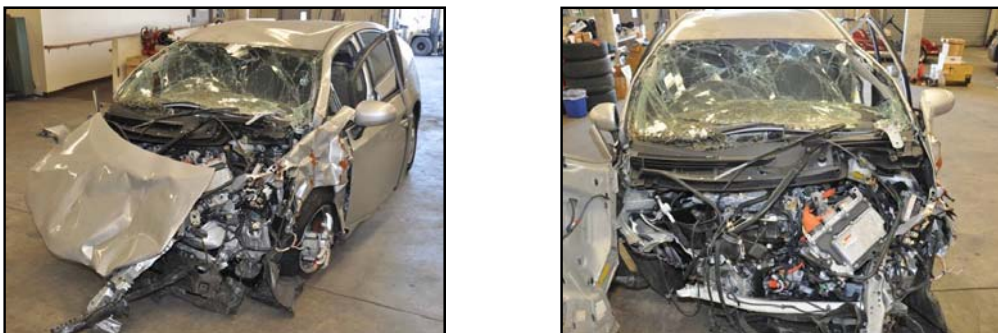
Fig. 20. Multiple Angled Frontal Impacts

Field Case 4 experienced an intersection collision when another vehicle, that had failed to yield right of way, turned left in front of the subject vehicle. This resulted in an initial vehicle-to-vehicle impact which redirected the subject vehicle across the intersection and into a concrete barrier (See Fig. 20). This collision therefore involved multiple frontal impacts. The frontal airbag deployed and physical evidence on the driver's webbing revealed load limiter spoolout of approximately 590 mm (23 in) (See Fig. 21). The initial impact, per the airbag module data, resulted in a deltaV of approximately 51 kph (32 mph), sufficient to deploy the airbag as well as several inches of load limiter spoolout. The second frontal impact was estimated to have produced a deltaV of approximately 48 kph (30 mph). The airbag control module indicated that the airbag had deployed at the first impact such that at the time of the second impact the airbag would have been partially deflated. The load limiter would also have spooled out during the initial impact such that at the time of the second impact it was able to spoolout further, however, at this point the airbag would have been less than optimally inflated. As such, the driver was allowed to move aggressively forward into the steering wheel (See Fig. 23). The steering column was found stroked and the occupant sustained fatal traumatic injuries associated with his forward excursion. The male driver was reported as being 183 cm (72 in), 109 kg (240 lbs) and sustained fatal head, chest and abdominal trauma.

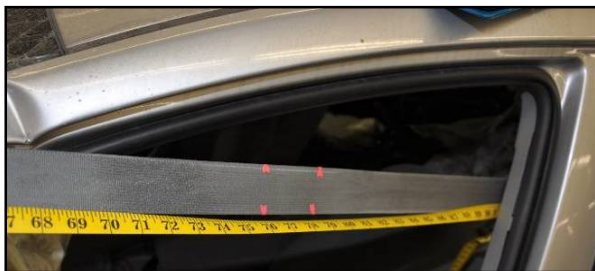
Fig. 21. 590 mm (~23") of Load Limiter Belt Spoolout

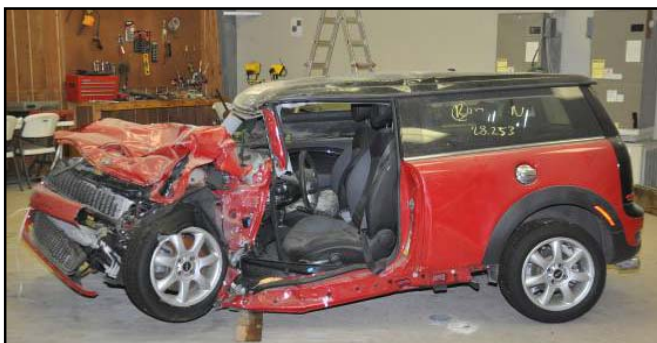
Fig. 24. Offset Frontal Impact

Field Case 5 experienced an offset frontal collision when a vehicle traveling in the opposite direction hydroplaned, lost control, and crossed into its lane of travel. During the collision, the vehicle's airbags failed to deploy and the driver's side door unlatched, resulting in the loss of supporting side structure and intrusion of the A-pillar (See Fig. 24 & Fig. 25). The PDOF was to the left of forward and the deltaV was in the mid 50's kph (mid 30's mph).

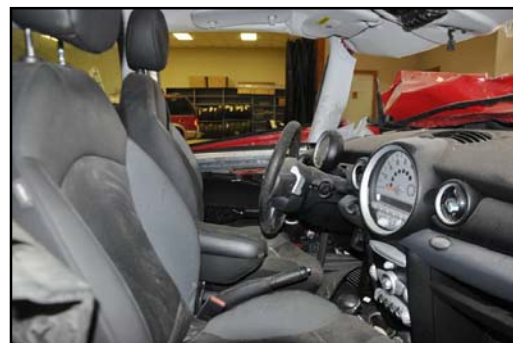
Fig. 25. Driver's Airbag Did Not Deploy, Door Failed to Remain Closed

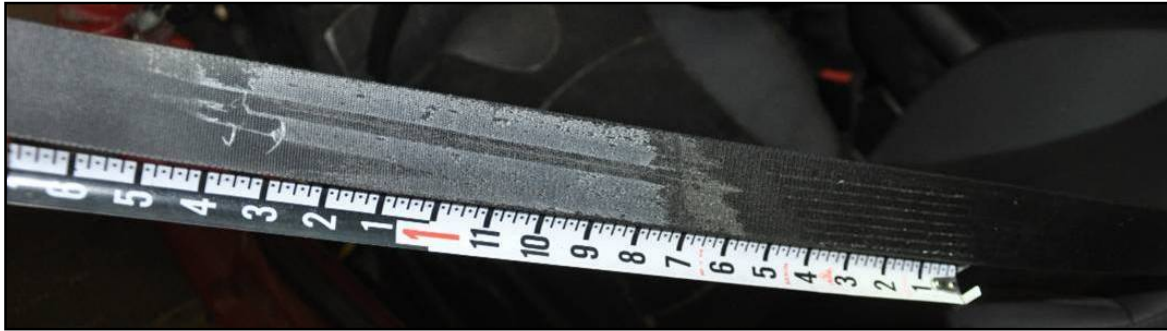
Evidence found on the seatbelt webbing indicates the load limiter allowed approximately 279 mm (11 in) of belt to be spooled out of the retractor (See Fig. 26). The driver moved forward and to the left sustaining multiple skull fractures as a result of contact with the A-pillar and was killed. The male driver's stature was approximately 183 cm (72 in) and 111 kg (244 lbs).

Fig. 26. 279 mm (~11") of Load Limiter Belt Spoolout

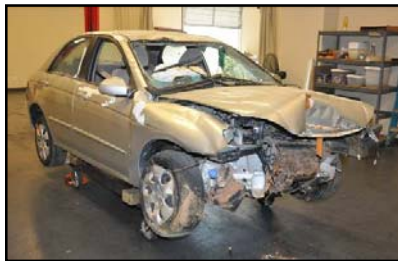
Fig. 27. Multiple Frontal Impacts

Field Case 6 experienced a loss of control with the car exiting the roadway into the adjacent shoulder where it ultimately impacted an embankment (See Fig. 27). The vehicle's frontal airbags were determined to have deployed during a curb impact as the vehicle exited the roadway such that at the time of the more significant frontal embankment collision, the occupants did not have the benefit of interacting with a fully inflated frontal airbags as they had deployed previously at the curb. At the time of the collision the vehicle was carrying two belted front seat occupants as well as an unbelted occupant in the rear seating area. No significant intrusion into the occupant compartment was observed. The right front occupant's belt spooled out approximately 560 mm (22 in) such that his head was able to make forcible contact with the front header structure causing neck fractures resulting in permanent quadriplegia (See Fig. 28, 30 & 31). The male right front occupant was 175-178 cm (69-70 in) tall and weighed approximately 75-77 kg (165-170 lbs).

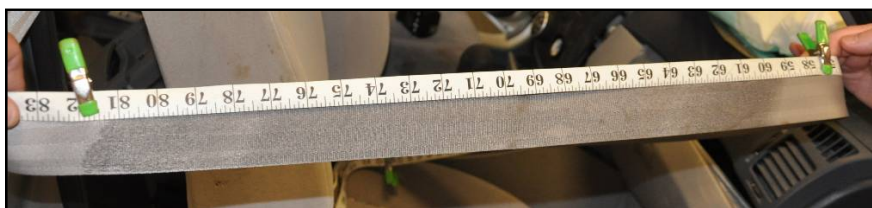
Fig. 30. 560 mm (~22") of Load Limiter Belt Spoolout

The disassembled retractor revealed the torsion bar component of the load limiter to have experienced up to 60 degrees of twist indicating it allowed the webbing spool to rotate  $3 \frac{1}{2}$  times during torsion bar deformation (See Fig. 29). Given the amount of webbing that would be present on the spool with this sized occupant,  $3 \frac{1}{2}$  rotations is consistent with the approximately 560 mm (22 in) of transfer marks noted on the webbing.

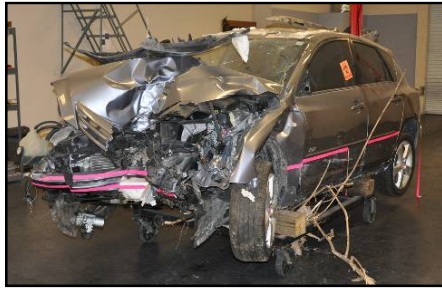
Fig. 32. Narrow Object Frontal Impact

In Field Case 7, the vehicle exited the roadway after swerving to avoid an animal and ultimately collided with a [line of trees](#) (See Fig. 32). The vehicle's frontal airbags failed to deploy and the seatbelt demonstrated clear evidence of load limiter spoolout (See Fig. 33). D-ring load marks on the webbing indicate shoulder belt spoolout of 508 mm (20 in) (See Fig. 34). In this case, the driver's injuries were fatal and included multiple facial fractures. The male driver was 188 cm (74 in) tall and weighed 102.5 kg (226 lbs).

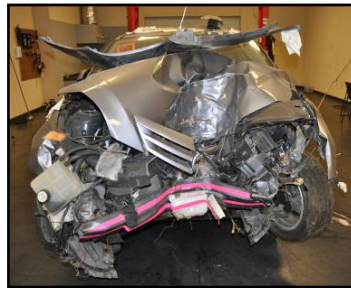
Fig. 33. Driver's Airbag did Not Deploy

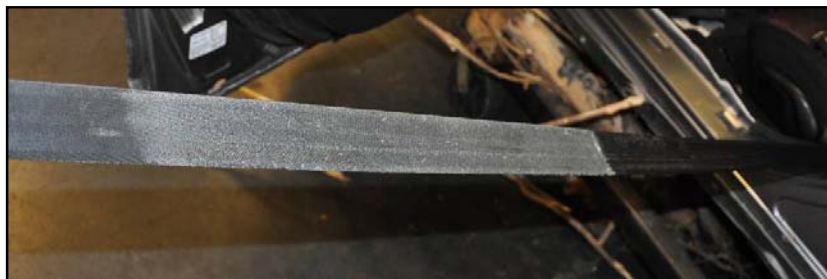
Fig. 34. 508 mm (~20") of Load Limiter Belt Spoolout

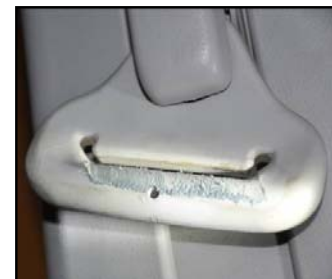
Fig. 35. Abraded D-ring

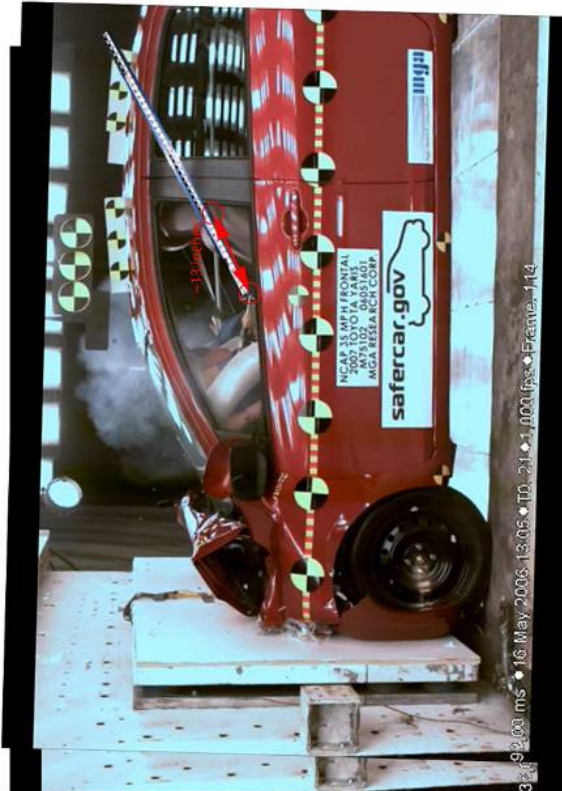
Field Case #1 / NHTSA #5677 2007 Toyota Yaris NCAP,  
~ 330 mm (~13") Belt Spoolout

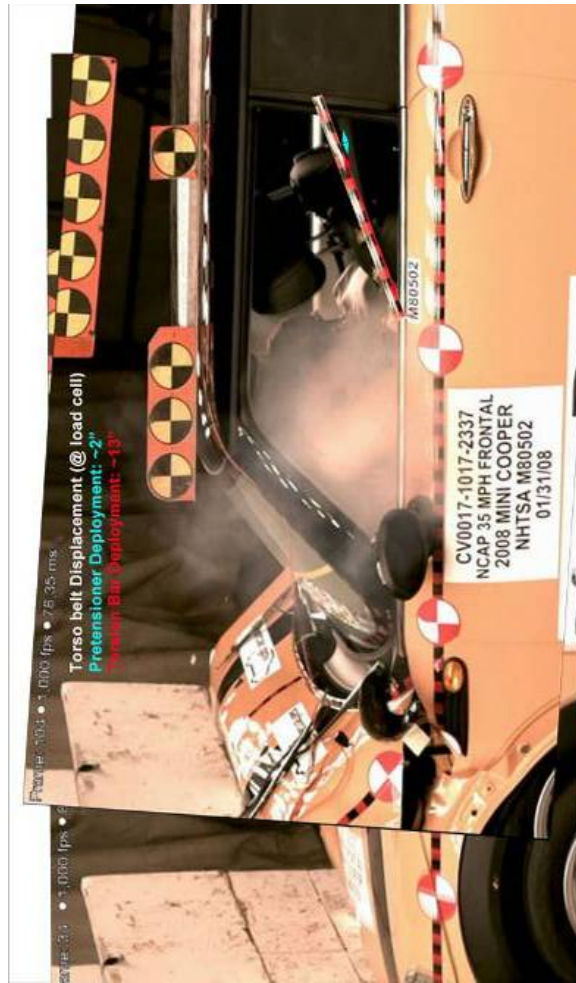
Field Case #5 / NHTSA #6291 2008 Mini Cooper NCAP,  
~ 330 mm (~13") Belt Spoolout

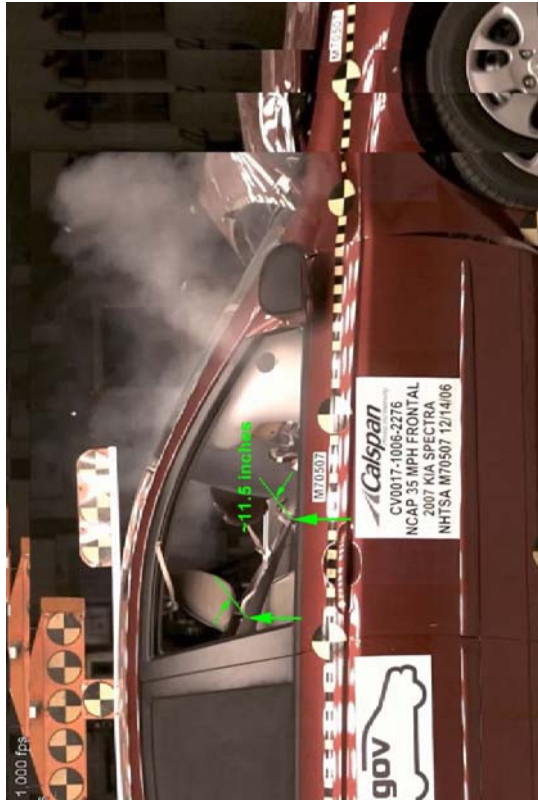
Field Case #6 / NHTSA #5906 2007 Kia Spectra 4-dr Sedan,  
~ 292 mm (~11.5") Belt Spoolout

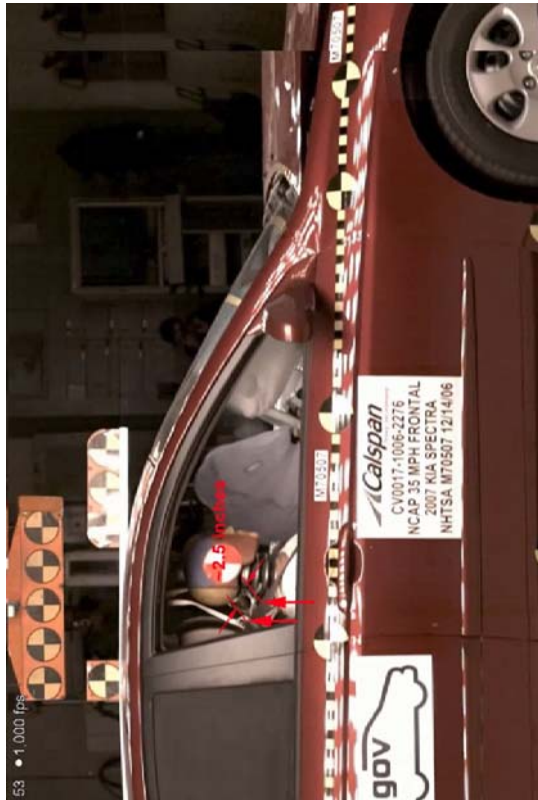
Field Case #6 / NHTSA #5906 2007 Kia Spectra 4-dr Sedan,  
~ 64 mm (~2.5") Belt Pretension

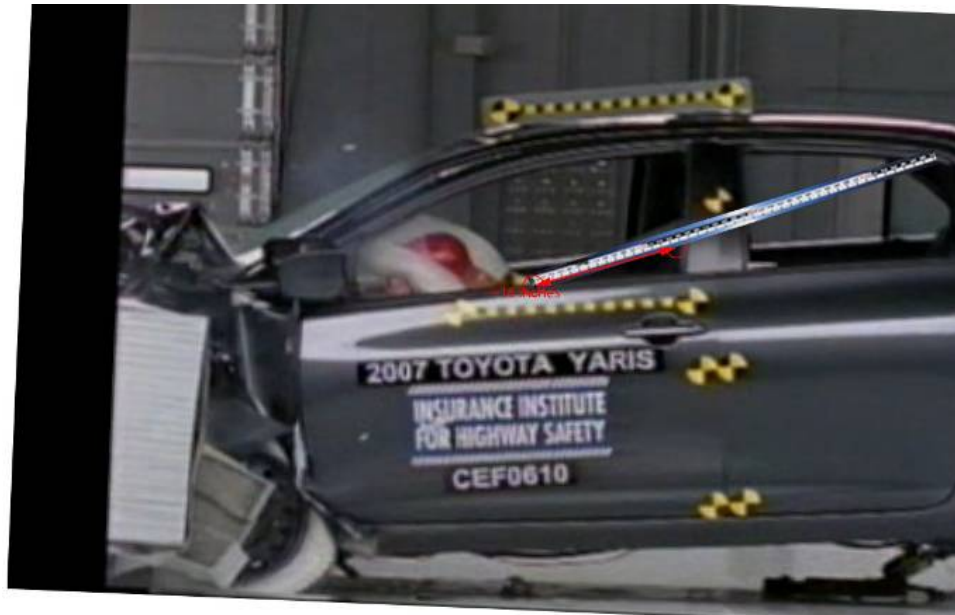
IIHS 2007 Toyota Yaris Moderate Overlap Frontal, ~ 406 mm (~16") Belt Spoolout

IIHS had also conducted a 40% Overlap frontal barrier test on a 2007 Toyota Yaris at 65 kph (40 mph). This test resulted in a more frontal PDOF than the field case or IIHS car-to-car test and the door remained latched. Video analysis of the load limiter seatbelt spoolout showed approximately 406 mm (~16 in) of seatbelt spoolout which allowed the head to bottom out the airbag and impact the steering wheel (See Appendix B). Although with the door structure still in place, the driver ATD was seen to more fully engage the airbag and the head-to-steering wheel contact was not above injury assessment reference values (IARV).
