## Investigating Head Impact Dynamics and Cervical Spine Injuries in Karting Rollovers: An Initial Assessment of Neck Brace Efficacy

Catherine Masson, Nicolas Bailly, Lucas Troude, Marianne Guesneau, Pierre-Jean Arnoux, Marie-Hélène Beauséjour

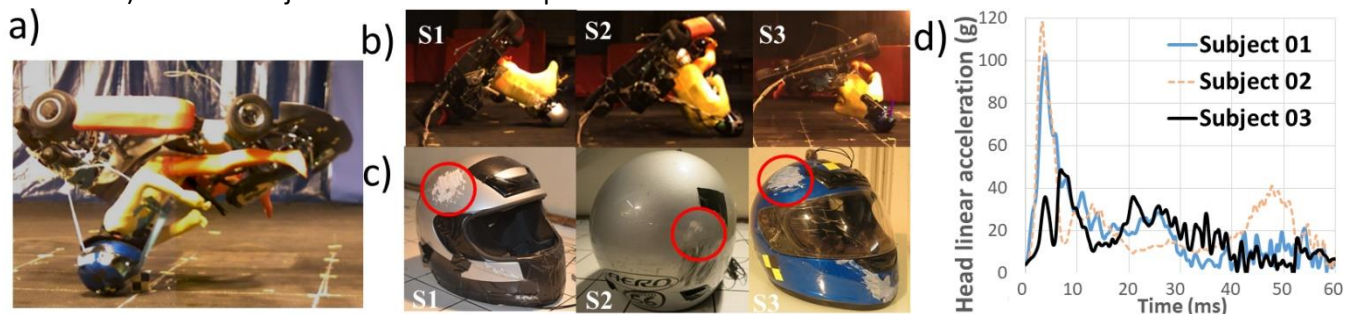
Figure 1: Head impact during rollover: (a and b) position of the PMHS and kart at the head impact, (c) first impact zone on the helmet for subject 1 to 3, (d) resultant head linear acceleration curves at impact

The three subjects fell on their head first (Figure 1). The normal and tangential velocities relative to the floor were measured as done previously with the Kinovea software at the contact with the floor. The mean normal velocity was  $4.5 \text{ m/s} \pm 0.4$  and the tangential velocity was  $11.0 \text{ m/s} \pm 0.5$ . These results are very close between the three-test showing a good repeatability of the experimental protocol (Table 1). The post-impact status of the helmets can be seen in Figure 1. We can see that the first impact was in the superior lateral part of the helmet for the three tests. Also, important abrasive marks were seen on the chin and on the left part of the helmet due to the axial rotation of the head after the impact as seen in the video. Some abrasions were also observed at the anterior part of the neck brace, but without important deformation. Peak head acceleration measured in the mouth (mean :  $92\text{g} \pm 33$ ) was approx. 3 time smaller than that measured in the helmet (mean :  $315\text{g} \pm 120$ ) and was well bellow injury threshold for severe brain injury ( $\text{HIC} \ll 1000$ ) suggesting that the helmet was effective at protective the head for this type of impact. Looking at the maximum mouth resultant accelerations for the three karting roll-over tests (Figure 1), we see that the resultant acceleration was two times lower for test 3, which might be due to the neck brace contacting with the helmet at the beginning of the impact (Figure 1) and limiting the acceleration of the head. The injuries are detailed in Table 1. Only the subject 1 and 3 (despite wearing a neckbrace) sustained injuries at the cervical spine.

This study presents the first karting rollover performed with PMHS and the first neck brace efficacy evaluation using PMHS. It provides valuable data on head impact conditions, neck loading, and cervical spine injuries. All three rollovers resulted in lateral head impacts with similar normal and tangential head velocities, but only two led to neck injuries. Two hypotheses may explain why PMHS 2 did not sustain a neck injury: first, his greater stature (above the 75th percentile, compared to below the 30th percentile for Subjects 1 and 3) may have provided some protection; second, video analysis shows that the helmet impact was more posterior than in the other two crashes. This likely caused PMHS 2 to roll onto his shoulder, which may have helped protect the cervical spine. In contrast, PMHS 1 and 3 experienced impacts to the top lateral part of the helmet and were subjected to neck hyperextension. Regarding the effectiveness of the neck brace, the videos show contact between the helmet and the brace early during the head impact, potentially dissipating some impact energy and reducing head acceleration. However, axial rotation of the head was still observed upon ground contact, which is consistent with recent studies showing that axial rotation is the least restricted movement by the neck brace [5]. As a result, the neck brace did not fully protect the PMHS from cervical spine injuries in this test configuration, and the injuries sustained were severe. This study presents several limitations, including the lack of head rotational kinematic measurements—an important metric for both head and neck injuries—as well as the absence of reflexes and active musculature in the PMHS, which might have altered impact posture and limited the risk of neck injury. While these findings are based on only three experiments, they offer valuable insights into kart rollover kinematics, support the development of numerical models, and contribute to the understanding of neck injury mechanisms. Further research is needed to fully assess the influence of neck braces on neck kinematics and injury risk [6].
