## PTW Rider Injury Mechanisms from Full-Scale Crash Testing Using PMHS

John Bolte IV, Jolyon Carroll, Mara Van Meter, Angela Tesny, Daniel Meringolo,  
Erin Higinbotham, Shiyang Meng, Yun-Seok Kang, Amanda Agnew

**Keywords** Injury Mechanisms, Pelvic Injury, Post-Mortem Human Subjects (PMHS), Powered Two-Wheelers (PTW), Thoracic Injury, Thoracic Spinal Injury

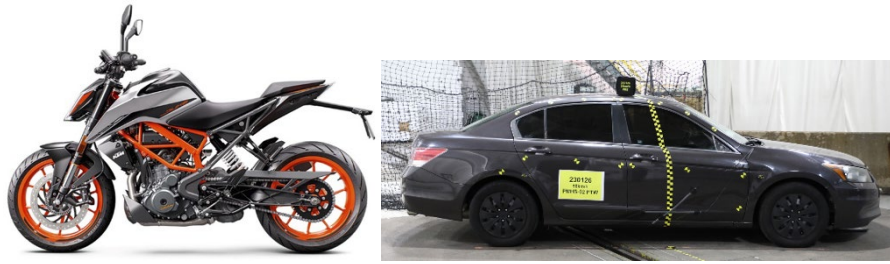
Fig. 1. 2022 KTM 390 Duke (left) and 2011 US Honda Accord (right)

For this study, the chosen powered two-wheeler (PTW) was a 2022 KTM 390 Duke (Fig. 1), sourced from KTM in Austria (Mattighofen, Austria). This PTW was selected as it represents a common style of motorcycle ridden around the globe and was easily accessible for testing both in the United States and in Europe. In addition, it falls into the sport category, which was the style with the largest number of fatalities in the US in 2021 [1]. The struck vehicle for all three PMHS tests was a 2011 Honda Accord. The US Honda Accord (Fig. 1) was selected to replicate similar experiments conducted in Sweden using an anthropomorphic test device (ATD) as the occupant riding a KTM 390 Duke into a stationary European Honda Accord [18]. The helmet selected for these PMHS tests was a Bell Qualifier (Bell Helmets, Rantoul, IL) which also matched the ATD tests.

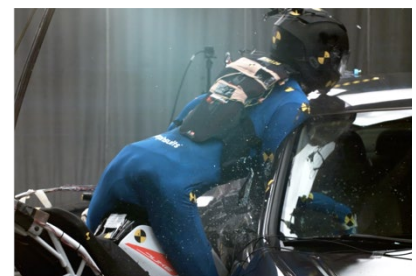
Fig. 5. Exemplar strain data for right and left side anterior ribs (each line is strain from a sperate rib as shown in each legend) and a still frame showing the position of the PMHS at the onset of fracture

Representative strain gage data from the anterior rib gages of one PMHS are presented in Fig. 5. Strain and strain rate histories were evaluated for each gage to determine the timing of rib fractures during the impact event. An exemplar plot using a single anterior rib gage to show how fracture timing was determined is shown in Appendix C. In this example, multiple right-side ribs exhibited fracture at approximately 111 ms, indicated by a rapid drop in measured strain. A corresponding high-speed video frame at 111 ms illustrates the PMHS kinematic position at the time of fracture. Synchronization of strain-based fracture timing with video analysis enables identification of the rider–vehicle interactions responsible for specific injuries. In this case, the timing of upper right-side rib fractures corresponds to impact of the right shoulder and upper right thorax with the upper A-pillar and leading edge of the roof rail.

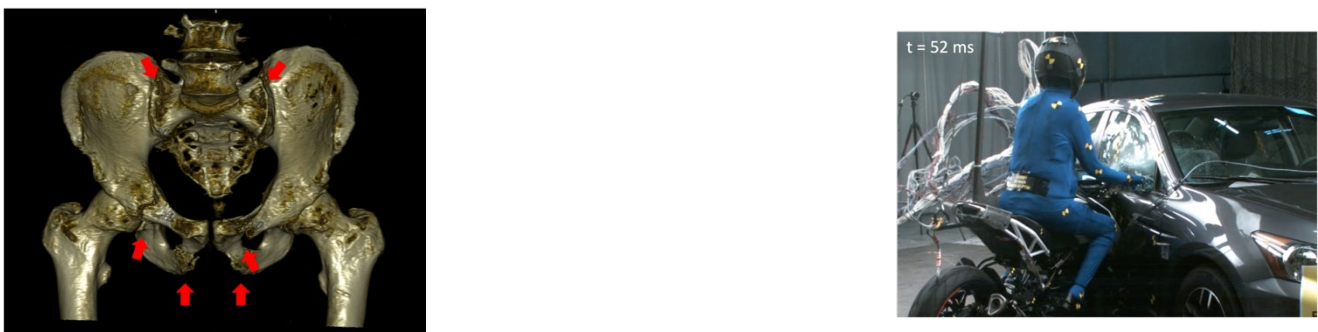
Fig. 8. Exemplar pelvis 3D CT revealing a complete disruption of the posterior arch (left), pubic ramus strain data revealing fracture timing (middle), and a still showing the timing of the pubic fracture (right)

All PMHS sustained complete disruption of the posterior pelvic ring, classified as a severe (AIS4) injury. An exemplar post-test CT image of the pelvis is shown in Fig. 8, with red arrows indicating fractures and joint separations identified during autopsy. Strain gage data from sensors placed on the bilateral superior pubic rami were used to determine the timing of anterior pelvic fractures. In the exemplar case, fracture of the pubic rami occurred at approximately 53 ms. The corresponding high-speed video frame (Fig. 8) demonstrates that, at this time, the pelvis had translated forward along the seat and engaged the fuel tank of the PTW.

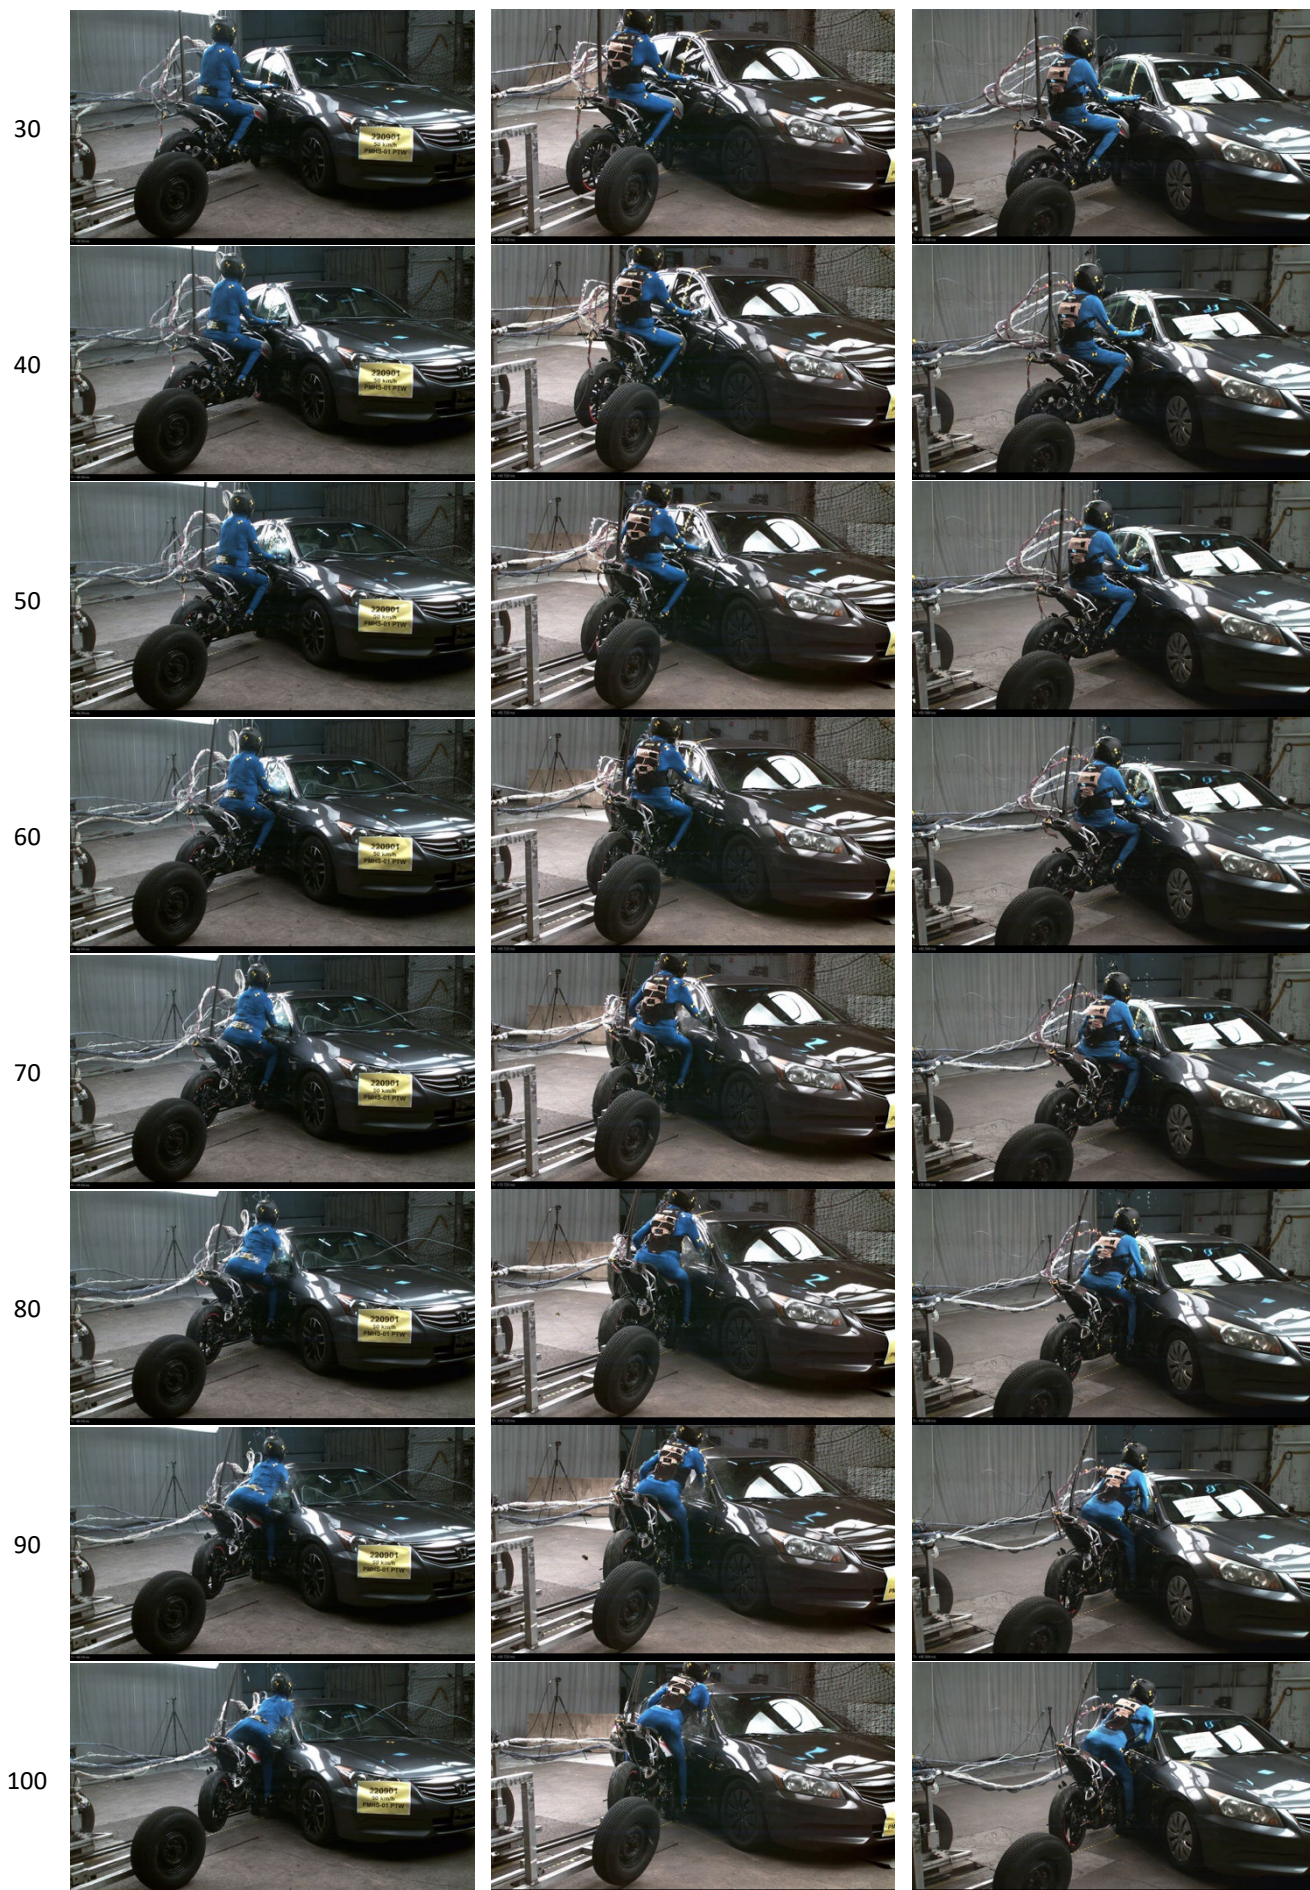
Appendix B – Still frames from the high-speed video of all 3 tests at 10 msec increments

The whole-body kinematics of each PMHS are shown in Appendix B. The sequential still images from an offboard camera begin at time zero, defined as initial contact between the PTW front wheel and the sedan-mounted pressure switch. Each row represents 10 ms intervals over the first 150 ms of the event.

As shown in Appendix A, the whole-body kinematics of the PMHS were highly consistent across all three crash tests up to and throughout the main contact with the vehicle. During the initial 0–50 ms, the rider maintained an upright posture while translating forward along the seat toward the fuel tank. Concurrently, the PTW front tire compressed against the side of the sedan, inducing a leftward rotation of the front tire and handlebars. At approximately 50–60 ms, the anterior pelvis of each PMHS engaged and compressed into the fuel tank, producing consistent tank deformations across all tests. As the pelvis and lower extremities decelerated due to this interaction, the upper body continued its forward motion, resulting in spinal extension between 50–70 ms.

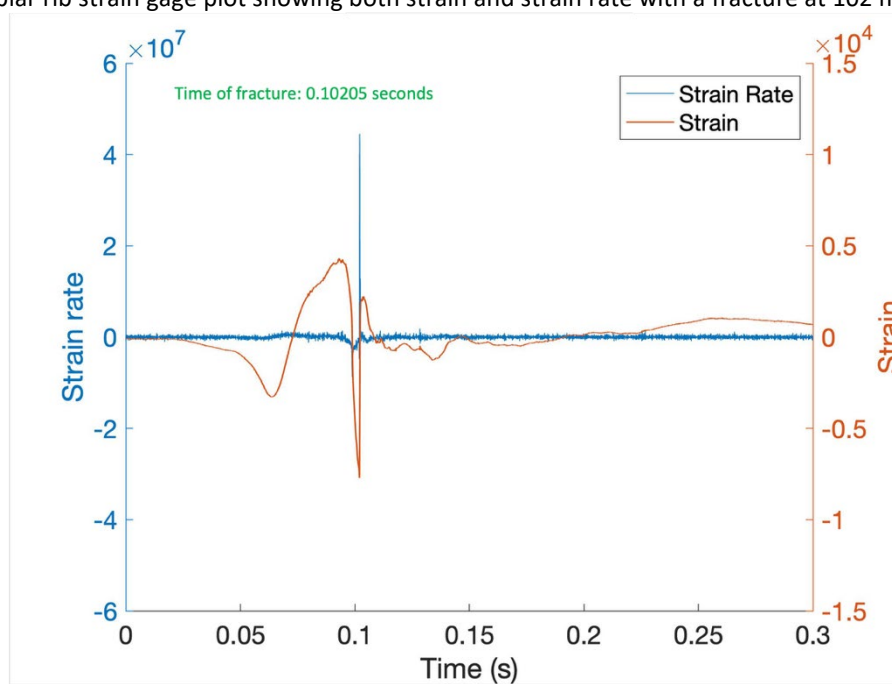
Appendix C – Exemplar rib strain gage plot showing both strain and strain rate with a fracture at 102 msecs
