## Investigation of Risk Factors Contributing to the Occurrence of Posterior Rib Fractures

Francisco J. Lopez-Valdes, Manuel Valdano, Ema Jokubaityte, Amaya Palacios Weiss, Carlos J. Carpintero Rubio, Rohan Govardhan, Sanjay Baladaniya, Jeya Padmanaban

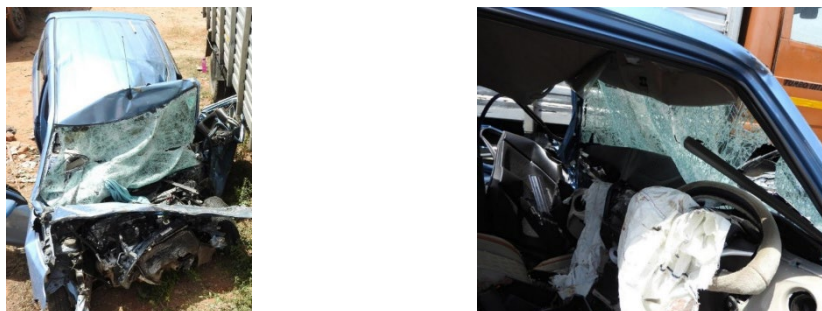
Fig. 1. Pictures from the exterior and interior (driver seat) of the relevant passenger car involved in Case 1.

This crash case involves a fatally-injured, belted, 42-year-old, male driver of a 2019 Maruti Suzuki Wagon R four-door small hatch, which was involved in a frontal collision with a truck. There were four other occupants (all unbelted) in the car and all four sustained fatal injuries. This head-on vehicle collision occurred on a rural, two-lane, two-way, dry asphalt roadway. The estimated delta-v for the passenger car was 90 km/h, while it was only 8 km/h for the heavy truck due to the mass differences. Both vehicles received almost a pure frontal impact (Principal direction of force (PDOF): 1 o'clock, passenger car; 12 o'clock, truck). Within the scope of this manuscript, only the injuries sustained by the fatally injured driver of the passenger car will be discussed.

The 42-year-old male driver was restrained by a three-point lap and shoulder belt not incorporating pretensioners, and by a frontal airbag, which deployed in the collision as shown in Fig. 1. The vertical position of the D-ring was not adjustable for this vehicle. A summary of all the injuries sustained by the driver is provided in Fig. 2, while the detailed description of the thoracic and abdominal injuries sustained by the driver is presented in Table II. After the investigation of the case, the posterior rib injuries of the driver were attributed to the direct contact with the seatback that was pushed forward by the unbelted occupants travelling in the rear seat of the vehicle.

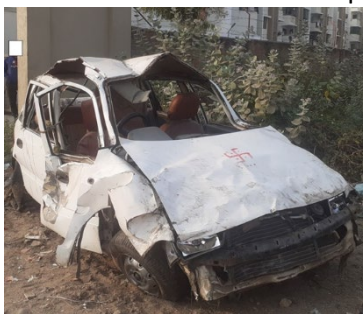
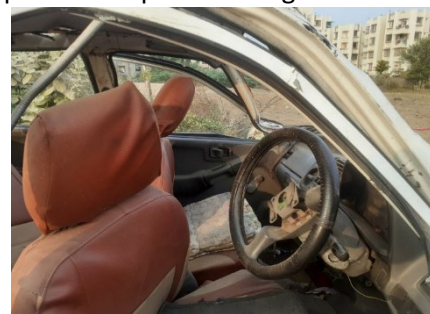
Fig. 3. Pictures from the car involved in Case 2.

This crash case involves a fatally-injured, belted, 28-year-old, male driver of a 2000 Maruti Suzuki Zen four-door mini hatch, which was primarily involved in a frontal-oblique collision with a roadside concrete structure on the left-side ditch. There were three other occupants (all unbelted) in the car, and all other occupants sustained minor injuries. This head-on vehicle collision occurred on a four-lane divided, dry asphalt national highway at night. The estimated impact speed against the rigid concrete structure was 32 km/h. The vehicle was not equipped with airbags, and the three-point seat belt was not pretensioned. The seatback angle of the driver's seat remained upright, and there was no evidence of hard contact of the driver with the seatback. The vertical position of the driver's seat belt was not adjustable in this vehicle. Pictures of the car and the interior are provided in Fig. 3., Fig. 4 and Table III include the summary of all injuries sustained by the driver and details of thoracic and abdominal AIS2+ injuries. This evidence suggests that the posterior rib fractures were caused by the distribution of deformation over the chest of the occupant without a direct impact to the posterior region of the rib cage.

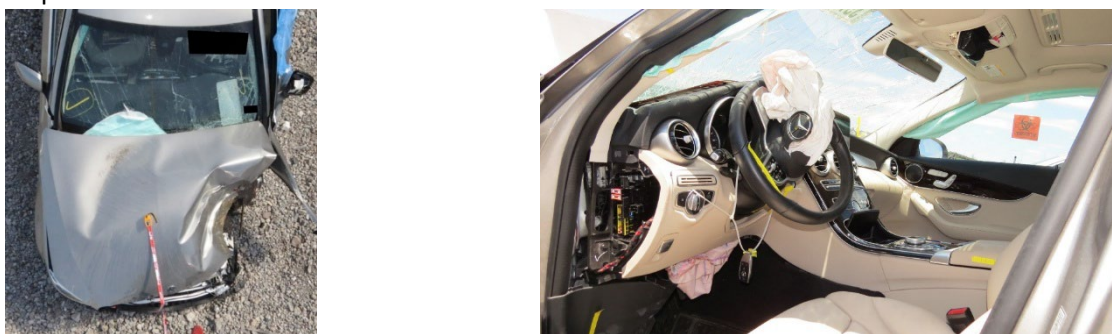
Fig. 5. Pictures of the exterior and interior of the vehicle in Case 3.

This crash case involves a moderately-injured, belted, 183 cm, 77 kg, 72-year-old, male driver of a 2019 Mercedes C300 four-door sedan, which was primarily involved in a frontal collision with a large tree. The driver of Vehicle 1 was restrained by his three-point lap and shoulder belt (with retractor pretensioner), and the vehicle was equipped with advanced frontal airbags, first and second-row seat backrest-mounted hip/torso airbags, and roof rail-mounted curtain airbags. As a result of the impact, the driver's steering wheel, knee bolster, and roof rail-mounted curtain airbags deployed. Pictures of the car and the interior are shown in Fig. 5. The driver sustained moderate injuries (summarised in Fig. 6). The driver seat was reported to be between the mid-track to rear positions. In post-crash images the seatback appears slightly reclined. The shoulder belt anchorage was reported to be in full-upright position. The posterior rib injuries were attributed to the contact with the left door panel (left forward upper quadrant) with the contributing factor of high delta-v and involving a compression mechanism. This causation scenario was considered certain, and the evidence was a non-optimal posture biased forward oblique by the slope of the road and the 1st event. The AIS information from the abdominal and thoracic AIS2+ injuries are provided in Table IV.

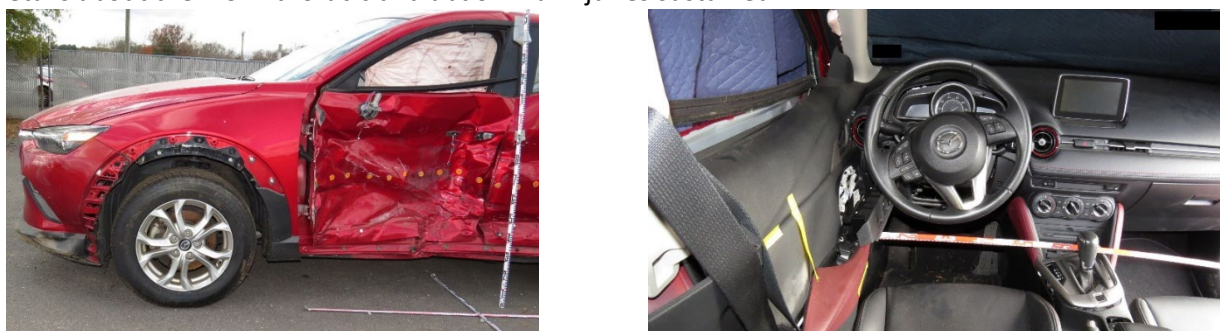
Fig. 7. Pictures of the exterior and interior of the vehicle in Case 4.

join the main road and was impacted by the second vehicle which was traveling on the main road. Pictures of the vehicle are provided in Fig. 7.
