## Causes of Spinal Injuries in Rear Crashes from the Crash Injury Research and Engineering Network (CIREN)

This study examines causal factors of spinal injuries in rear-impact crashes. The authors queried the CIREN database and performed an in-depth clinical review of twenty-two belted front-seat occupants who sustained moderate severity spinal injuries in rear-impact crashes.

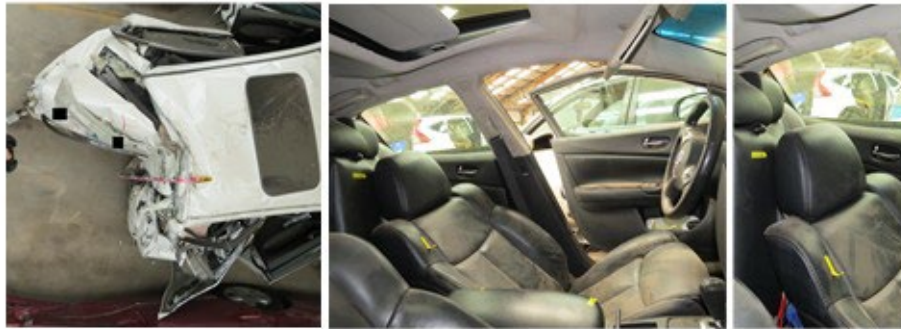
Crash severity

2<sup>nd</sup> row intrusion  
supporting seat

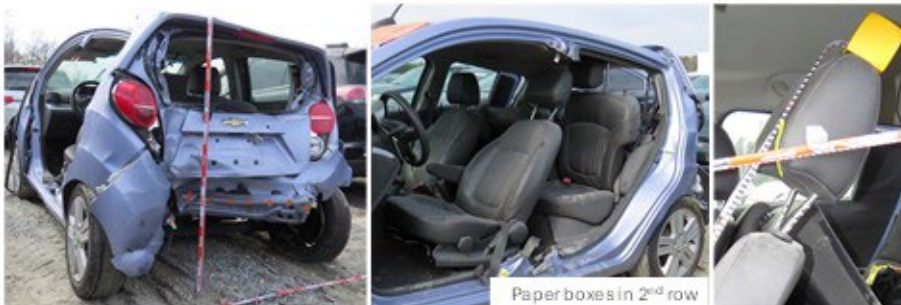
2<sup>nd</sup> row cargo

supporting seatback

**Kinematics:** The occupant moved rearward with the PDOF and loaded the seat. The occupant pocketed into the seatback. The fused thoracic spine straightened along seatback and fractured. The seatback rotation was stopped by backseat cargo (boxes of paper). Her body likely ramped as she rebounded forward. The head loaded the underside of the head restraint.

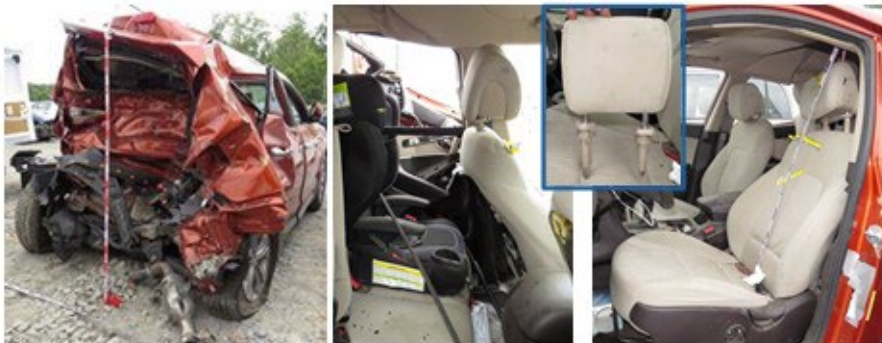
Crash severity

Cargo contact

Kinematics: The crash was severe. The crush and intrusion likely occurred early, pushing the 2<sup>nd</sup> row seat forward. There was a child seat in the left-rear. The case occupant moved rearward and inboard, loading the seat and head restraint. The seatback likely contacted the CRS that was pushed forward with intrusion, bolstering the seat. The occupant likely ramped up the seatback. The head may have contacted the roof structures. The head restraint showed signs of loading and was pulled out of its mounting. The occupant then rebounded forward.

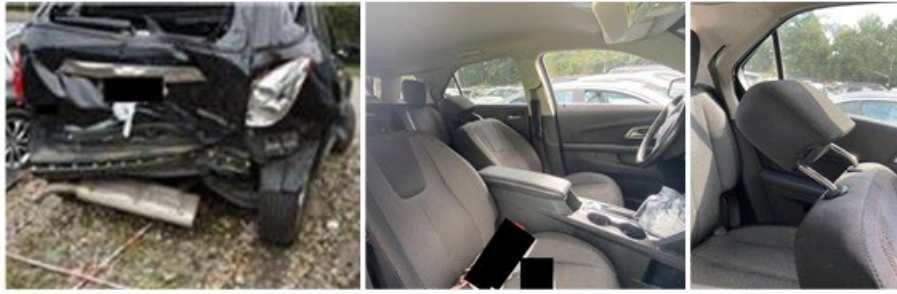
Oblique loading

Kinematics: The driver moved rearward and loaded the seat. She pocketed into the seatback and straightened her stiffened spine along the seatback as it rotated. The driver moved slightly inboard with PDOF. The seat yielded. The seatback contacted the second-row seat cushion. The driver likely ramped. The head restraint showed signs of occupant loading.

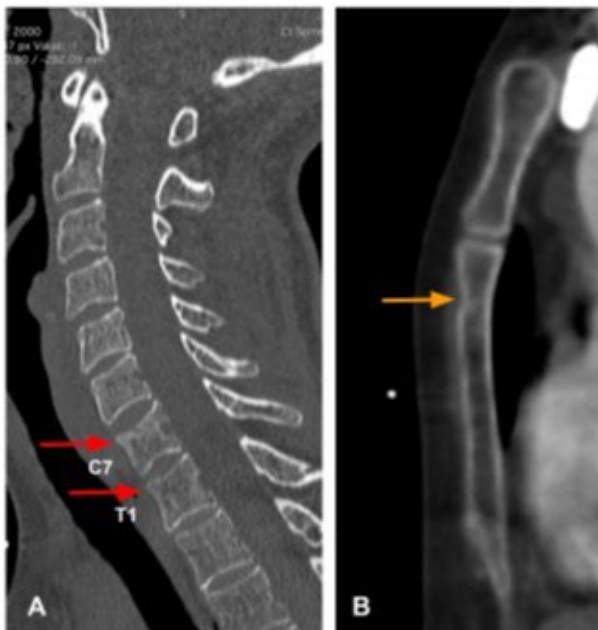
**CASE 10. (A)** Sagittal CT image of the cervical and upper thoracic spine demonstrates mild anterior wedge compression-flexion fractures of the C7 and T1 vertebral bodies (red arrows). **(B)** Sagittal CT image of the sternum demonstrates buckle fracture of the anterior cortex of the sternal body (orange arrow).

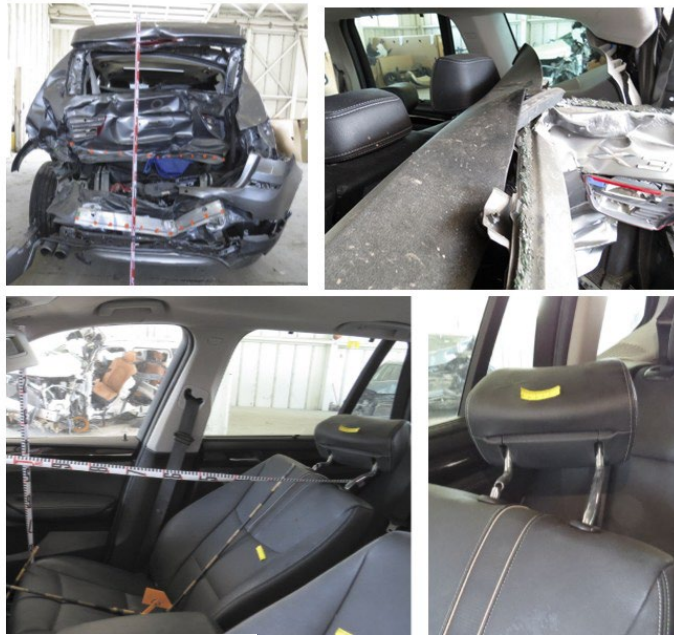
Intrusion

Rear tailgate intruded  
through cargo area

Kinematics: The occupant moved rearward and loaded the seatback. The fused thoracic spine fractured during spine straightening. The seat yielded and the seatback rotated. The occupant ramped. His head contact the intruded 2<sup>nd</sup> row area

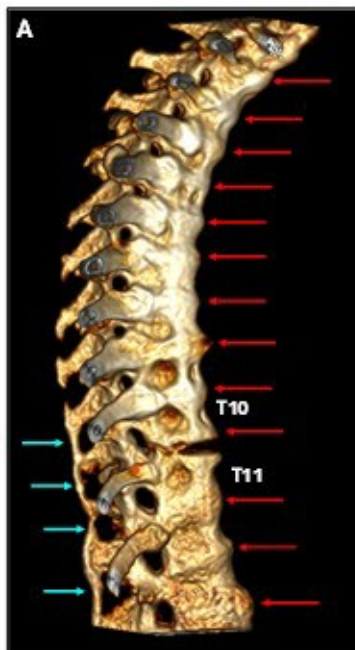
**CASE 12. (A)** Right lateral view of 3D reconstruction of thoracic spine CT demonstrates multilevel Degenerative Spondylosis and DISH, stiffening the spine, with flowing syndesmophytes bridging the disc spaces (red arrows). Ossification of the supraspinous ligament (blue arrows) further stiffens the spine. **(B)** Sagittal CT images demonstrate extension fracture through the calcified anterior longitudinal ligament (red arrow), widening of the T10-T11 disc space with slight posterior tilting of T10 relative to T11, fracture of the T11 spinous process (orange arrow), and mild T10-T11 facet joint widening (yellow arrow). **(C)** Sagittal STIR MR image shows disrupted anterior longitudinal ligament (red arrow), and abnormal bright signal (edema/blood) within the widened T10-T11 disc space (orange arrow). No compressive vertebral body flattening nor compressive bone marrow edema is observed.

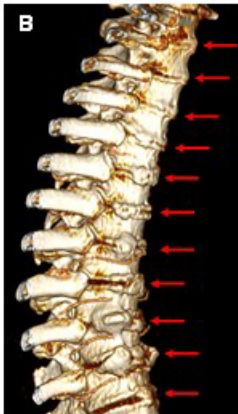
**CASE 20.** (A) Sagittal head CT image demonstrates scalp hematoma posterior to the head vertex (red arrow). (B) Right lateral view from 3D reconstruction of thoracic spine CT demonstrates multilevel degenerative spondylosis and DISH, stiffening the spine, with osteophytic narrowing/bridging of the disc spaces (red arrows). (C) Sagittal CT (left) and MR STIR (right) images demonstrate mild compression fractures of the C7 and T1 vertebral bodies (red arrows) with characteristic bright bands of compressive bone marrow edema (orange arrows). (D) Sagittal CT (left) and MR STIR (right) images demonstrate T11 vertebral body extension fracture with distraction of fracture fragments (red arrow), disruption of the anterior longitudinal ligament (yellow arrow), and fluid within the fracture clefts (orange arrows). No compressive vertebral body flattening nor compressive bone marrow edema is identified.

Cervical/Thoracic injury  
C7 major VB comp fx (AIS 3);  
T1 minor VB fx (AIS 2)  
T10 disc injury (AIS 2)  
T11 VB comp fx (AIS 3)  
Spine injury mechanism:  
Extension from spine straightening of fused spinal segments (T10-T11)  
Compression w/flexion (C7-T1)

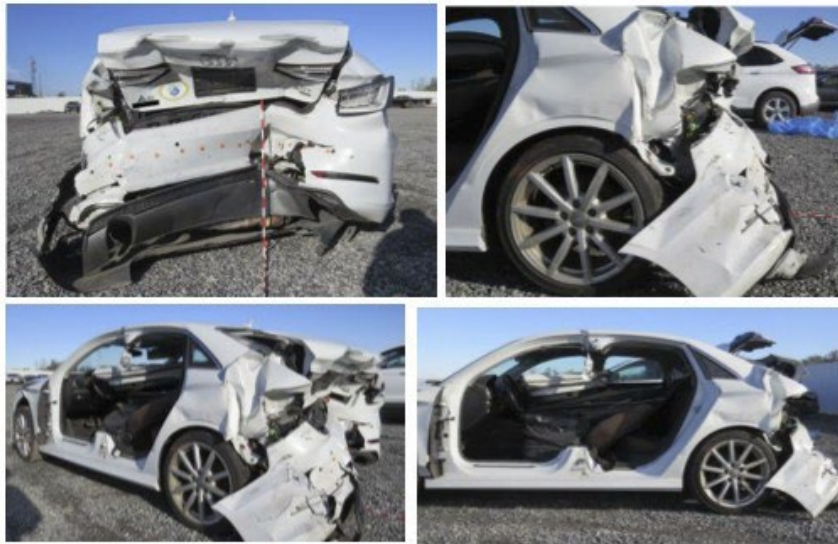
Seat moved rearward &amp; seatback reclined for extrication
