THE PATTERNS OF DIAPHYSEAL FRACTURES OF THE LOWER LIMBS IN VULNERABLE PARTICIPANTS IN REAL WORLD TRAFFIC ACCIDENTS

G. Teresiński and R. Mądro

Department of Forensic Medicine, Medical University of Lublin, Poland

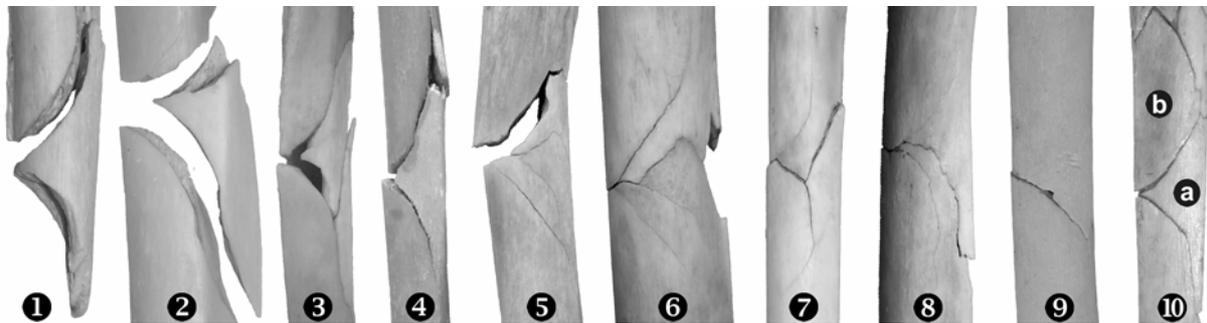
Fig. 1 - Various patterns of “classical” (1-3) and “incomplete” (4-9) bending fractures. 10 – “true” (a) and “false” (b) wedges. Direction of bending from right to left side of the figure.

The base of the distinguished wedge fragments usually correlated with the force application place and direction of impact of the vehicle into the victim's body. Beside the "true" Messerer's wedges (with sharp apices and edges concave in relation to the bases), 16 "false" triangular fragments were found with the edges convex towards the base, which was most often situated opposite the force application place. However, 36 "true" flexion fractures were also "reversed" (their apices were directed towards the impact side) – usually in the regions distant from the force application place and probably caused by the lever mechanism. The fractures close to metaphyses were mostly non-characteristic (comminuted).

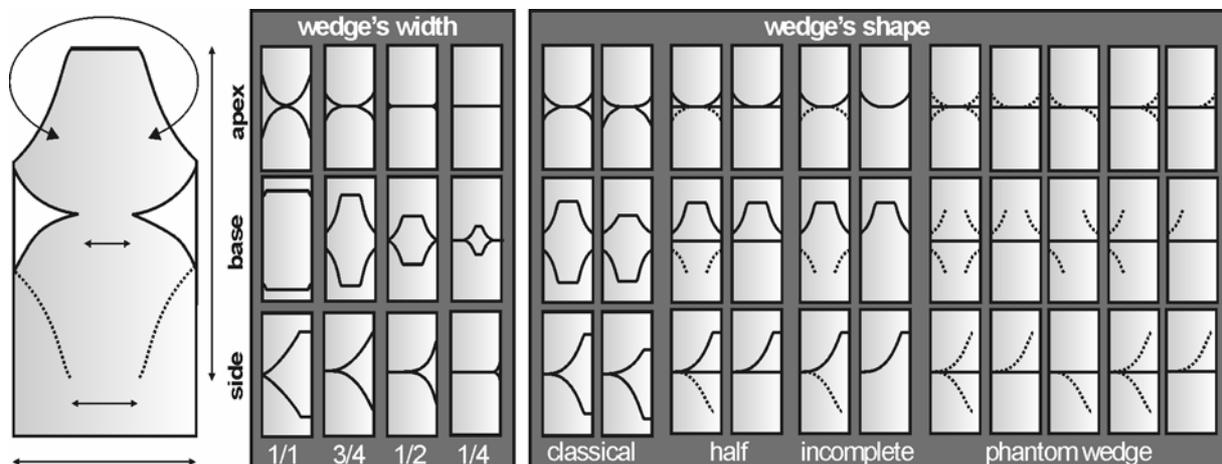
Fig. 2- The classification of the most common morphological forms of long bones bending fractures.

The analysis showed that 55% of oblique fractures assessed on autopsy as non-characteristic ones, after maceration were found to be flexion fractures in which "the Messerer's wedge" was complemented by additional fissures. Furthermore, in 70% of transverse fractures the pattern of additional fissures formed the contour of a triangular fragment. On the basis of the course of fissures of fractures and cracks the most common morphological forms of fractures were determined and their taxonomy was proposed according to the way of distinguishing the "classical", "incomplete" and „phantom" wedges (Fig. 2).
