CHARACTERISTICS ON FRACTURES OF TIBIA AND FIBULA IN CAR IMPACTS TO PEDESTRIANS – INFLUENCES OF CAR BUMPER HEIGHT AND SHAPE

ABSTRACT

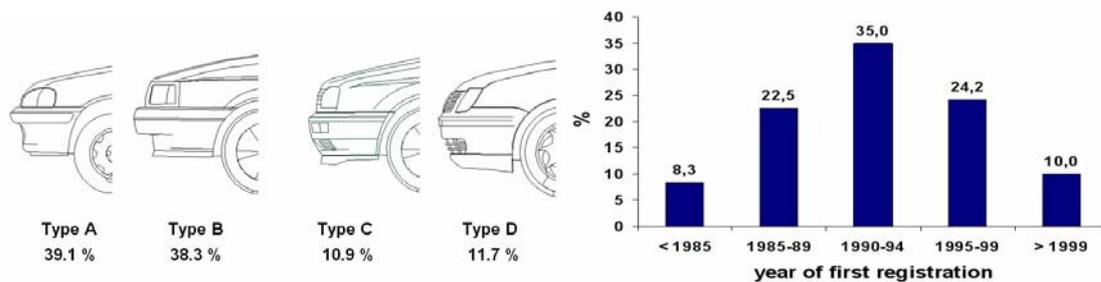
For classification purposes the frontal shapes of passenger cars were sub-divided into 4 different types regarding bumper shapes (figure 1).

Figure 1: Classified frontal shapes of bumpers and the incidence of involvement in accidents with pedestrians (all vehicles = 100%, n=120, 23 missing)

Corresponding to the relatively old population of vehicles within the current traffic scenery, two thirds of the bumpers were protruding and rather rectangular (Type A at 39.1% and Type B at 38.3%). Newer, significantly rounded bumper structures, which have also been integrated into the front of the vehicle (Type C and D), are represented in only 10.9% (Type C) and 11.7% (Type D) of the cases.

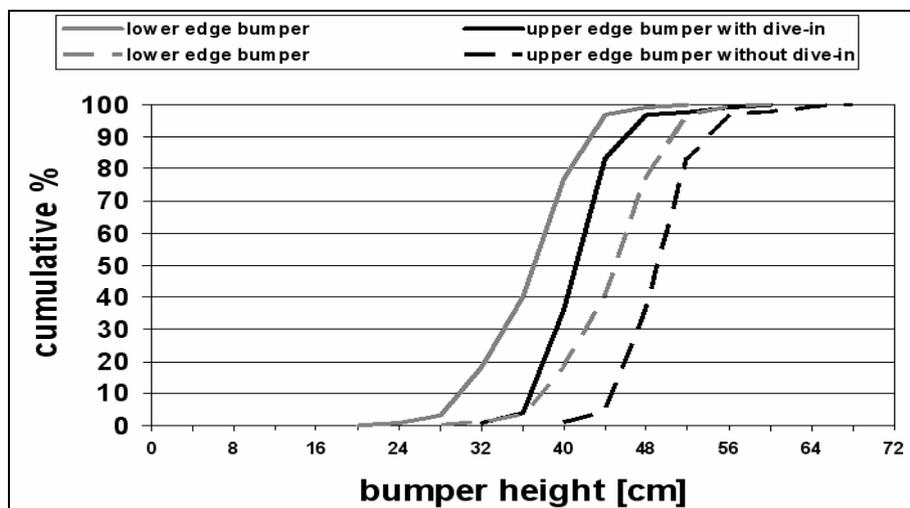
The effective height of impact was derived from the sideways profile of the vehicle and the part protruding most was chosen as impact transfer point, the height of which was measured from the road level. If this was not a well-defined point, but rather an area, as can be seen partly approached on the pictures of Types B and C in figure 1, this was taken into account by entering two values for the "lower and upper edge of the bumper". Always the most frontal point was chosen as effective impact height. 80% of the bumpers had an effective static impact height of at least 40 cm and at most 52 cm with a maximum at 70 cm for Sport Utility Vehicles SUV (figure 2). The so-called nose-dive of the front occurring during the application of the brakes due to the distribution of the braking weight change was provided for with a reduction of 8 cm for establishing the effective dynamic bumper height and resulted in the fact that 80% of the effective dynamic impact power is transferred between heights of 32 cm at least and 44 cm at most.

Figure 2: Cumulative frequency of the bumper heights derived dynamic height including an 8-cm nose dive (n= 130, 100%)

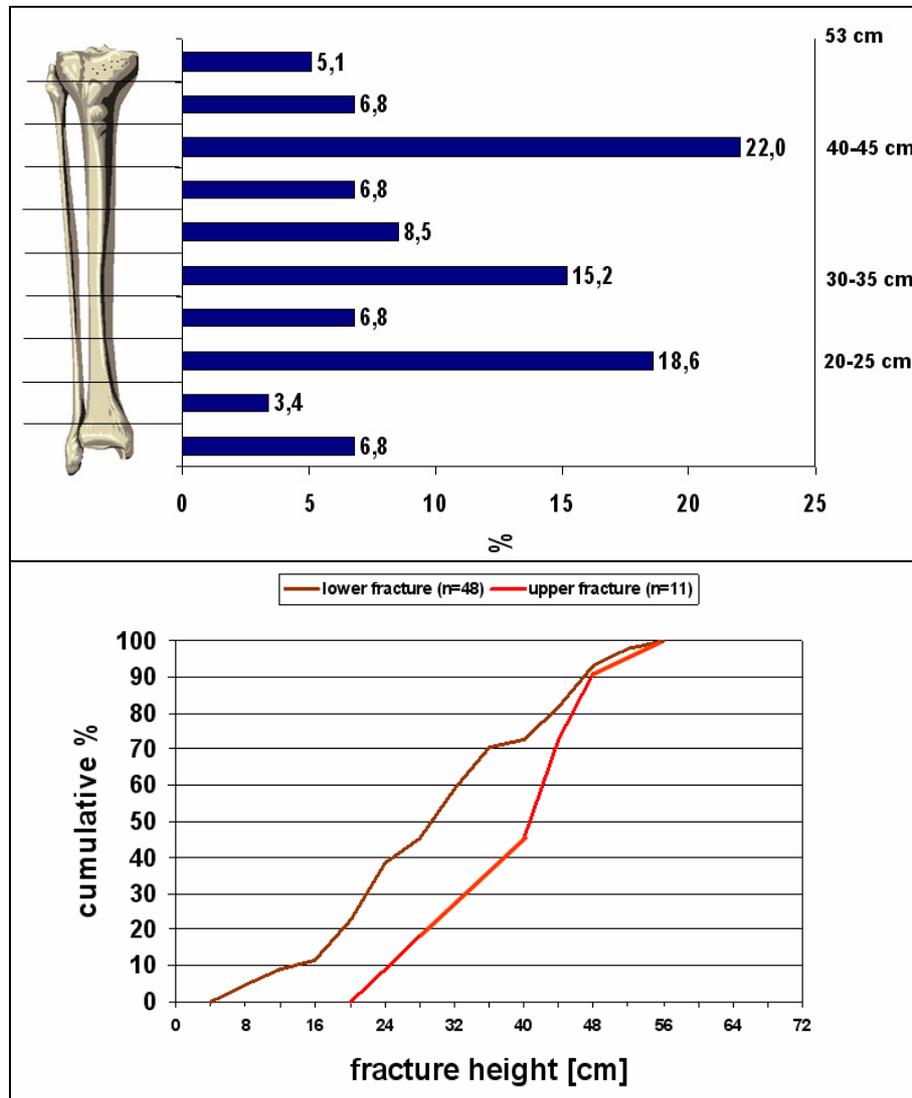
as percentages of 10% each started the account at ankle joint level (figure 3). If several fractures had occurred on one bone, these were separately included in the evaluation as lower (n=48 with X-rays) and upper fractures (n=11 with X-rays). Clusters of fractures were found at 31 to 40% (18.6%), at 51 to 60% (15.2%) and at 81 to 90% (22.0%). This corresponds to the three most frequently occurring fracture heights at the lower leg of 20 to 25 cm (18.6%), of 30 to 35 cm (15.2%) and of 40 to 45 cm (22.0%).

Figure 3: Incidence of fractures of the lower leg (Tibia and/or Fibula - total length of the lower leg =100%) and cumulative incidence of the fracture heights from the level of the road in cm

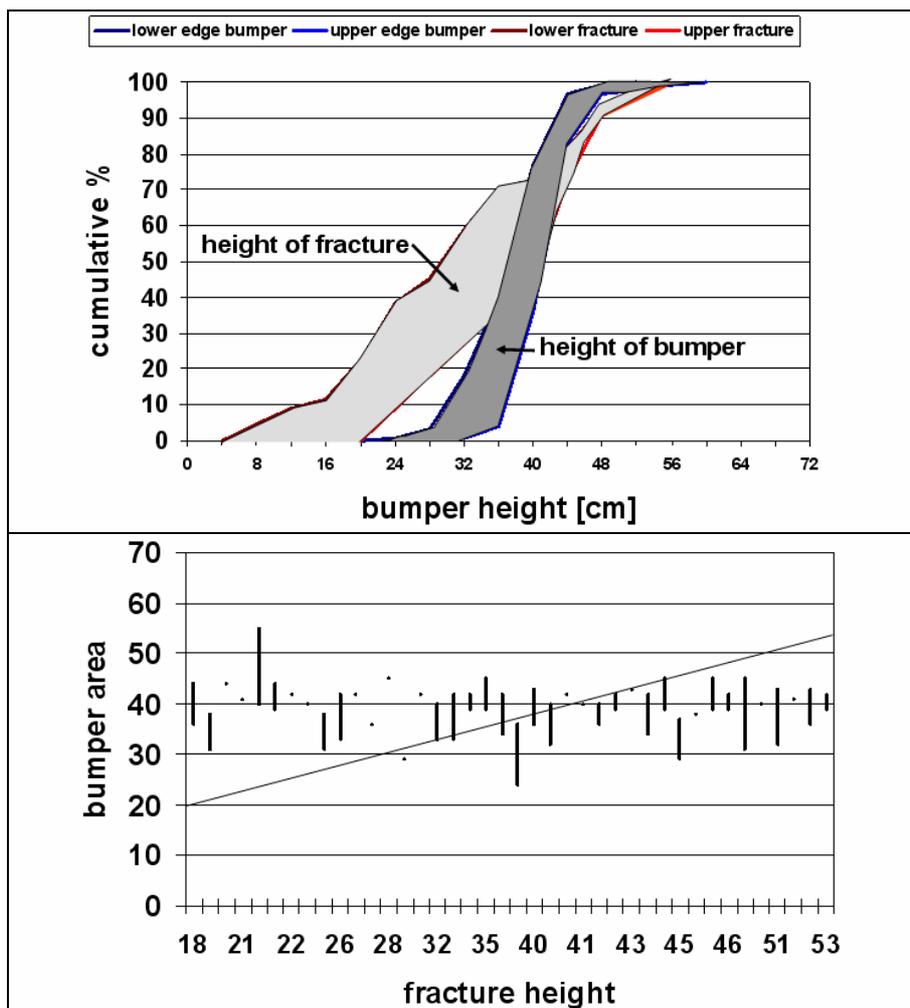
If the heights of the fractures are correlated to the effective dynamic heights of the bumpers, it turns out that 80% of all fractures are located between 19 and 46 cm, whereas 80% of the impact forces are transferred at heights of 32 to 44 cm of the lower leg (Figure 4). Thus the cause of the fractures is frequently located above the fracture itself. Fracture height and bumper height were only identical in 17.5% of the cases, in 47.5% fracture was above the bumper and 35% fracture below the bumper.

Figure 4: Measured fracture heights and effective dynamic bumper heights in cm (the line indicates identical heights). The x-axis is non-linear; representation of individual data only

The study showed that the height of the bumper usually does not correlate to the location of the fracture of the legs of pedestrians. 80% of all fractures occurred at an effective bumper height of at least 32 cm up to 44 cm above road level considered the braking of the car with approx. 8 cm. 80% of all fractures were located from 19 cm up to 45 cm above road level. Frequently, the fracture was located below the point of impact effective on the lower leg. Only in 1.5% of the cases did fracture and bumper impact height overlap, in 47.5% of the cases it was lower and in 35% higher.

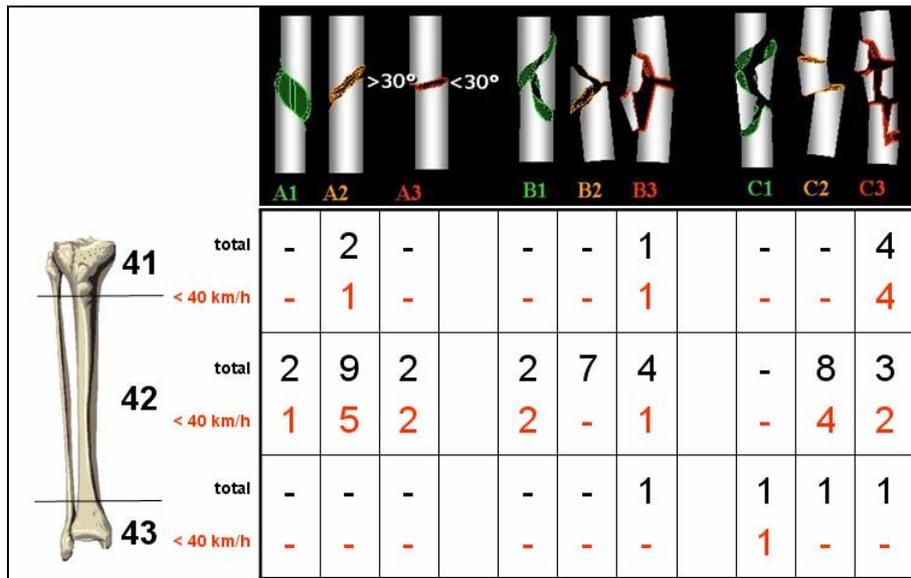
Especially frequently fractures occurred in the middle third of the bone as shown in Figure 5 (location 42). Multiple fractures (Type C2 n=8), as well as the wedge fracture named after Messerer (Type B2 n=7) and the Oblique fracture Type A2 (n=9) also frequently occurred in the middle third.

Figure 5: Incidence of fractures according to the AO classification, comparing overall situation and impact velocities <40 km/h

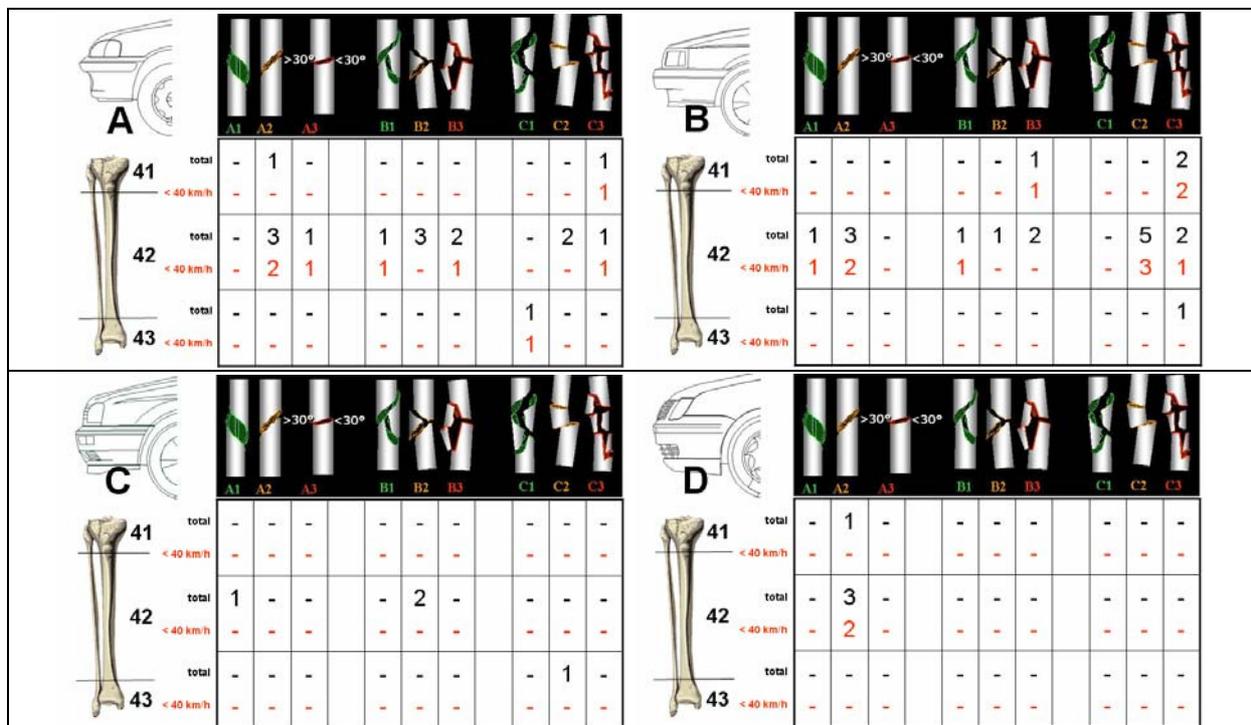
The analysis of different bumper shapes shows that the bending wedge fracture (Type B2) occurred with bumper shapes A, B and C, multiple fractures (Types C2 and C3), however, only occurred in collision with cars having A and B bumpers labeled as "old" (figure 6). In contrast, the bumper shapes of the newer cars with integrated and rounded bumper shapes (groups C and D) showed fewer fractures altogether on the one hand and on the other hand only oblique fractures of the types A1, A2, B2 and no C fractures occurred. Generally, these constitute easily treatable fractures, as a rule without treatments possibly leading to complications.

Figure 6: Incidence of fractures according to the AO classification for different bumper types A, B, C, D; comparing the total population and impact velocities <40 km/h

It turned out that the design of the front part of the vehicle significantly influences the kind of fractures, which occurred. Thus usually, the older, protruding bumper shapes or those with a distinct pointed shape of the bumper resulted more frequently in complex fractures as compared to the newer, as a rule integrated and rounded shapes, having a more extensive impact transfer area. Multiple fractures occurred especially frequently in the middle third of the lower leg (Type C2 n=8), as well as the wedge fracture named after Messerer (Type B2 n=7) and the oblique fracture Type A2 (n=9) also frequently occurred in the middle third. A fracture with bending wedge (Type B2) occurred with bumper shapes A, B and C; multiple comminuted fractures (Types C2 and C3), however, only occurred in collision with cars having A-shaped or B-shaped bumpers labeled as "old". In contrast, the bumper shapes of the newer cars with integrated and rounded bumper shapes (groups C and D) showed fewer fractures altogether on the one hand and on the other hand only oblique fractures and no C fractures, which frequently result in complications. It can thus be postulated that – taking into account the small case numbers of vehicles built in later years - the fracture incidence was lowered by the altered design of the bumper and the emergence of complicated fractures involving complex long-term consequences has been prevented. A definite statement concerning that fact should only be made, however, after more cases have been collected, but with this study a trend can be seen. The influence of the impact velocity also seems significant. On the one hand it was shown that 50% of all collisions resulting in fractures occurred at velocities of up to 40 km/h. On the other hand it was also shown that for impact velocities up to 40 km/h no complex fractures result. These are only to be expected at higher speeds. Thus the majority of all type B and C fractures of the AO classification were documented in a speed range above 40 km/h. A correlation between origin of the fracture and the kind of fracture based on the impact velocity was not established. The types of fractures close to the knee (proximal lower leg) obviously all occur in the lower speed ranges, whereas the shaft fractures in the middle third occurred more frequently at velocities > 40 km/h. Fractures in the area of the ankle (distal lower leg) nearly all occurred at higher impact velocities

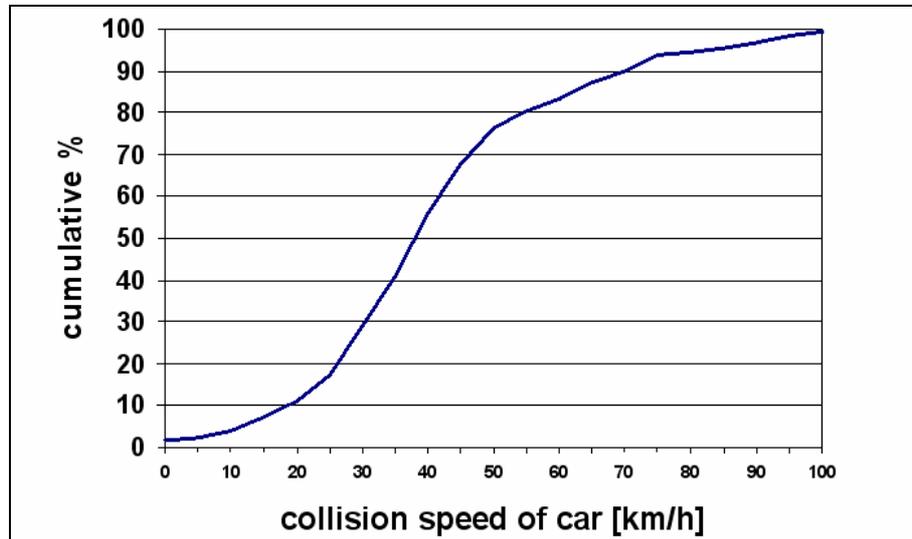
80% of the documented fractures occurred at collision speeds of up to 55 km/h (Figure 7 - 80% between 20 and 70 km/h). A correlation between origin of the fracture and the kind of fracture based on the impact velocity was not established.

Figure 7: Cumulative incidence of collision speeds of passenger of accidents involving cars and pedestrians and resulting in fractures

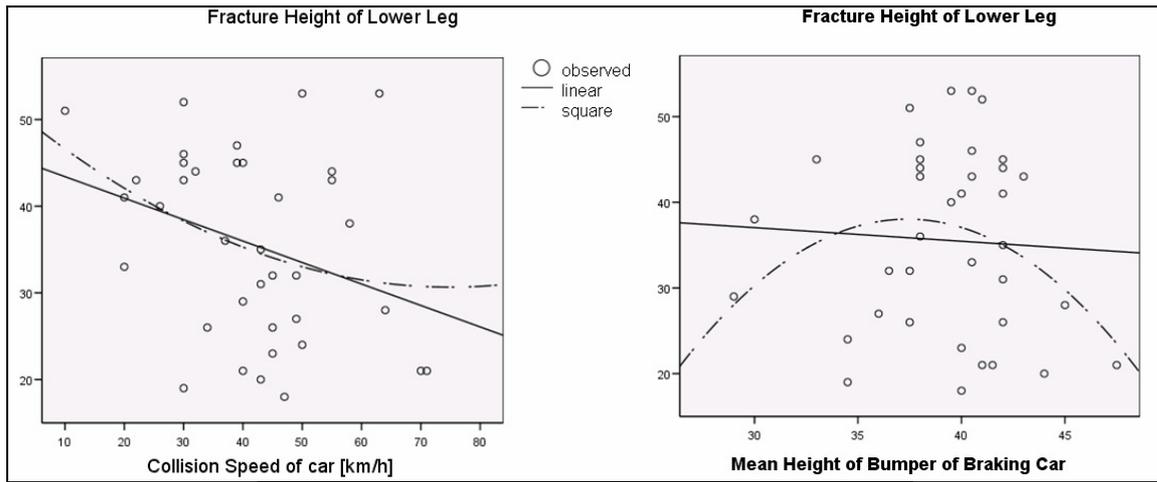
If the simultaneous effects of collision speed and the height of the bumper on the height of the fracture are investigated based on a regression analysis, it turns out that only the collision speed has an influence of the origin of the fracture and at $p=0.058$ a statistically low one. In the statistic tests a low negative correlation between collision speed and the height of the fracture ($r=-0.321$, $p=0.053$) resulted; no correlation to the mean bumper height was found (figure 8).

collision speed car	mean height of bumper
height of fracture	correlation by Pearson	-.321	-.055
	significance	.053	.745
	N	37	37

non standard coefficient		standard coefficient	T	significance
	B	standard error	Beta		
(constant)	50.139	18.761		2.673	.011
collision speed of car	-.246	.125	-.319	-1.963	.058
mean height of bumper of braking car	-.110	.464	-.039	-.238	.814

Figure 8: Regression analysis of the correlation between collision speed, the height of the fracture and the height of the bumper

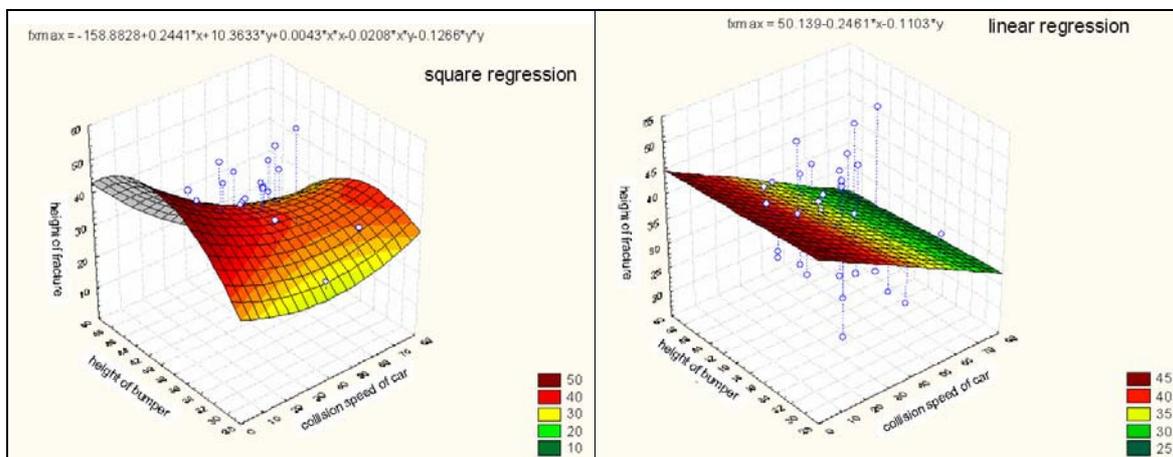
This interrelation can be expressed in a three-dimensional diagram (figure 9), using a square fit of the regression analysis. It was proved, that the height of the fracture is reduced significantly with the increase in impact velocity on the one hand and only increases with very high speeds of approximately 60 km/h, and that on the other hand, the height of the bumper seems to have very little influence on the height of the fracture. Still, for very low and very high bumpers a lower height of the fractures occurred more frequently and only for bumper heights between 33 and 43 cm a constant correlation was found.

Figure 9: Linear and quadratic adaptation of the regression areas of collision speed vs. height of the fracture vs. height of the bumper in a 3-D-diagram

Using a square fit of the regression analysis it was proved, that the height of the fracture is reduced significantly with an increase in impact velocity on the one hand and increases only with very high speeds of approximately 60 km/h on the one hand, and that on the other hand, the height of the bumper seems to have very little influence on the height of the fracture. Still, for very low and very high bumpers a lower height of the fractures occurred more frequently and only for bumper heights between 33 and 43 cm a constant correlation was found.
