## Experimental investigation of motorcycle safety

Katsunori Taneda , Japan Automobile Research  
Institute, Inc.

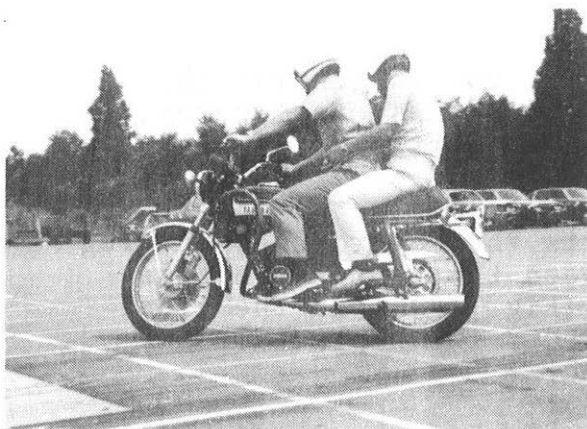
Fig.9 Use by two persons

- (4) Operator-passenger use--Assurance of leg space for a rear-seat passenger (Fig.9).
- (5) Optional status--Ability to be removed (until the effectiveness of the device is fully demonstrated, used of the device being made optional).

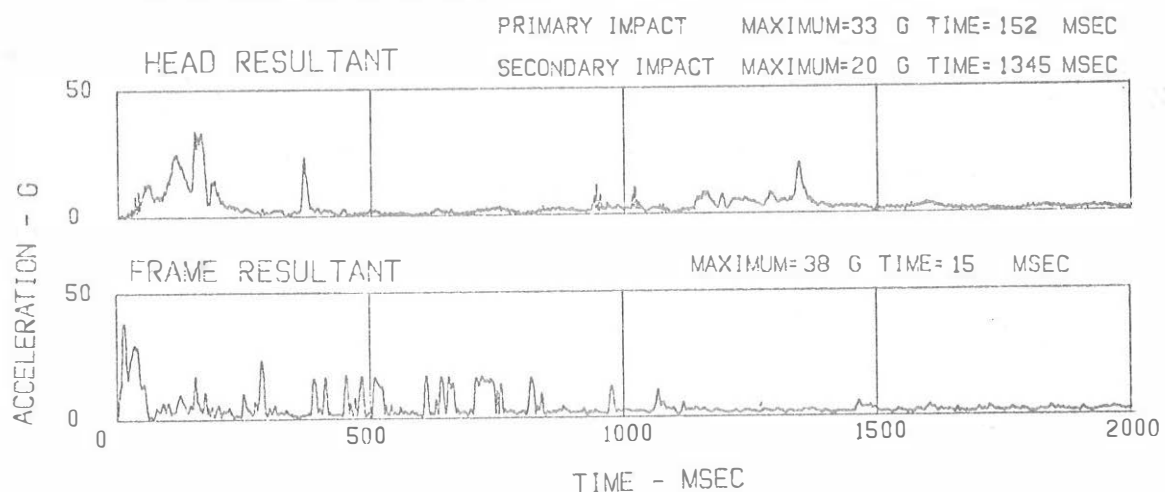
Fig.14 Acceleration history of the dummy and the motorcycle in test No.2

In Fig. 13 is displayed an experimental example of a collision at 40km/h with a motorcycle equipped with a side protection device. Since the leg is not pinned, the body slides smoothly up onto the vehicle hood, and overall injuries are few. Fig.14 is acceleration history of this case.
