# HUMAN TOLERANCE TO LOWER EXTREMITIES IMPACTS

R. L. Stalnaker, Ph.D., J. W. Melvin, Ph.D.\*

# ABSTRACT

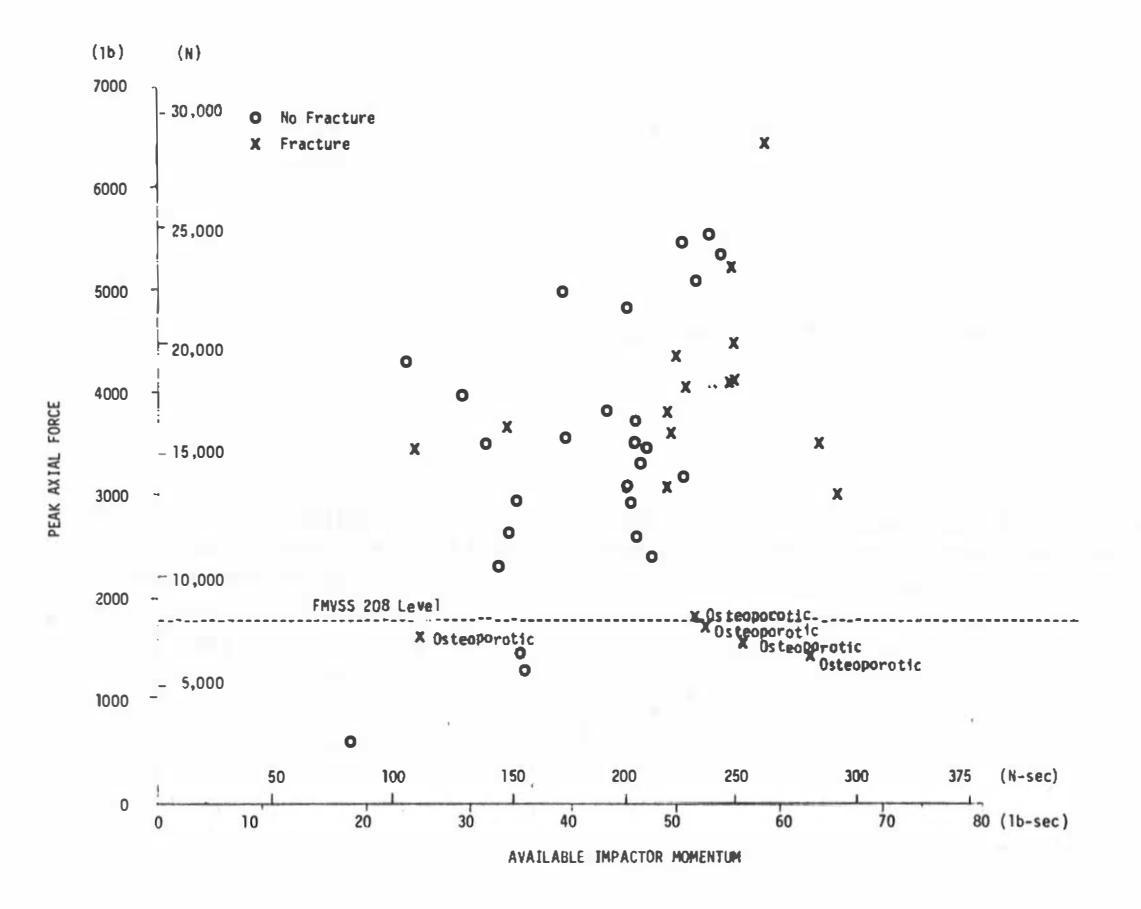
A plot of peak impact force versus available impactor momentum is shown in Figure 5. Examination of this plot indicates that peak load alone is not an adequate indicator of impending fracture. It appears that a sufficiently high energy or momentum level must be associated with the impact to produce fracture. In the data shown in Figure 5, the threshold momentum level appears to be between 40-50 lb-sec. (178-220 N-sec.) and the corresponding force threshold level is about 3000 lbs. (13,350 N). Impactor energy could have been used in place of momentum, but in crashworthiness testing with dummies, only forces are recorded in femur impacts and the impulse of the resulting femur load-time trace can be obtained easily. In all of the high-energy impacts conducted in this study, the available impactor momentum was transferred to the knee, as indicated by the impulse calculations, in those cases where fracture did not When fracture occurs in the cadaver knee, its load-carrying ability occur. is diminished and, with the test procedures used in this study, only part of the available momentum is indicated by the impulse calculation. Direct application of the data generated in this study to the interpretation of test dummy results cannot be made, however. Preliminary tests on a dummy indicate that, under the same test conditions used in the cadaver tests, the lack of biomechanical equivalence of the dummy knee-femur-pelvis complex produces considerably higher forces for a given impulse level.
