KINEMATICS AND HEAD INJURIES IN VEHICLE/PEDESTRIAN ACCIDENTS AT SPEEDS ABOVE 50 KPH

Dipl.-Ing. Jürgen Grandel Dipl.-Ing. Helmut Zeisberger Deutscher Kraftfahrzeug-Überwachungs-Verein e.V. (DEKRA) Stuttgart Federal Republic of Germany

Dr. Felix Walz Gerichtlich-Medizinisches Institut der Universität Zürich Zürich Switzerland

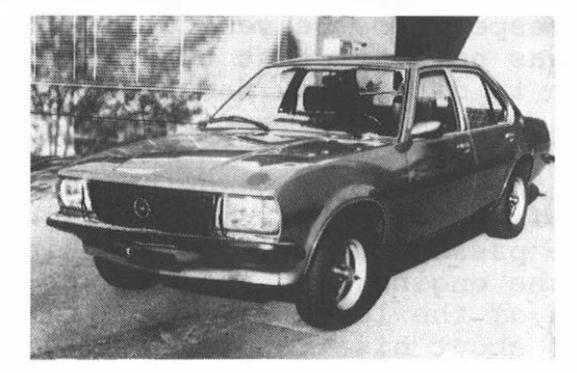
Fig. 1: Opel Ascona, collision speed approx. 55 kph, braked impact

As a result of the collision, the front skirt and the bumper were pushed back in the area of the left-hand front section of the vehicle, <u>Fig. 1</u>. This damage corresponds with injuries of the pedestrian in the area of the knees (particularly on the left-hand side). These injuries are abrasions and haematomas.

No deformations are detectable at the front edge of the hood; merely on the hood are slight indentations, which, however, were produced primarily by a vertical application of force. Correspondingly, there are merely abrasions in the areas of thigh and pelvis. The impact of the left shoulder, resulting

in fractures in the sternum and in the area of the ribs, took place in the transition area between hood and cowl panel, i.e. in the area of great rigidity.

The head of the pedestrian impacted against the windscreen, which, as a result, was destroyed. This led to a breaking of the neck with death ensuing immediately.

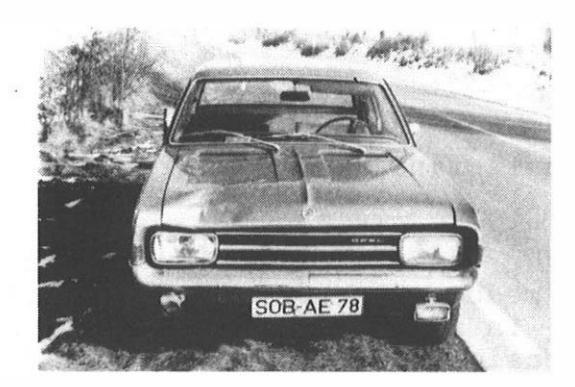
Fig. 2: Opel Rekord C, collision speed approx. 50 kph, braked impact

In this case, too, the front apron panel was pushed back slightly by the collision. In contrast to case A, however, this accident shows a severe indentation of the front edge of the engine hood with the direction of force application being longitudinal with respect to the vehicle. Also worthy of note is the fact there was no contact at the windscreen, <u>Fig. 2</u>. Nor was it possible to detect any damage in the area of the roof.

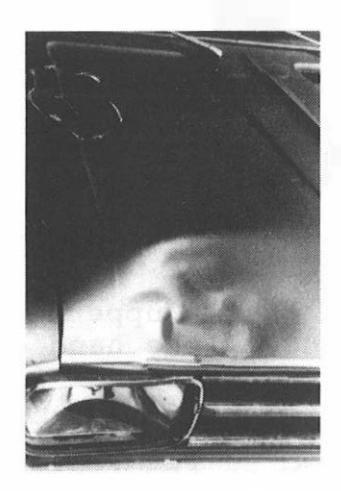
Fig. 3: Damage to Opel Rekord in respect of case B

The initial impact took place by means of the bumper in the area of the knees of the pedestrian. The right leg was pulled partially under the passenger car, and the hip impacted against the front edge of the engine hood. As a result of these impacts in the area of the lower extremities, the pedestrian was set in rotation about his transverse axis and struck the rear region of the engine hood with his shoulder, Fig. 3. The

head-impact location can be found as a round indentation in the cowl panel at the transition to the fender. If one compares the hip-impact location with the head-impact location, this shows the direction of motion of the pedestrian; the head struck further to the right, as viewed in the forward direction of travel of the vehicle. This is attributable to the time offset between hip impact and head impact in conjunction with the walking speed. The distance the pedestrian was thrown due to the impact is also of importance with regard to the reconstruction of the accident. In this case, the pedestrian was thrown approx. 19 m, which agrees with values obtained from tests with dummies. Fig. 4 shows a sketch of the accident.

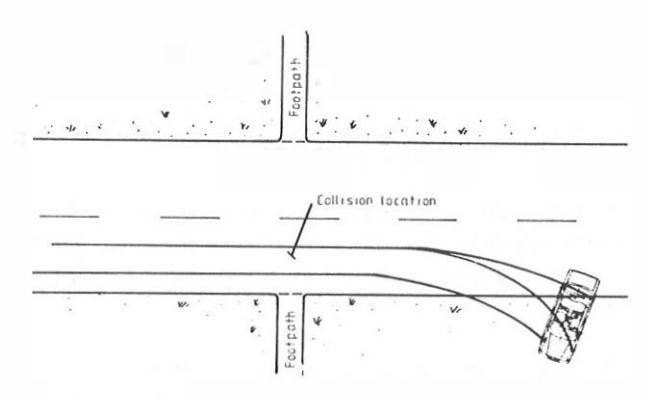
Fig. 4: Sketch of accident in respect of case B

If, once again, one compares the unwound length with the headimpact location, it can be seen that, in this case, the penetration of the vehicle under the pedestrian was virtually nil; on the contrary, the pedestrian underwent positive no-slip acceleration and the individual parts of the body contacted the passenger car merely one after the other.

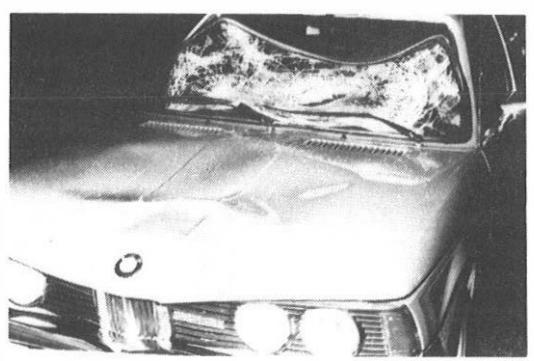
Fig. 5: BMW 323 i, collision speed approx. 70 kph, unbraked impact

In the further course of motion, the pedestrian impacted against the windscreen with his head and shoulder, Fig. 5. This resulted in severe injuries, rupturing of the atlantooccipital with tearing of the medulla oblongata from the Lissauer's tract and tearing of the spinal marrow from the medulla oblongata, which led to cerebral paralysis and to the death of the pedestrian. In addition, a fracture of the bony roof of the skull as well as extensive scalp bleeding were found.

With the exception of a small indentation on the upper frame of the windscreen, which was apparently caused by the hand of the pedestrian, there was no further damage in the area of the roof.

There is an unwound length of approx. 2.3 m to the impact of the head. If one compares this with the height of the pedestrian, it can be seen that, after the initial impact, in addition to the rotation of the pedestrian there was also a higher velocity of the passenger car, allowing a relative motion between vehicle and pedestrian.

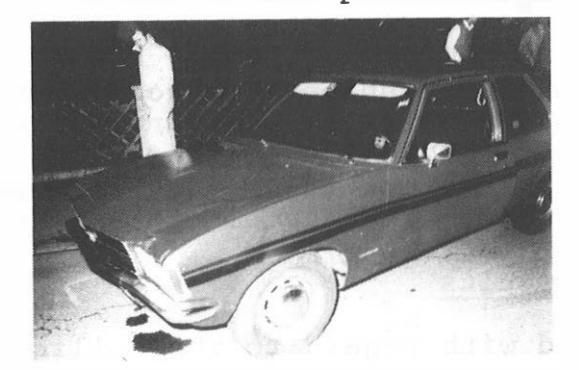
Fig. 6: Opel Rekord D, collision speed approx. 70 kph, braked impact

Apart from the contour of the vehicle, particular importance is attached also to the height and weight of the pedestrian when assessing the sequence of motions. In this case, the initial impact took place both in the area of the bumper and front skirt and at the front edge of the upper cowl panel. This damage to the hard front structure shows that relatively large forces were opposed to the forward direction of travel of the passenger car, Fig. 6. Accordingly, in the collision, the pedestrian sustained both a comminuted fracture of the right thigh and a fragmentary fracture of the left thigh-bone. Conversely, the lower legs showed no bone injuries. As a result of the relatively high point of impact on the upper cowl panel, the pedestrian was not only set in rotation about his transverse axis but was also heavily accelerated in the forward direction of travel of the passenger car. There was a large-area indentation on the engine hood as a result of the impact of the shoulder and the chest. The head-impact location is at the level of the air-inlet slits on the engine hood. As a corresponding injury, a serial rib fracture was found on the right-hand side of the chest, covering the 2nd to the 12th ribs in the midaxillary line. On the left-hand side of the chest, too, there was a serial rib fracture from the 1st to the 9th rib. In the roof of the skull, a fracture centre was found in the left-hand and right-hand crown areas. Furthermore, the base of the skull could be moved against the cervical vertebral column, there having been in this connection a breaking of the medulla oblongata. This is also to be viewed as the cause of death of the pedestrian.

The unwound length to the head-impact location is approx. 1.75 m. A comparison with the height of the pedestrian of 1.65 m shows that, in this case too, the vehicle had to a certain extent penetrated under the pedestrian. This, however, is weakly pronounced, apparently because of the central impact against the pedestrian at the upper cowl panel, since this caused a substantial translational acceleration of the pedestrian.

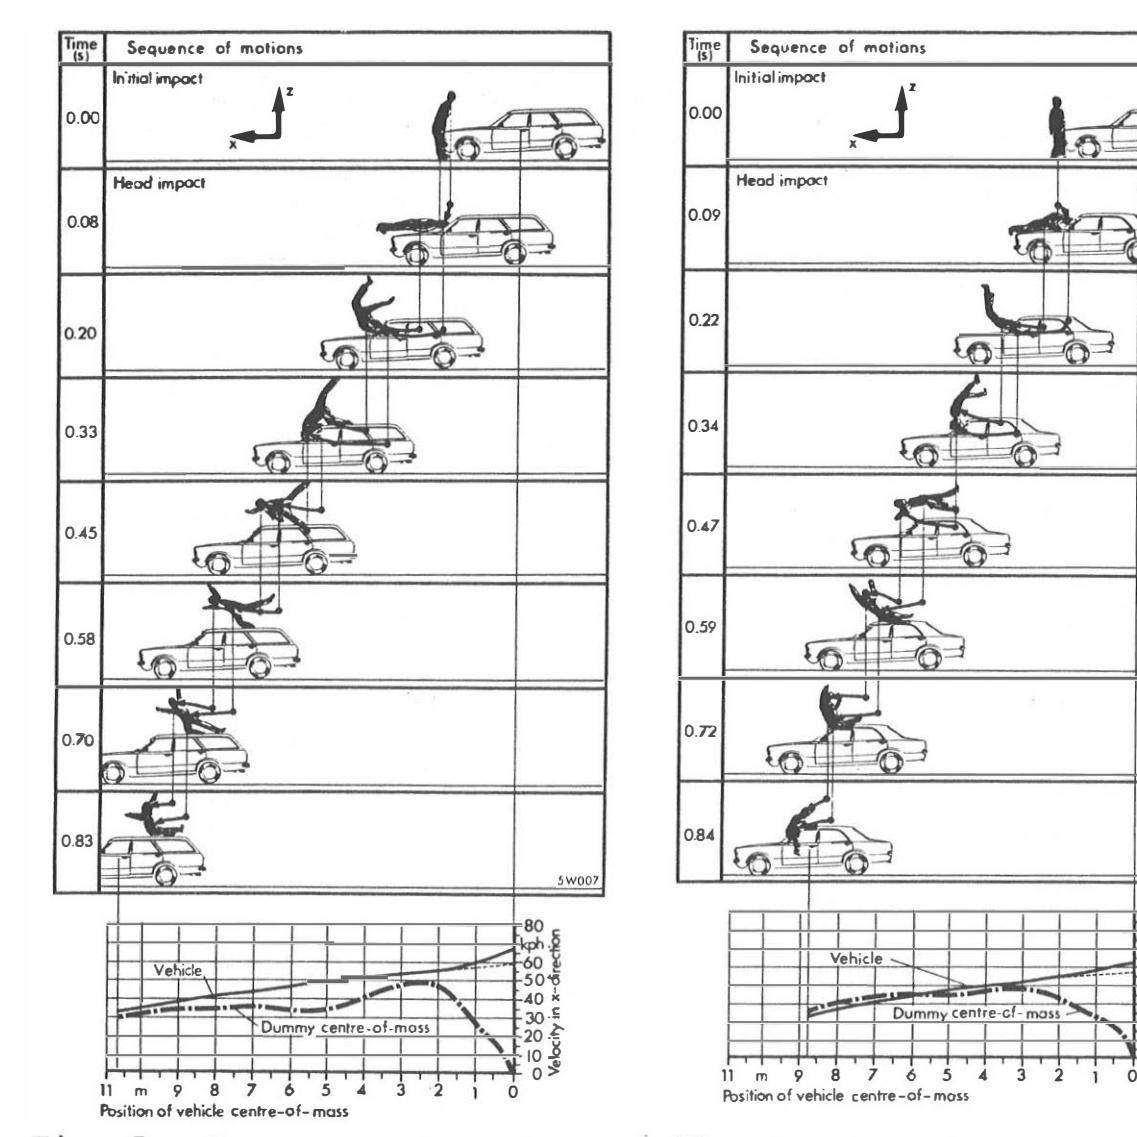
Impact events and speed Fig. 8: Impact events and speed curves, Ford Taunus, collision speed 54 kph, braked impact

By comparison, Fig. 8 shows a braked passenger-car/pedestrian collision at 54 kph collision speed. It can clearly be seen that, despite the lower impact speed, the phase sequences are in virtual agreement as regards time with corresponding body positions. A comparison of the positions of the dummy in relation to the passenger car starting at approximately 0.4 s after the initial impact shows that, at the lower impact speed, the center of mass of the dummy is above the top edge of the windscreen, while at the higher collision speed, it is above the B-pillar. In both cases, however, after reaching the speed of the passenger car, the dummy slides across the engine hood into a final position in front of the fully stopped passenger car.

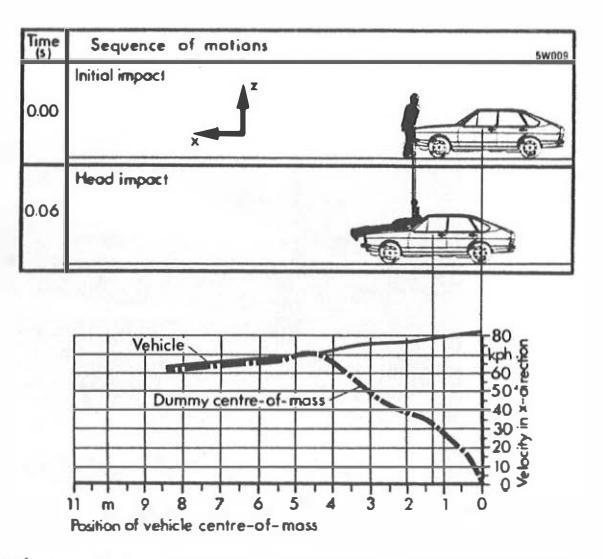
Fig. 10: Head-impact situation and speed curves, VW Passat, collision speed 83 kph, unbraked impact

Finally, Fig. 10 shows the sequence of motions at an impact speed of 83 kph, the passenger car being a VW Passat which was unbraked at the moment of impact. The impact of the head takes place approx. 0.06 s after the start of impact in the upper area of the windscreen. In the course of further rotation, there is a violent impact in the rear pelvic region of the dummy against the roof edge of the passenger car above the windscreen. As a result of extensive entangling with the passenger car, the body of the dummy is destroyed, with parts of the dummy remaining in the passenger compartment of the vehicle. In this case, the dummy of necessity reaches the speed of the passenger car after approx. 4.5 m.

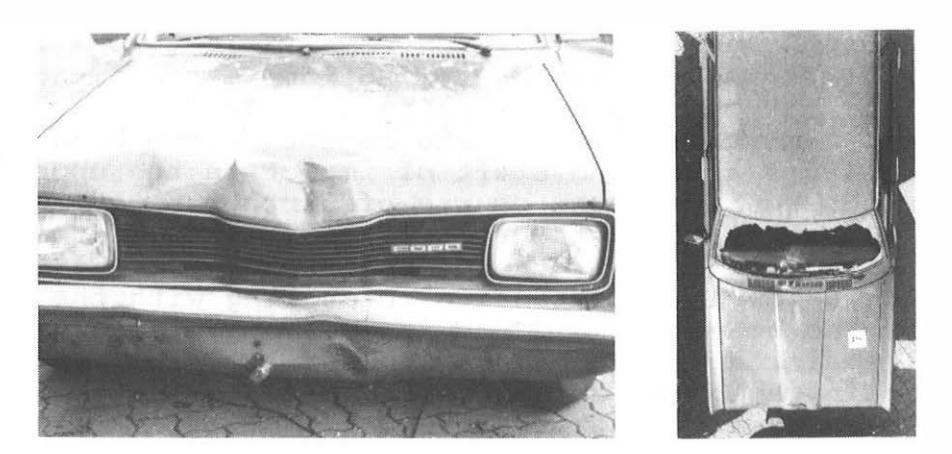
Fig. 11: Damage in respect of test shown in Fig. 7

For the previously described test as in Fig. 7, Fig. 11 shows the damage that was produced. Typical are the comparatively small indentations in the front-impact area and on the engine hood as indications of low collision-contact forces. The dummy contacted the windscreen with its head and destroyed the latter. Even at the considerably higher impact speed in the test as in Fig. 10, one sees this likewise comparatively minor damage in the initial-impact area of the front section of the passenger car, Fig. 12. In contrast, Fig. 13 shows considerably greater damage to the front of the passenger car at an impact speed of 68 kph, with the head not impacting in the windscreen but before it on the hood. The characteristic phase of the motion of the dummy at the instant of head impact after

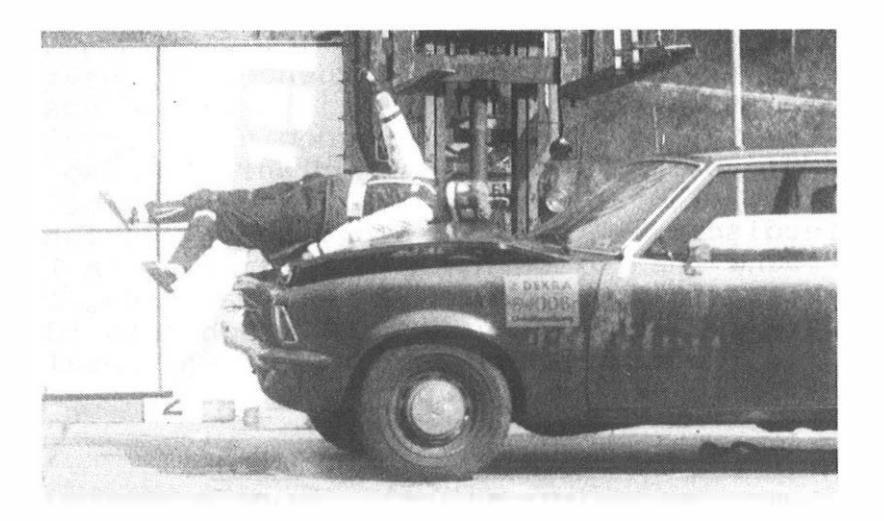
0.08 s is shown in Fig. 14. The top edge of the front of the passenger car as well as the engine hood undergo severe deformation as a result of the effect of intense initial-impact forces. A high degree of positive no-slip contact with the upper body of the dummy impedes the further motion of the dummy relative to the passenger car in the direction of the windscreen. Already 1.5 m after the initial impact, the dummy reaches the speed of the passenger car, almost simultaneously with the impacting of the head.
