THE INVESTIGATION OF TRAFFIC ACCIDENTS BY THE POLICE

Rolf Halonbrenner Zurich Municipal Police Scientific Service 8004 Zurich/Switzerland

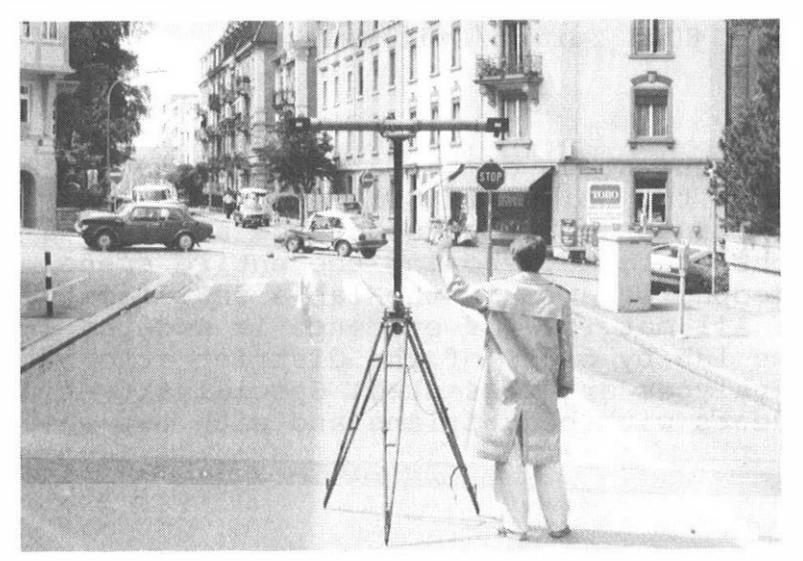
2. Documentation of situation and damages The police cars are supplied with necessary equipment such as cameras, measuring tapes, etc. In all accidents where only minor bodily injuries were caused, the police officer reporting the scene makes all the documentation himself. He starts with a general photographic survey. Step by step he goes on to details. First the final positions of the cars involved are photographed, then the traces and damages. The final position of the vehicles and the traces are measured for making a scaled situation plan. During the time these measurements take place, the traffic around the place of the collision must be blocked off. Complicated situations are rather time consuming in order to record all the needed measurement. Therefore the Zurich City Police Department started already over 50 years ago to work with a stereometric camera. In the meantime most of the Swiss police departments have followed this example.

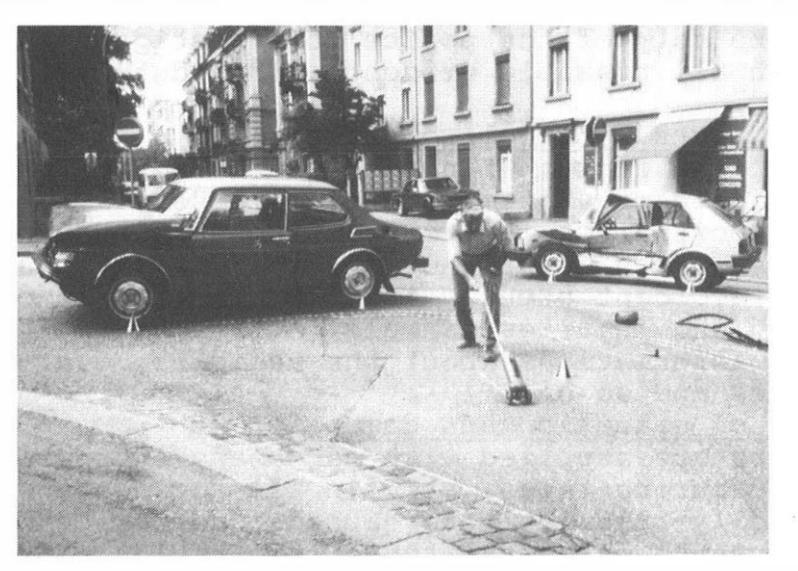
With a gypsum powder marker all traces of the accident are emphasized so that they contrast well with the surrounding.

This procedure is used mainly for skid marks of vehicles, scratch marks, the zone of scattered glass or car paint and car parts which fell or broke off. After the stereometric camera had been set up properly, a stereopair of photos is taken, showing the entire scene of the accident. On the photos all the necessary informations are saved, so that the road can after this immediately be reopened for traffic. The stereophotographs are subsequently analysed in the lab by a so called autograph. With this method the two central perspective photos are transformed into a scaled situation plan.

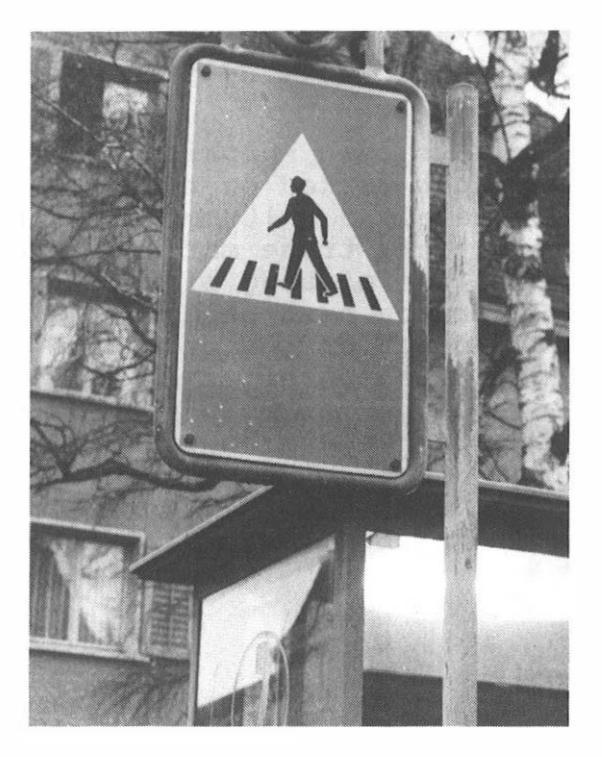
A pedestrian crossing the street was hit by a car and thrown down in the direction the car was travelling. The car stopped without producing skid marks and it appeared first that a calculation of its speed would not be possible. Prior to the accident the pedestrian had shopped at a grocery store and the milk she carried was spilled and splattered around as a result of the collision. Small splashes of milk were found at the front side of a traffic sign, located at the edge of the crosswalk in the driving direction of the car.

This proves that the point of collision was <u>in front of the</u> <u>crosswalk</u> and therefore the pedestrian had not crossed the street on the crosswalk. Considering this site of the collision in relationship to the final position of the pedestrian and to the damages of the car, we can conclude that the driver of the car has probably violated the speed limit on this part of the road.

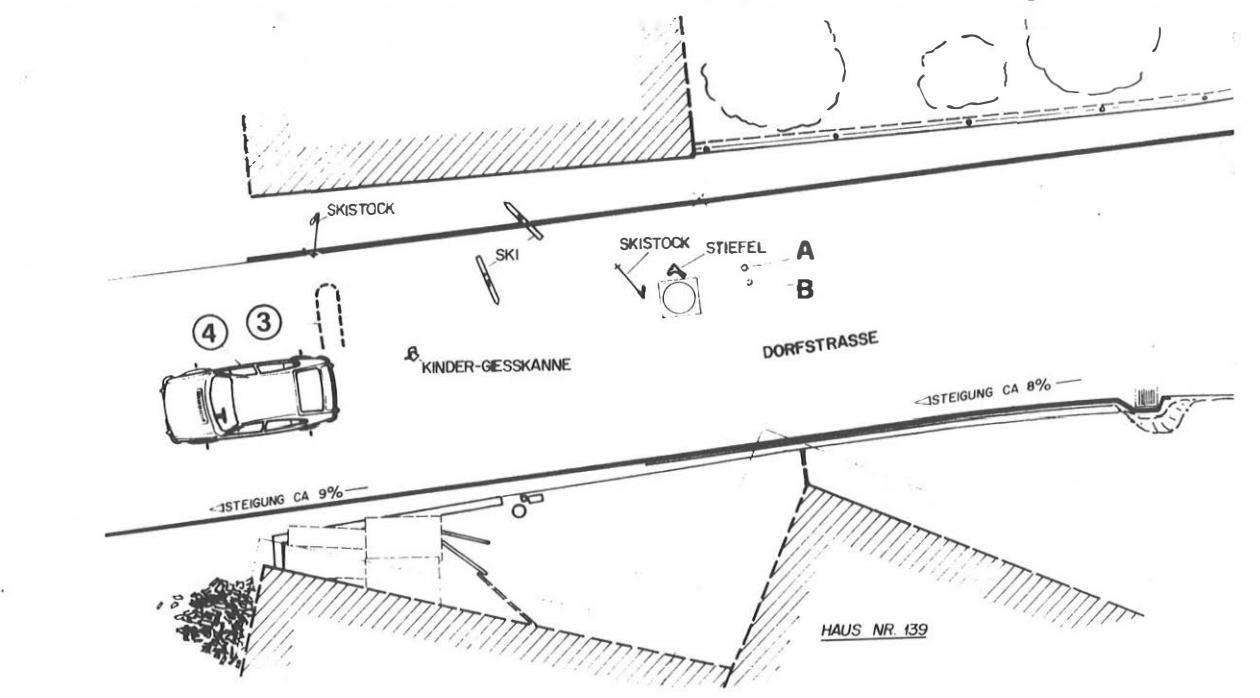
A car collided with a boy returning home from a trip and carrying a pair of skis and ski poles. The final position of the boy caused the driver to assume that the boy had ran into the road from behind of one of the two houses bordering the street.

The driver claimed to have been surprised by the sudden appearance of the boy. On a spot marked on the plan by position "A", a piece of paint approximately 3 x 16 mm was found, which showed light-and-dark stripes. This trace matched to one handle of the ski poles and fitted as the missing piece into the colour design of the handle (see Figure on next page).

With this evidence the point of impact on the road of the ski pole was established. It is therefore certain, that the site of collision was not left of position "A" but rather to the right of position "A", proving that the boy was walking on the street towards the coming motorist.

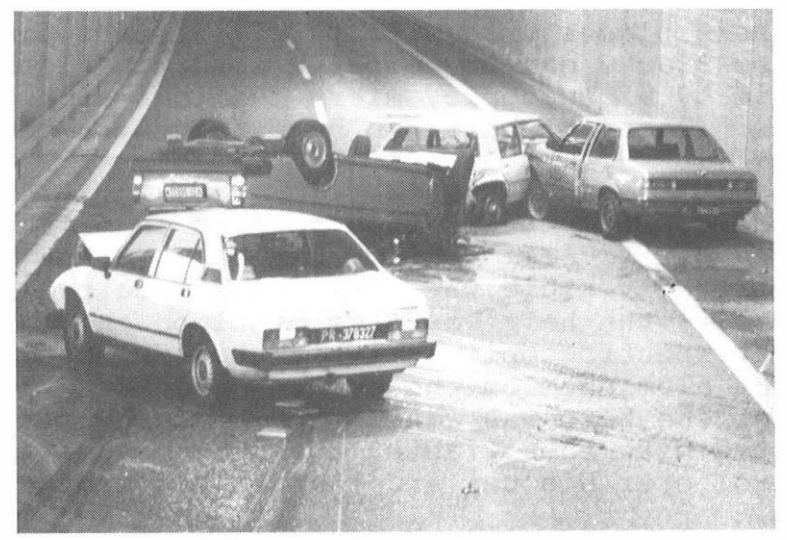
Traces of paint transferred from one car surface to another sometimes allow a chronological order in the interpretation of multiphased accidents. Owing to the analysis of transferred traces of paint we could prove the following sequences of a highway accident:

- First, the Volvo started to slid, then collided with the center divider, turned on its side and finally landed on its top
- the driver of the Oldsmobile that was following the Volvo was able to stop his car without collision in the passing lane
- then the Alfa Romeo crashed into the rear end of the Oldsmobile, pushing it towards the right side of the road, where it collided with the overturned Volvo;
- the BMW finally, riding in the right lane, crashed into the right side of the Oldsmobile.

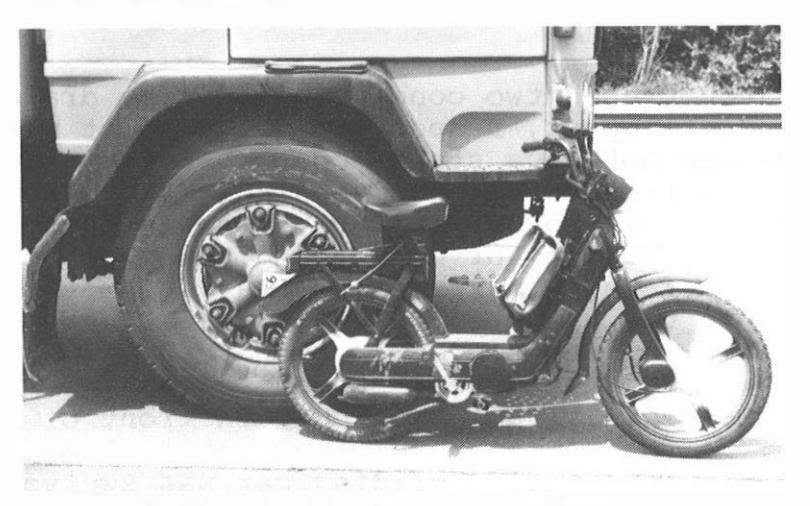
The driver of a heavy road train said that he had stopped at a traffic light and by starting to move again he had felt something unusual. After stopping the second time he noticed that he had run over the driver of a motor-bike, which he alledgedly had not seen. When asking him how the accident happened, he supposed that the driver of the motor-bike must have passed him on the right sidewalk and had fallen under his truck. The analysis of the traces led to a classical crossing of traces between the left side of the seat and the licence plate of the bike on the one hand and the disc of the right front wheel of the truck on the other hand. This enabled a reconstruction of the situation of collision of both vehicles.

On the outside of the right twin tire of the truck's rear axle we found an accumulation of blue cotton fibres, which matched with the clothes of the motor-bike driver. Thus it was established which wheel had run over the teenager. According to the analysis of the tachographic disc the truck had continually increased his speed over a distance of about 500 meters, to get a final velocity of approximately 37 kilometers per hour. Then it stopped abruptly. The alledged start to move again after the stop was not recorded and therefore the recordings of the diagram were in contradiction with the statement of the driver. Also the traces observed at the site of collision contradict to his statement:

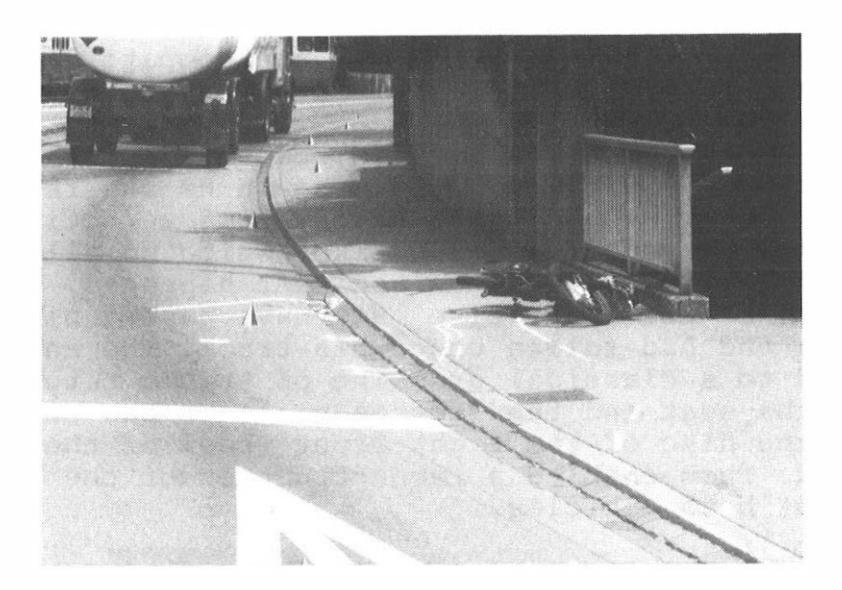
The first scratches caused by the motor-bike are located more than one meter in front of the crosswalk marking and the traffic light. They are on the sidewalk and spread out with interruptions over a distance of approximately 5.5 meters up to the final position of the motor-bike.

From these scratch traces two conclusions can be drawn: First, the point of impact, respectively the point where the motor-bike driver was not in a stable course, is at least approximately 2 meters in front of the crosswalk marking. Second, the length of scratches of approximately 5.5 meters is not matching with a practically stopping or barely beginning to move again vehicle; it points rather to the fact, that the motor-bike had to have a speed in the range of about 30 kilometers per hour at the time of collision. Therefore we can say that the driver of the truck collided at full speed with the motor-bike driver who was riding at practically the same speed in front of him in the same direction.

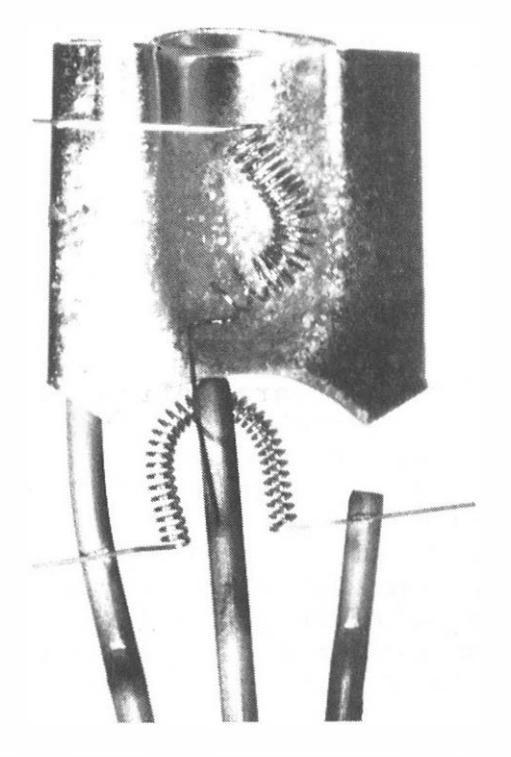
The filaments in a light bulb are made of tungsten wire and are very brittle in cold state. When submitted to an impact they can break at any place and the surfaces of fracture will show a typical crystalline structure. In cold state, filaments can hardly be deformed.

If electric current passes through the filament the material is much more elastic. At an impact it can be deformed permanently.

Such deformations can cause a disintegration of the filament, showing at its broken ends taperings and melt-pearls or other traces of melting. All these traces are evaluated unter the stereomicroscope and if necessary, additionally under the scanning electron microscope. If in course of collision the glass bulb becomes destroyed or leaking while electric current passes a filament, oxygen from the air comes in touch with the glowing filament. The tungsten oxidizes producing yellowish tungsten oxide that evaporates and condenses at cooler places, such as at the electrodes, the low beam filament shield etc. If the electric current is interrupted just before the bulb breaks, the filament cools down in air which leads to famous colours at the filament or at the shield caused by the temperature. At a head-on crash between a car and a motor cycle, the driver of the car insisted that the light of the motor cycle was not

of the car insisted that the light of the motor cycle was not on. The head lamp bulb had remained intact. The low beam filament was broken, both parts not being deformed. The main beam filament however, was considerably stretched and melted through. The conclusion that electric current passed the main beam filament at the moment of impact confirmed the statement of the motor cyclist.
