Otte, D. Accident Research Unit Medical University Hanover

ABSTRACT

Key words; In-depth investigation, accident analysis, airbag deployment, airbag non-deployment, airbag in juries

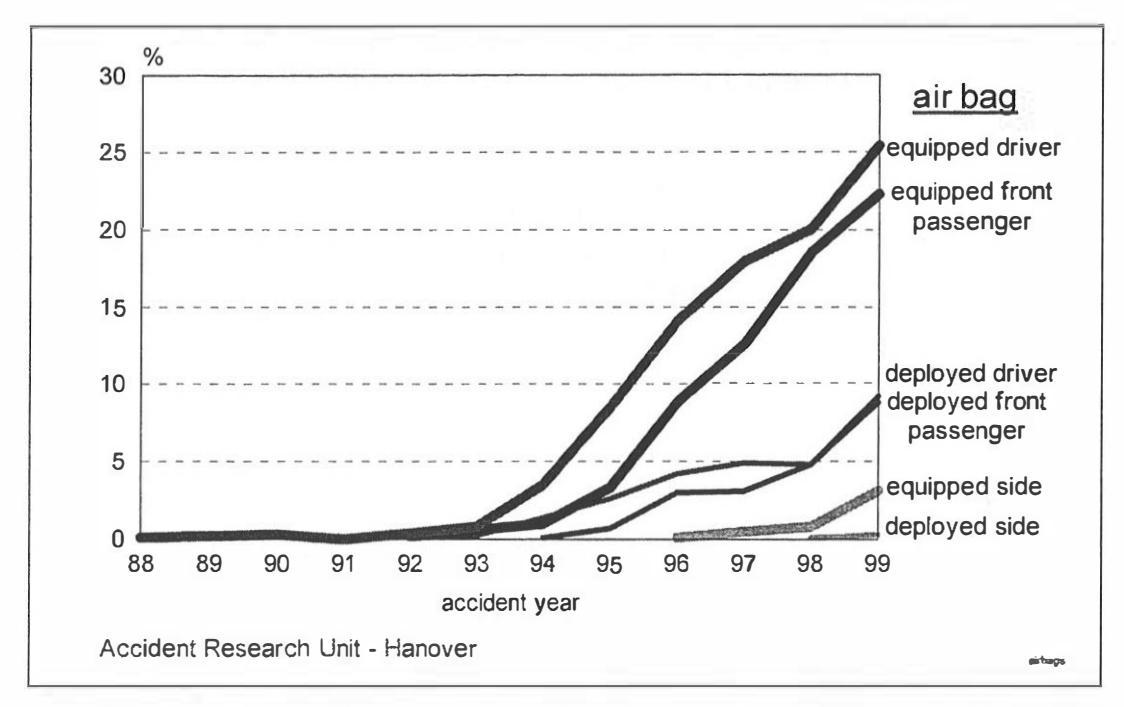
Figure 1 Frequencies of equipment and deployment of air bag systems in cars distributed according to accident year (in-depth study Hanover)

A CONSIDERABLE NUMBER of cars on the road today are equipped with front airbags and side airbags. Many cars involved in accidents have an airbag system. Accident studies show that approximately ¹/₄ of all cars involved in accidents are equipped with driver and passenger airbags. Since approximately 1996, some cars involved in accidents have been equipped with side airbags too. In 1999 3% of cars involved in accidents were equipped with side airbags (Figure 1). It also shows that the airbag was released in only about 1/3 of vehicles equipped with airbags.

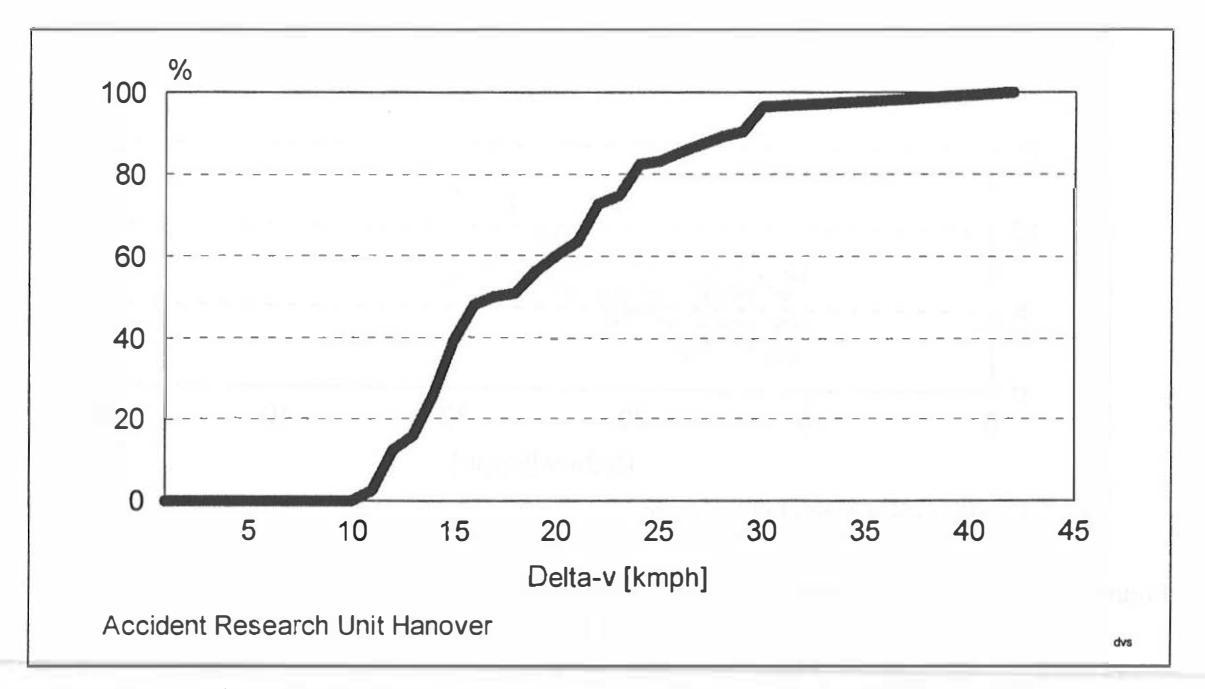
Figure 2 Delta-v distribution of cars in frontal collision (n=66), in which an air bag was not deployed

HEAD-ON COLLISION, IN WHICH A FRONT AIR BAG WAS NOT DEPLOYED During the analysis of 66 cases of head-on collisions, in which a front air bag was not deployed, in 64 of these cases, this could be attributed to collision conditions and/or the low impact intensity. Thus, the figure below shows that almost all values of collision-related speed change are below 30 km/h (Figure 2), thus, predominant lower degree of accident severity does exist for these cases.

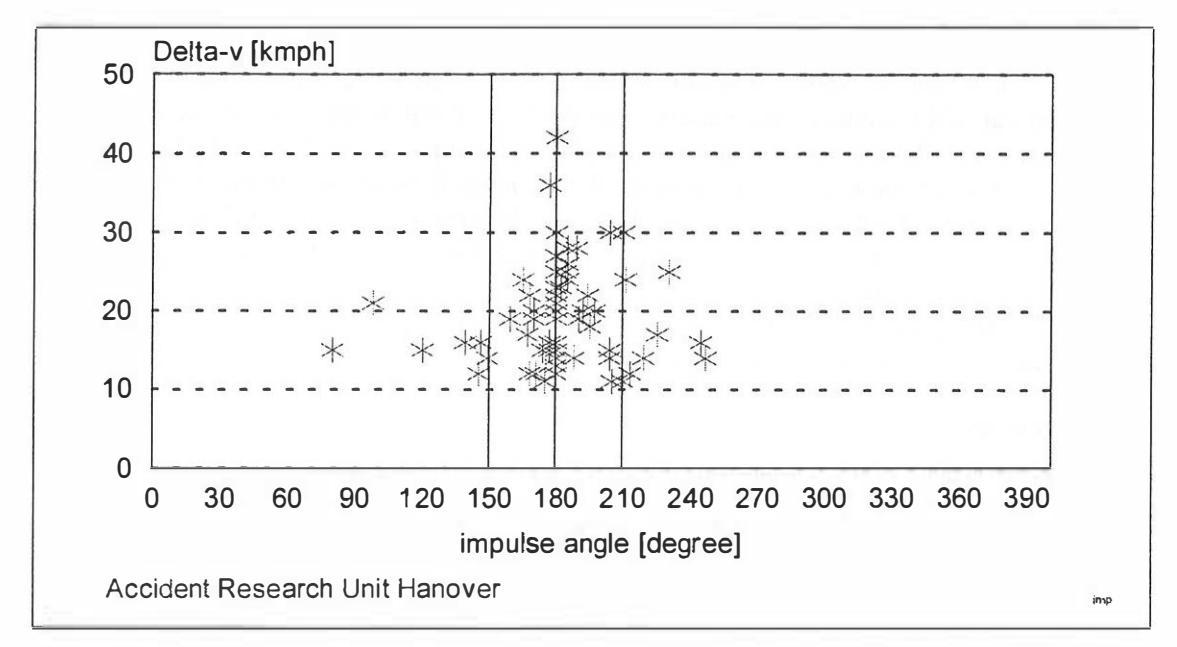
Figure 3 Impulse angle of cars according to delta-v during frontal collision (n=66), in which the frontal air bag was not deployed, marked is the ± 30° trigger area

Also, 82% of impulse angle was primarily $\pm 30^{\circ}$ to the longitudinal axis of the vehicle (Figure 3), only in n = 12 cases (18%) was an oblique impulse transfer greater than 30° observed.

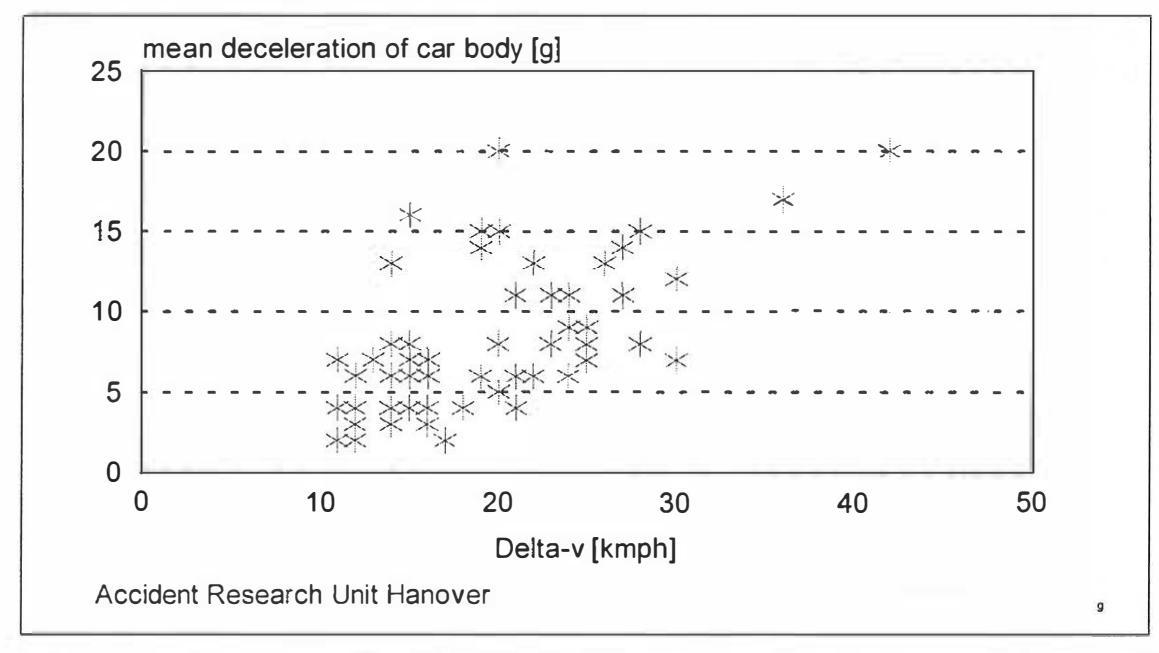
Analysing the frontal collisions with non-deployment of frontal air bags, it can be established, that the trigger level for deployment of the air bag was not obtained. This can be seen by the calculated mean decelerations of the car body with a maximum of only 20 g (Figure 4), calculated by speed change value and the maximal deformation depth.

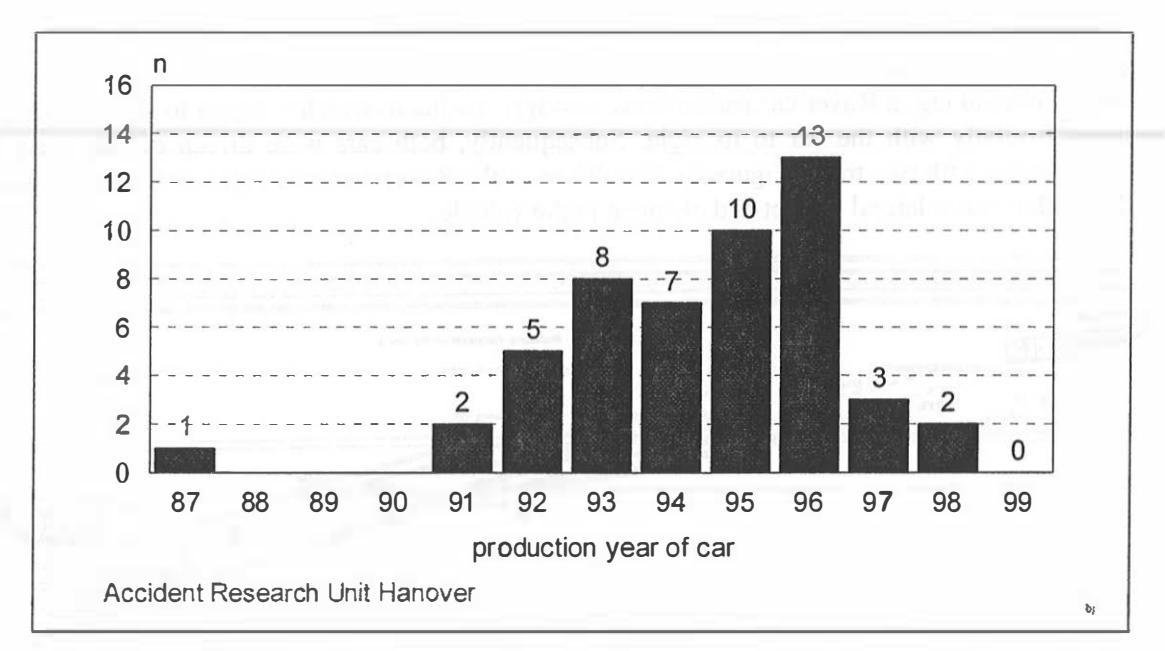
Figure 5 Distribution of year of production for cars involved in frontal collisions with no air bag deployment (n=51, 15 years of production not known)

As a whole, the analysis of head-on collisions, in which a front air bag was not deployed, indicates that in the most cases these were older cars with the year of first registration up to 1996 (Figure 5). This means that such situations will probably not so often occur in newer vehicles with optimised systems.

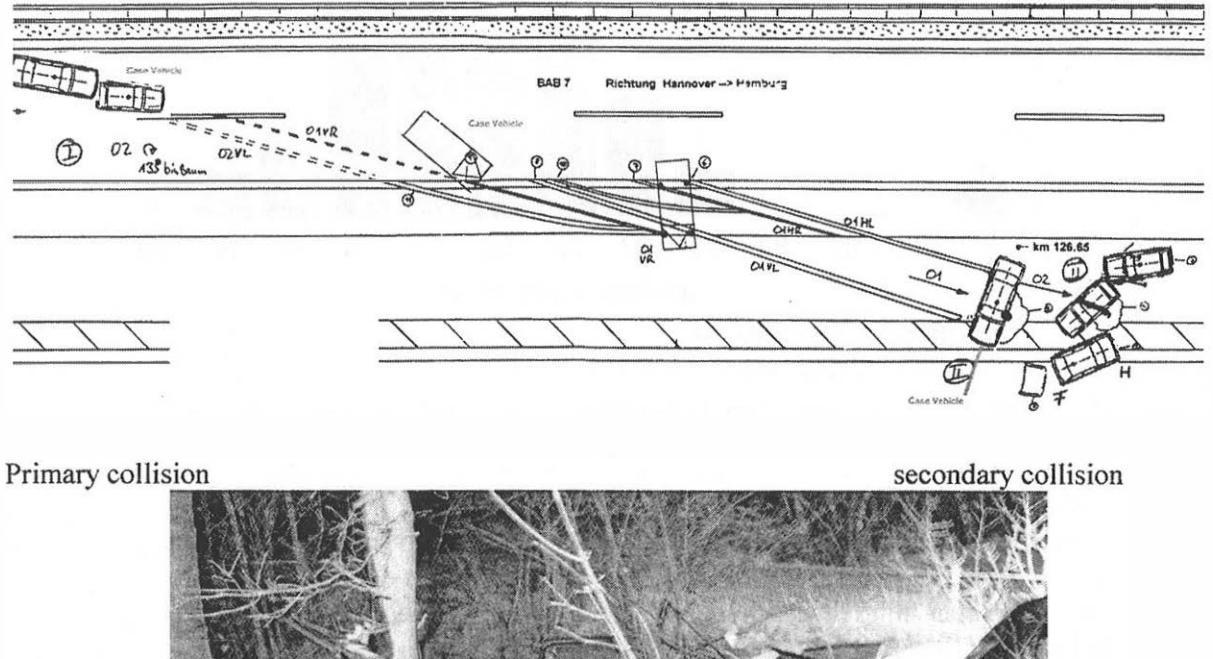
Figure 6 Example fatal accident

While overtaking, a Rover car had to brake strongly, owing to which it began to skid. As result, it collided frontally with the car to its right. Subsequently, both cars were driven off the road. The Rover collided with two trees (Figure 6). The driver of the Rover was fatal injured during this second collision that was a lateral impact and clamped in the vehicle.

The reconstruction of the accident, showed that during the primary collision with the other car, the Rover was travelling at 118 km/h. The vehicle collided frontal with the right front part of the rear of the other vehicle. Delta-v and ESS were approximately 10 km/h only. Then, the Rover collided with the left side of the vehicle near the A-pillar with a tree, the speed of impact was approximately 80 km/h, Delta-v and ESS were around 60 km/h. During this collision, the front part of the vehicle was torn off.

It is very difficult to assess just how much the driver would have been protected during this collision if the front airbag had released. This case clearly illustrates the problems associated with multiple collisions. During the first collision, the severity of the accident with approximately 10 km/h was not sufficient to deploy the front air bag. During the secondary collision, only a side air bag would have been helpful.

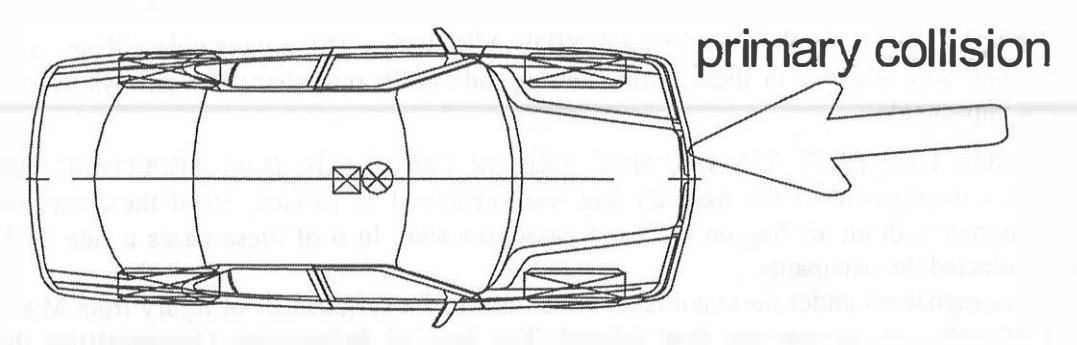
Figure 7 Impact situation of a car with deployment of all driver related air bag systems

A BMW 328 collided against a tree following in a longitudinal deceleration, without rotation. All three airbags were released on the driver's side, front airbag in the steering wheel, the side airbag in the driver's side door and the upper side airbag in the roof frame (Figure 7).

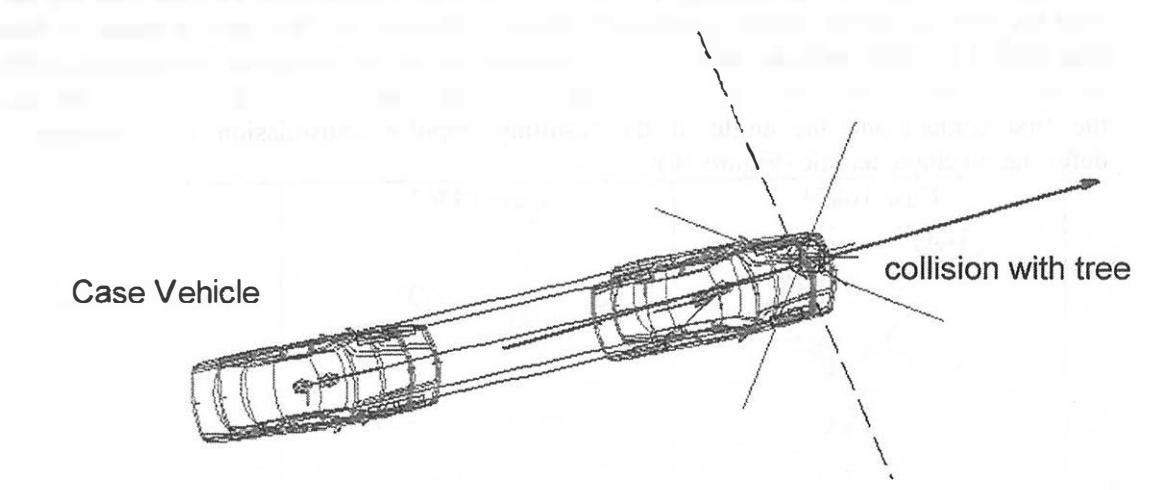
Figure 8 Reconstruction of an accident of a car with deployment of all driver-side air bags

During the reconstruction (Figure 8), on the basis of the final position and the traces on the road, vehicle and environment a collision speed of approximately 55 km/h was determined at Delta-v and ESS of approximately 50 km/h.

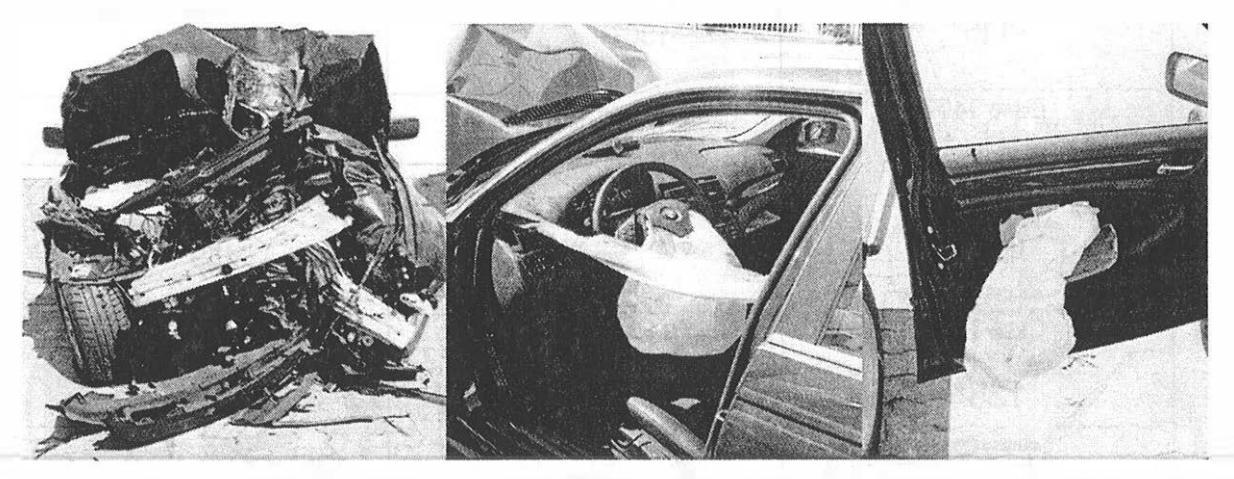
Figure 9

The driver was protected by a seat belt and the steering wheel air bag. The driver suffered a neck strain so called whiplash in jury (AIS 1), no other injuries were found.

Car with deployment of all driver-side air bags (steering wheel, door and Inflatable Tubelar Structure ITS)

The deployment of the side air bags may be the result of a small side-related part of the impact. This case is a good example for full fire theory of all existing air bags. The deployment of the side bag instead of a frontal collision had no negative consequences to the injury result of the driver.

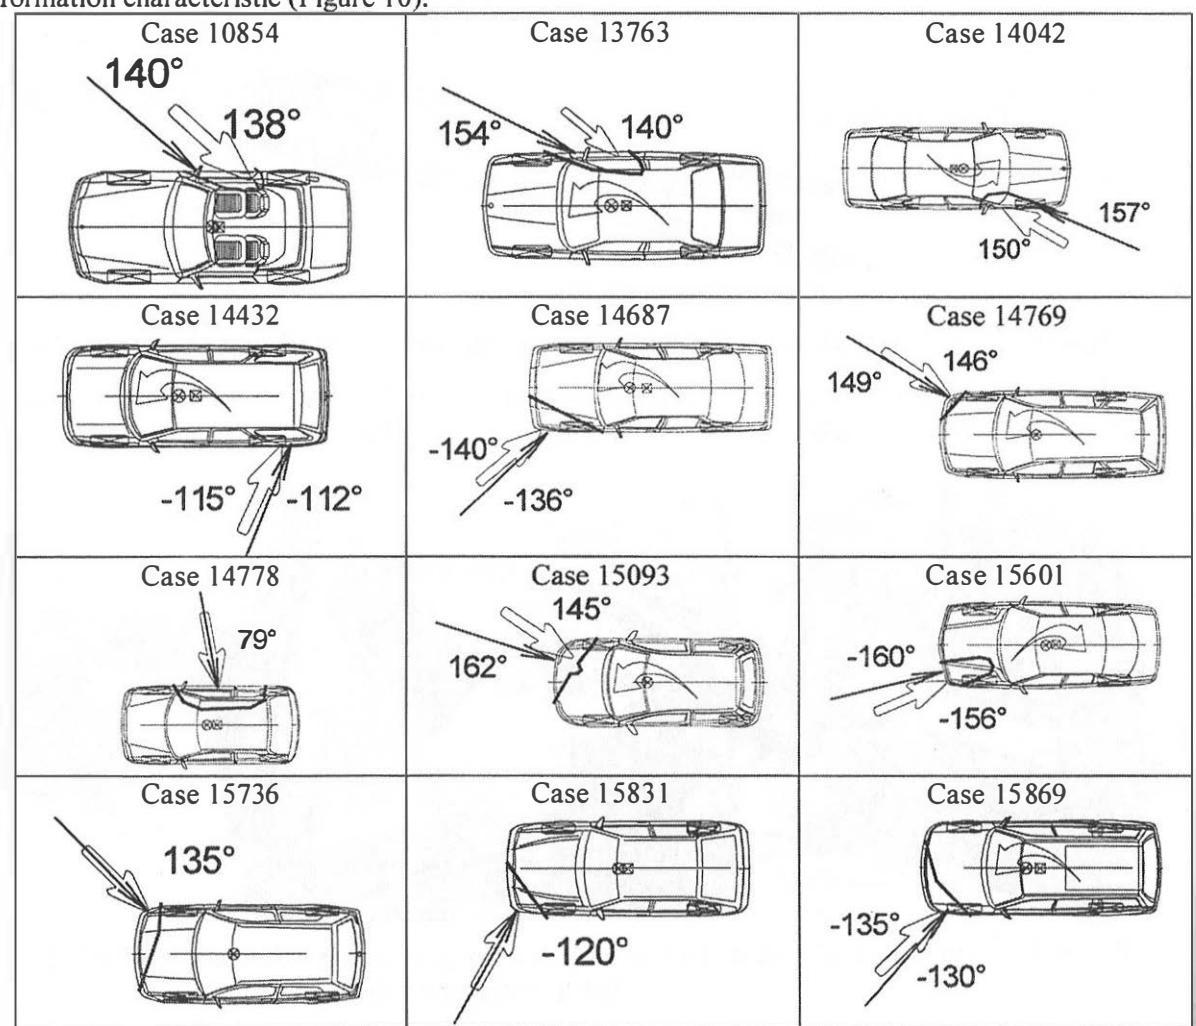
The 18 cases registered under these collision conditions had a seriousness of injury from MAIS 0 to MAIS 4, whereby one person was fatal injured. The detailed deformation characteristics show clearly in all cases a resulting side deformation with resulting lateral impact impulse direction, however mostly oblique impact run-in direction. In all cases a frontal component was determined during the first part of deformation process, which could be explained by the difference of impulse and impact run-in angle. 2/3 of the vehicles swerved before the accident and show a rotation around the high axis, right or left rotating. The resulting direction and the vehicle structure deformed, so that during the deformation period the car rotated further to maximum deformation while impact impulse transfer. Within the framework of the accident reconstruction, the angle of the directions of the first contact and the angle of the resulting impulse transmission was evaluated from the deformation characteristic (Figure 10).

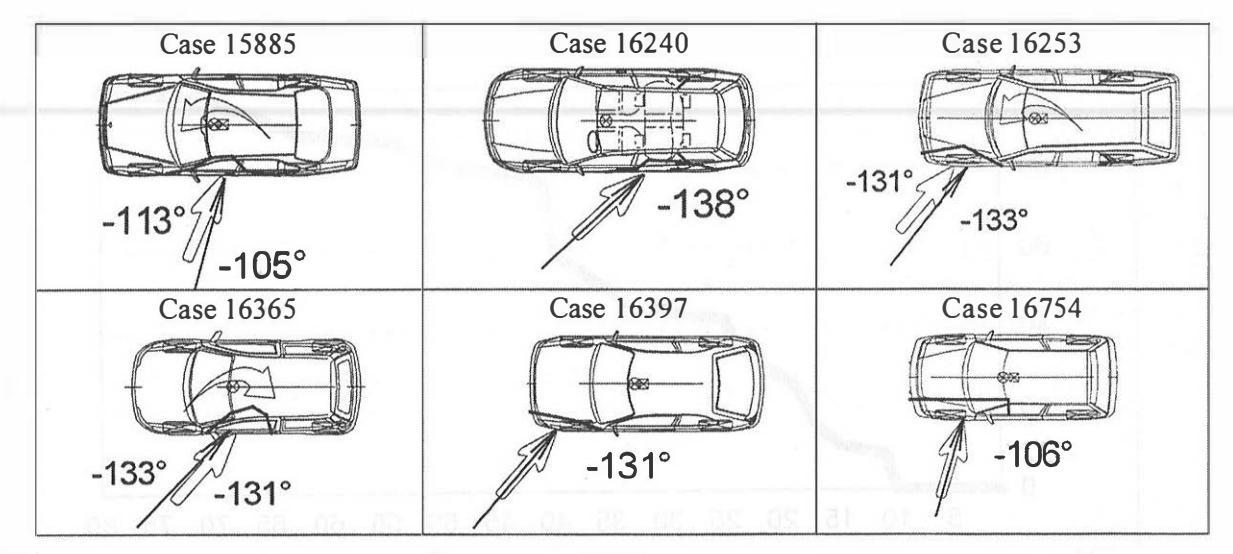
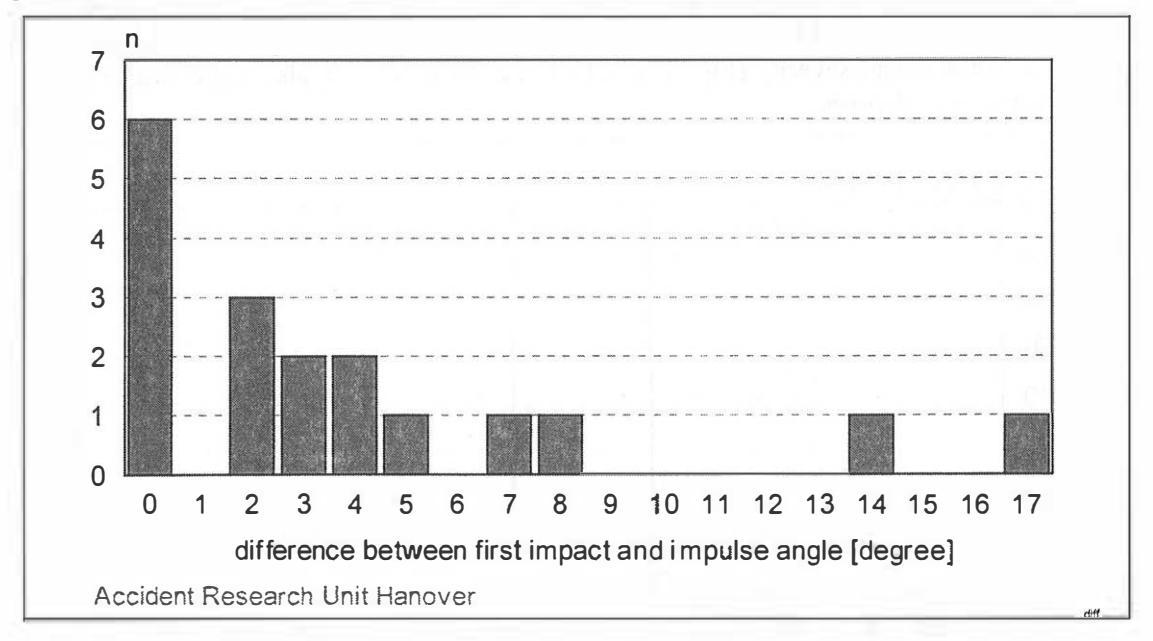
Only one third of the cars (n=6) did not rotate before collision and no difference between impulse and run-in angle could be established. In the other cases this difference was between 2 and 17 degrees (Figure 11).

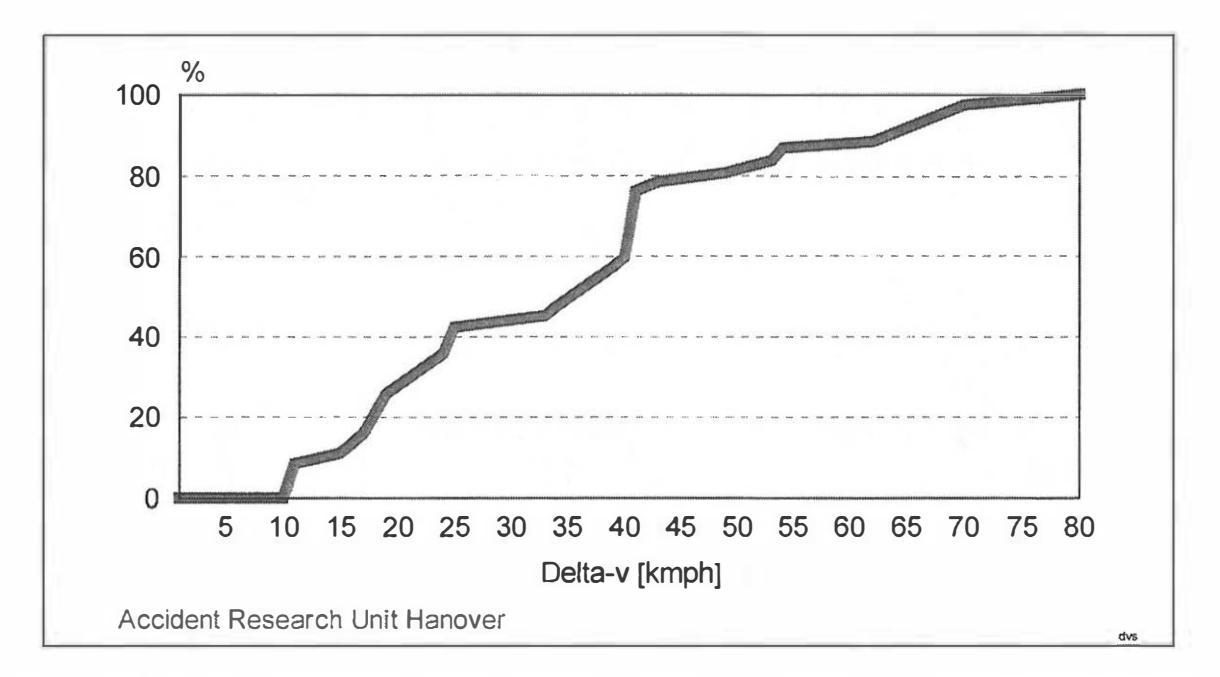
Almost 80 % of the cars involved in side collisions and head-on collisions, collided with a Delta-v of up to 40 km/h (Figure 12).

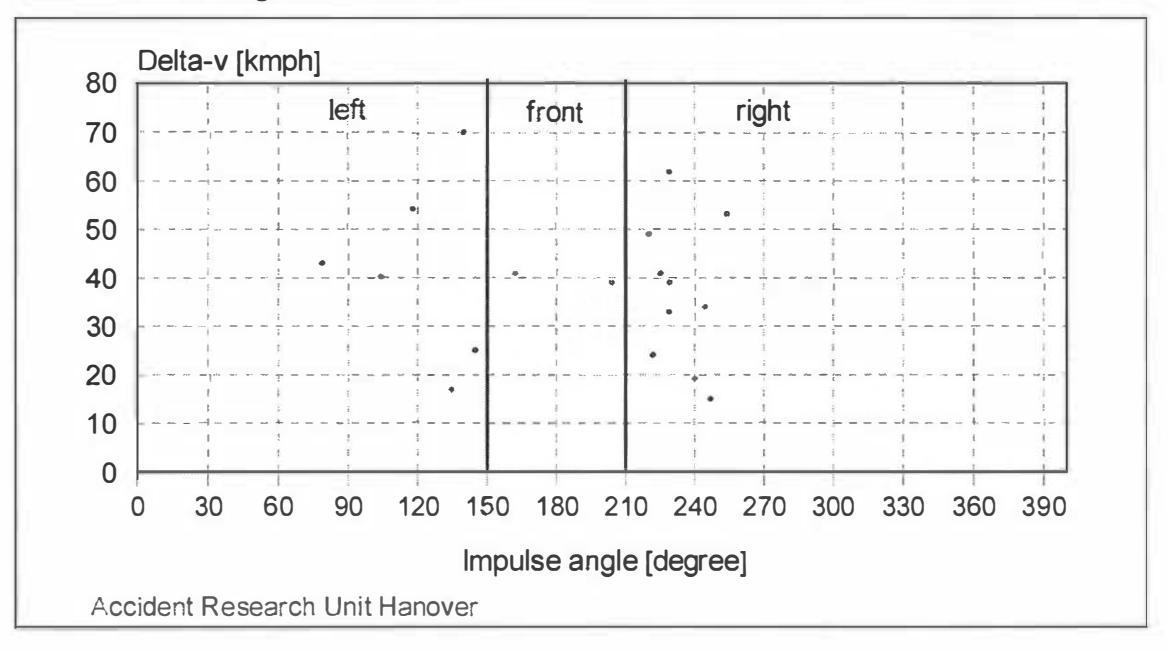
The distribution of the resulting impulse angle shows two frequent occurrences in the areas, inclined front right (130 to 150 degrees) and inclined left (220 to 250 degrees) without a significant influence of the accident severity (Figure 13). Only for 2 cars the impulse angle was in longitudinal direction within ± 30 degrees.

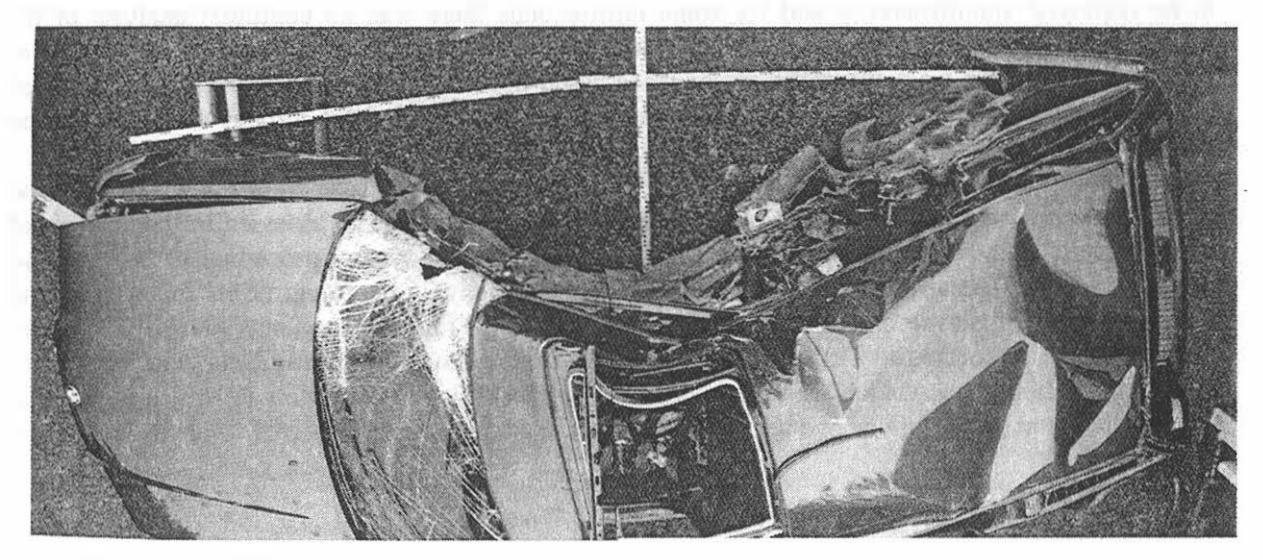
Figure 14 Side impact with deployment of frontal air bag and non-deployment of side bag

Examination revealed considerable bleeding in both hemispheres with displacement of the ventricle and subarachnoidal bleeding as well as massive contusion on the right with haematothorax and pneumothorax. The side airbag installed in the car was not deployed, the front airbag was deployed.

The car had a huge dent on the right side, starting from the frontal A-pillar and extending to the rear C-pillar, running into the area of the rear axle. The deformation characteristic made it possible to recognise an almost even deformation characteristic with a clear imprint of the front of the opposite car. There was a maximum side penetration of 85 cm in the area of the middle of the front passenger door. The right B-pillar moved approximately 60 cm into the inside of the car at the height of the lower edge of the window frame (Figure 14).

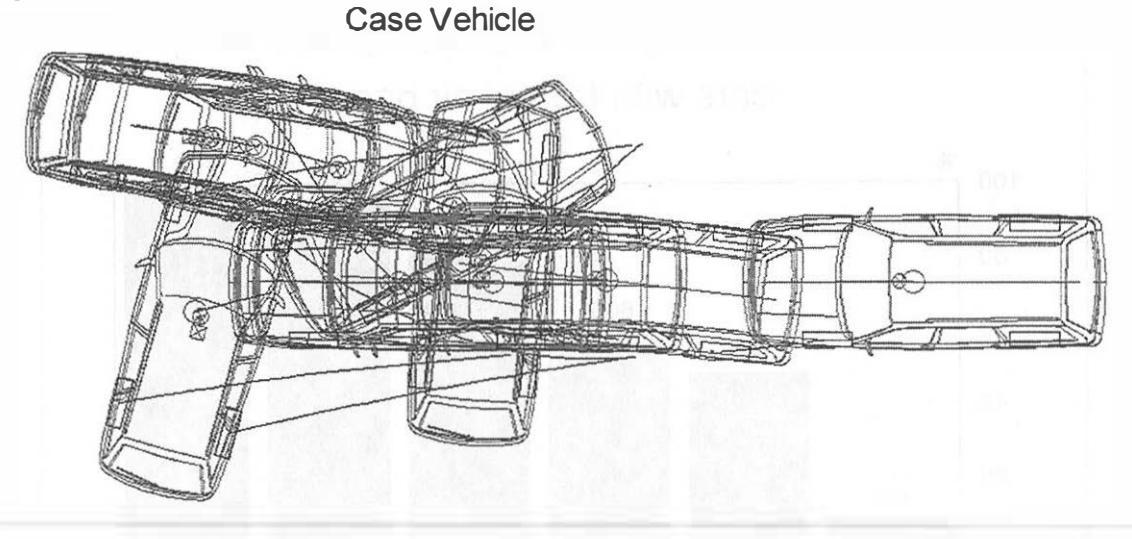
Figure 15 PC-Crash-Analysis with collision position and movement after impact

The exact accident reconstruction by means of PC crash² showed a change in speed as a result of the collision amounting to approximately 60 km/h as well as a right-angle impact impulse transfer (Figure 15).

The driver, who was protected by a seat belt was held back in the pelvis area only, while the driver's shoulder belt goes from the left shoulder to the right iliac crest and consequently the top part of the body cold move out to the middle region of the interior. Contrary to this relative movement, the right side of the car was deformed and the passenger's side door moved in, so that the upper part of

the body banged head first against the right B-pillar and the thorax was put under pressure in the area of the right front passenger back rest. The front passenger seat was completely pushed diagonal over the middle tunnel area towards the driver's side. The sensor and release module for the side airbag on the front passenger side including the deployed airbag module were removed and insofar as retrospectively possible from the accident analysis a time analysis of the occupants' kinetics was performed. The evaluation of the algorithm resulted in the fact that the data relevant to the crash in the central control equipment as well as in the satellite sensor, had registered a head-on collision, thus the front airbag had been deployed, but no lateral impact was detected. This took place between 7 and 15 ms after the first contact. In the case described above it was not possible for a front and side airbag to be deployed simultaneously and for some milliseconds there was no continual analysis of the impact signal. Thus, in this case, the impact characteristic of a side collision compiled by the sensor system and resulting from the collision sequence could not be identified. By contrast, the detected primary head-on impulse component started the deployment of the front airbags which served no purpose here.

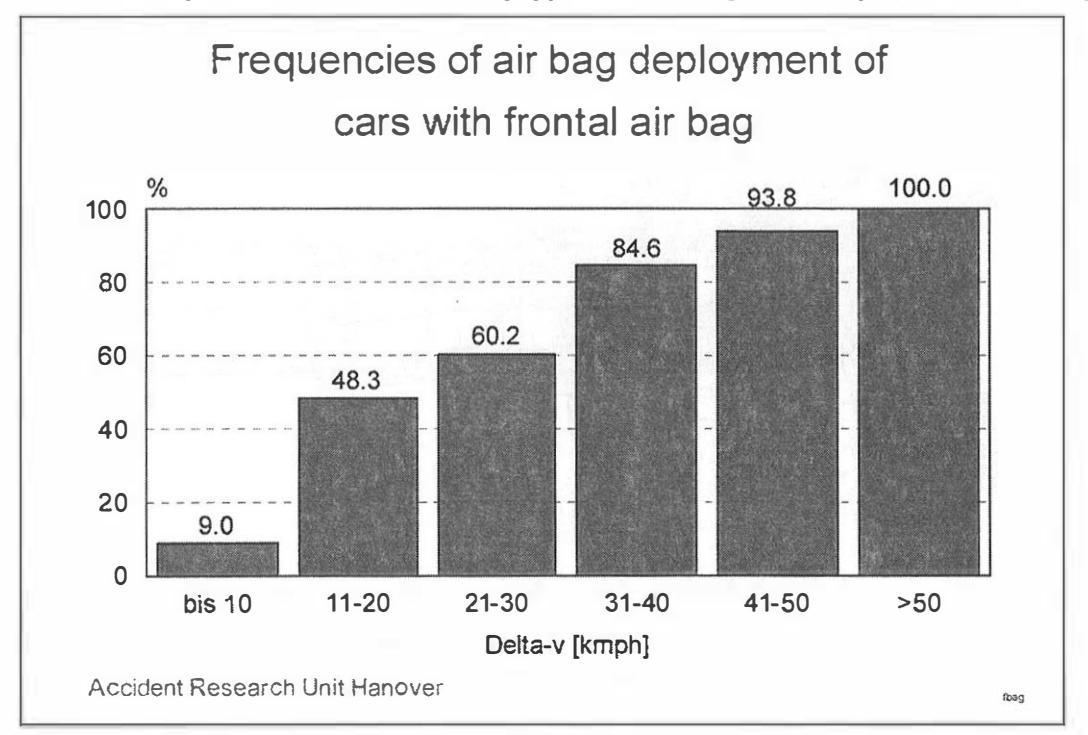
Looking at the ratio of vehicles in traffic accidents, it is striking that around ¹/₄ of all vehicles are equipped with front airbags, but only about 40% of the airbags are deployed. The proportion of deployed airbags increases with increasing speed change Delta-v (Figure 16), for instance in Delta-v range of 21 to 30 kmph 60.2% of the vehicles equipped with air bags had a deployment of the bag.
