## Airbag Jacket for Motorcyclists: Evaluation of Real Effectiveness

**Abstract** This paper aims to evaluate the level of protection offered by airbag jackets for Powered Two Wheeler users. This study is based on a double approach which combines real accident data collected with a field survey and experimental data obtained in laboratory.

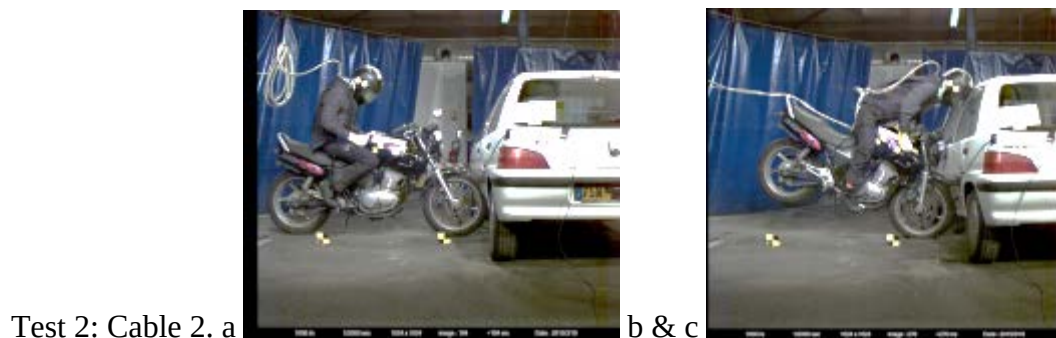
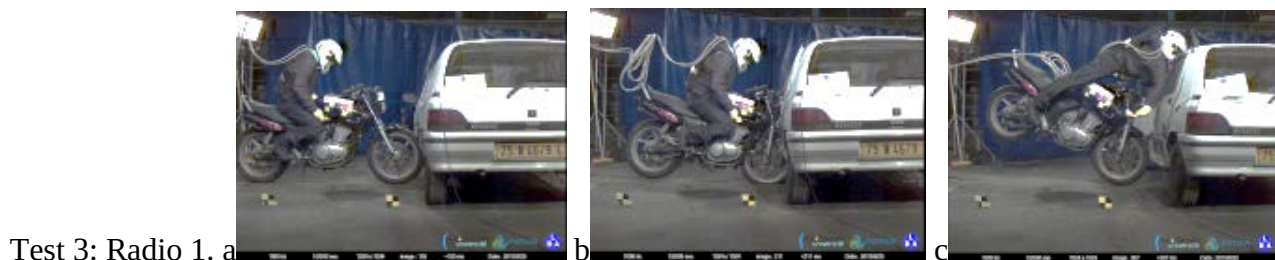
Fig. 5. Chronology of the four crash tests. Test 1 & 2 with mechanical triggering (cable), Test 3 & 4 with electronic triggering (radio).

Figure 5 shows the chronology of the four crash-tests in three images:

- a) The first image corresponds to the first contact between the front wheel and the obstacle. This contact has been considered as  $t=0$ ms.
- b) The second image corresponds to the triggering of the airbag jacket.
- c) The third image corresponds to the contact between the motorcyclist and the obstacle.

From a general point of view, it can be observed that the airbag jackets with cable are triggered later than electronic ones. All the airbag jackets except during test n°2 were triggered before the impact of the motorcyclist against the obstacle.
